The Slade School of Fine Art
Gower St London WC1E 6BT
External Repairs

Gutter Detail 1
Top of gutter outside Store
As Existing

identifier :
4682-FBR-A1-XX-DR-A-156

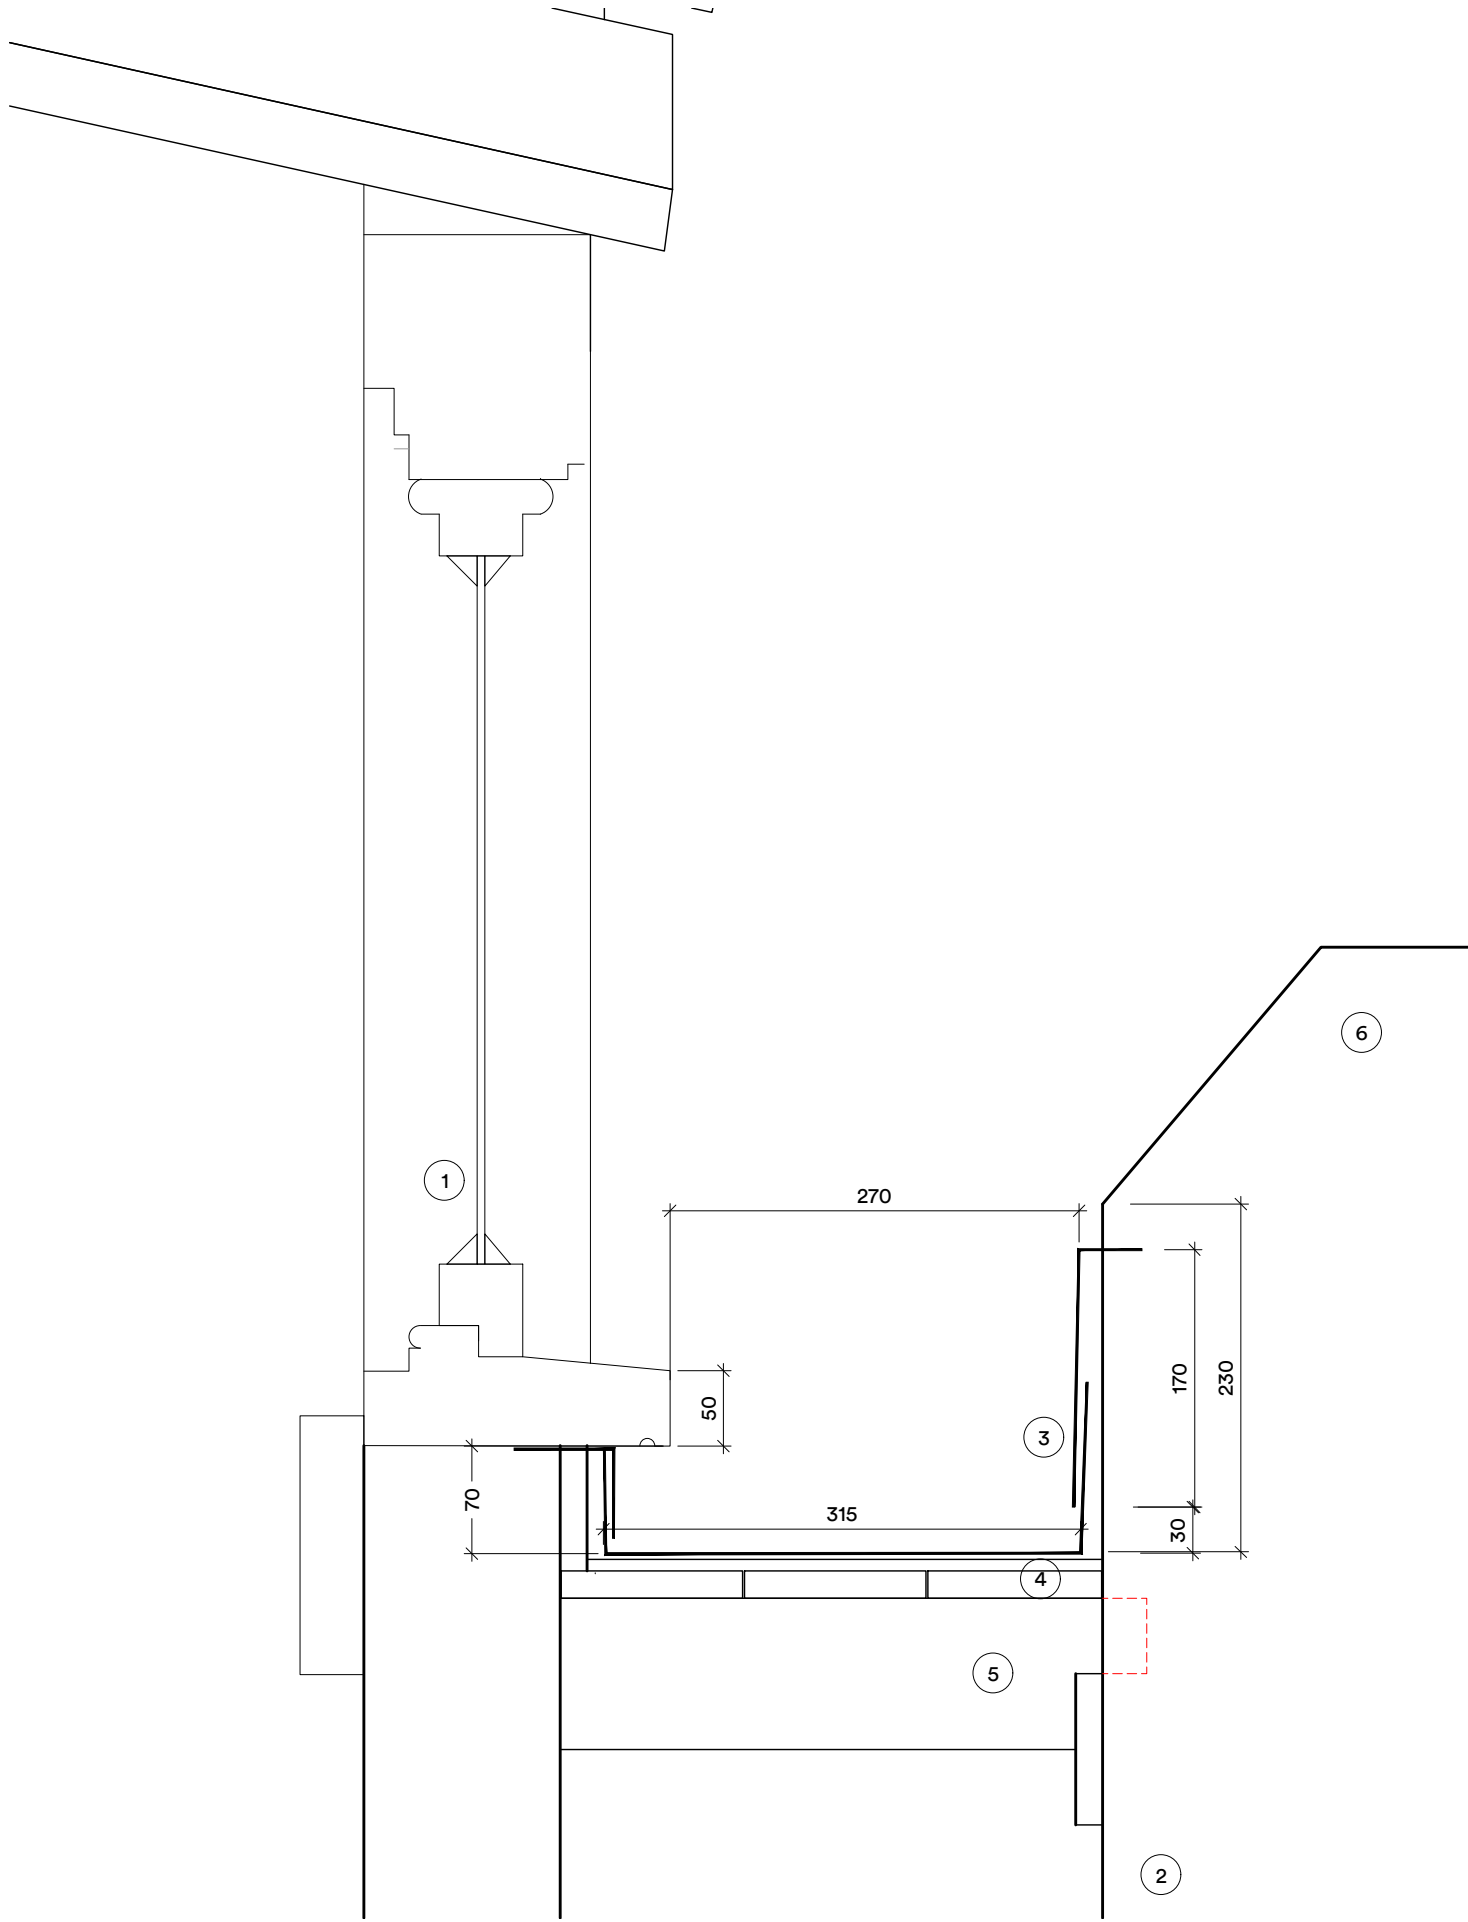
Top of gutter detail outside Store window
As Existing

- 1 Existing timber clerestorey Window to Store
- 2 Existing brickwork
- 3 Existing lead lined gutter
- 4 Timber furring and boards below lead gutter
- 5 Timber joists below timber boards assumed notched into brickwork
- 6 Existing facing stonework
