GEOTECHNICAL SURVEY REPORT

**16 Pilgrim's Lane
London
NW3 1SN**

Site Investigation &
Basement Impact Assessment

J22352
Rev 0

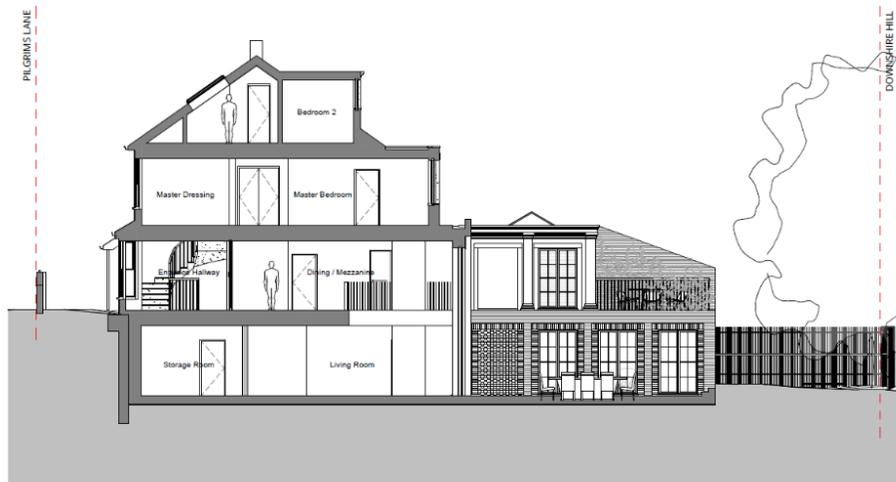
Proposed Section AA
1 : 100

It is understood that it is proposed to extend the existing lower ground floor level beneath the full footprint of the house, and construct a new rear extension and terrace, as part of alterations to the house. Formation level for the proposed lower ground floor level is understood to be approximately 3.60 m below the existing ground floor level, which is around 1.00 m below the existing lower ground floor level.

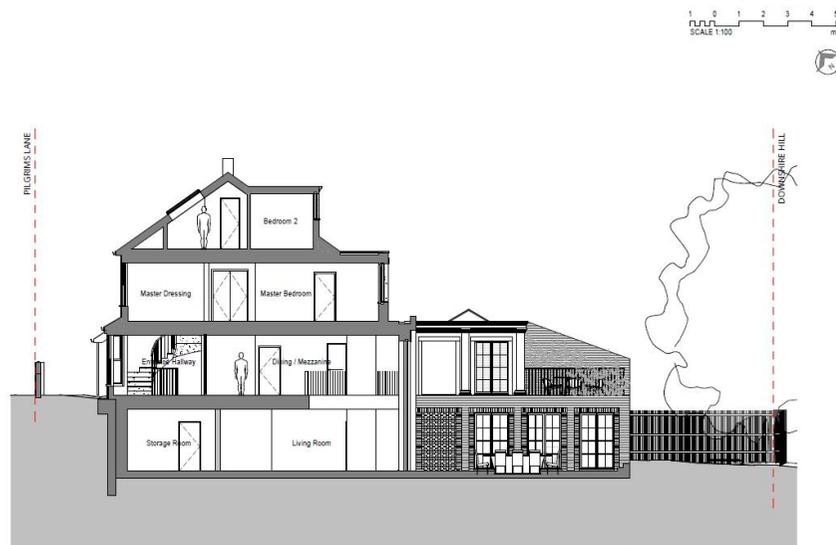
Proposed Section AA
1:100

It is understood that it is proposed to extend the existing lower ground floor level beneath the full footprint of the house, and construct a new rear extension and terrace, as part of alterations to the house. Formation level for the proposed lower ground floor level is understood to be approximately 3.60 m below the existing ground floor level, which is around 1.00 m below the existing lower ground floor level, at roughly 79.00 m above Ordnance Datum (OD).

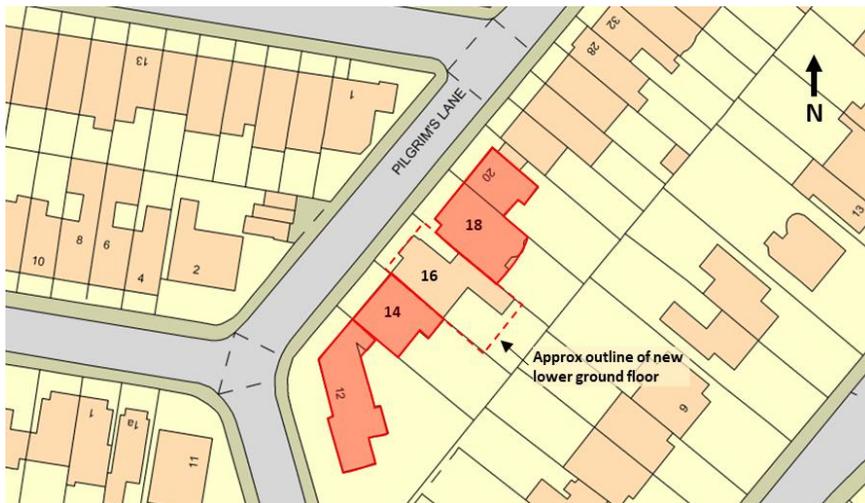
Nearby sensitive structures comprise the adjoining 18 and 20 Pilgrims Lane to the northeast and the adjoining 14 and 12 Pilgrims Lane to the southwest, as shown on the plan below.

The heights of the buildings have been estimated from observations, and from drawings provided by the consulting engineers. The underside of the foundations of 12 and 14 Pilgrims Lane have been determined based on the trial pitting completed at 12 Pilgrims Lane, the findings of which were found during a recent search of planning records held by Camden Council, and the foundations of 18 and 20 Pilgrims Lane have been assumed to be the same. Trial Pit No 2, excavated alongside the southeast flank wall of 18 Pilgrims Lane did not reveal the base of the foundation to this wall within the 1.39 m depth excavated, but the foundations to 18 Pilgrims Lane have been conservatively modelled at a depth of 0.70 m, as per 12, 14 and 20 Pilgrims Lane. The heights and underside of foundations are summarised in the table below.

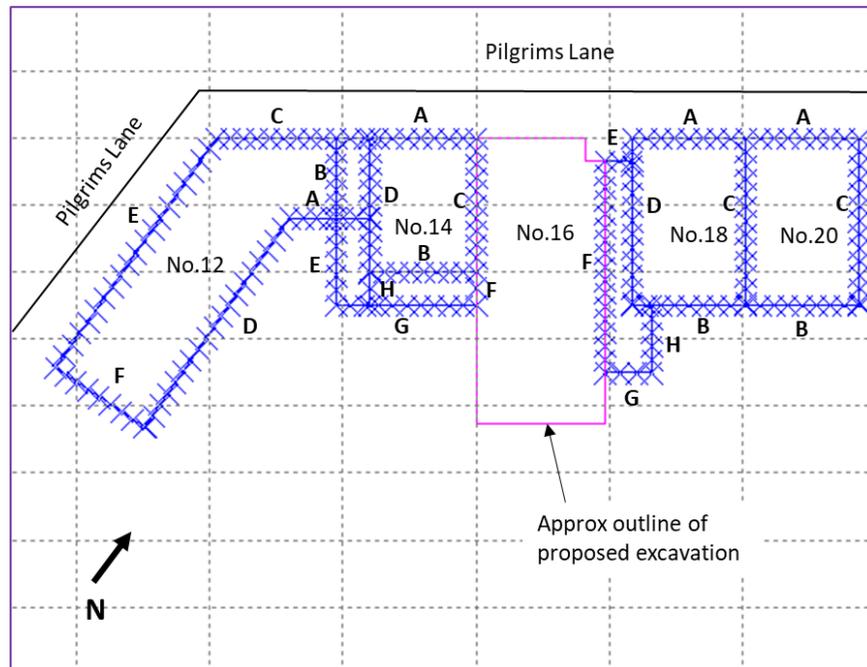
The sensitive structures outlined previously have been modelled as displacement lines in the analysis along which the damage assessment has been undertaken. The labelling adopted is shown on the diagram below.

Plan view of neighbouring structures and the labelling of each wall

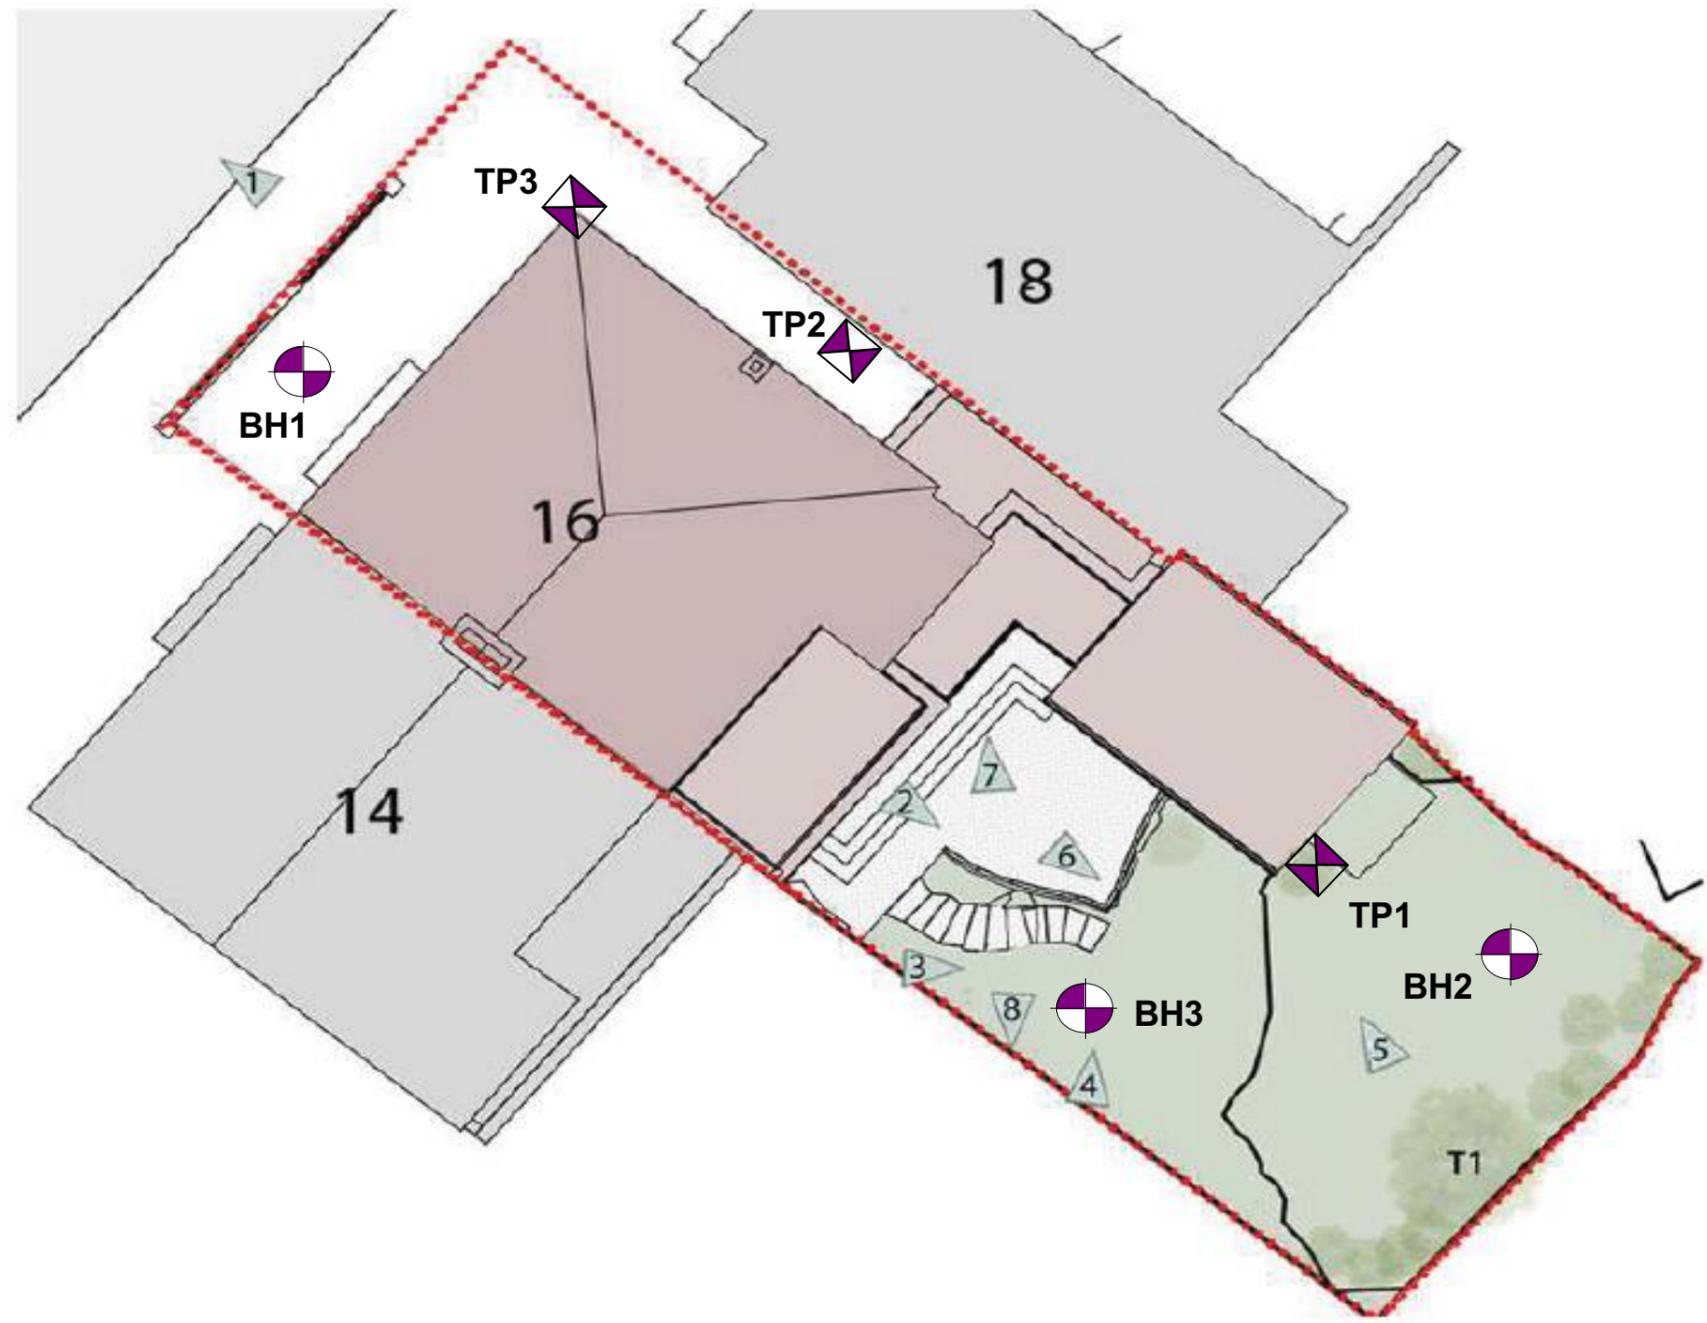
Project 16 Pilgrims Lane, London NW13 1SN				BOREHOLE No BH1	
Job No J22352	Date 16-11-22 16-11-22	Ground Level (m OD) 82.65	Co-Ordinates ()		
Client Mr Andrew Lavery		Engineer GSE		Sheet 1 of 1

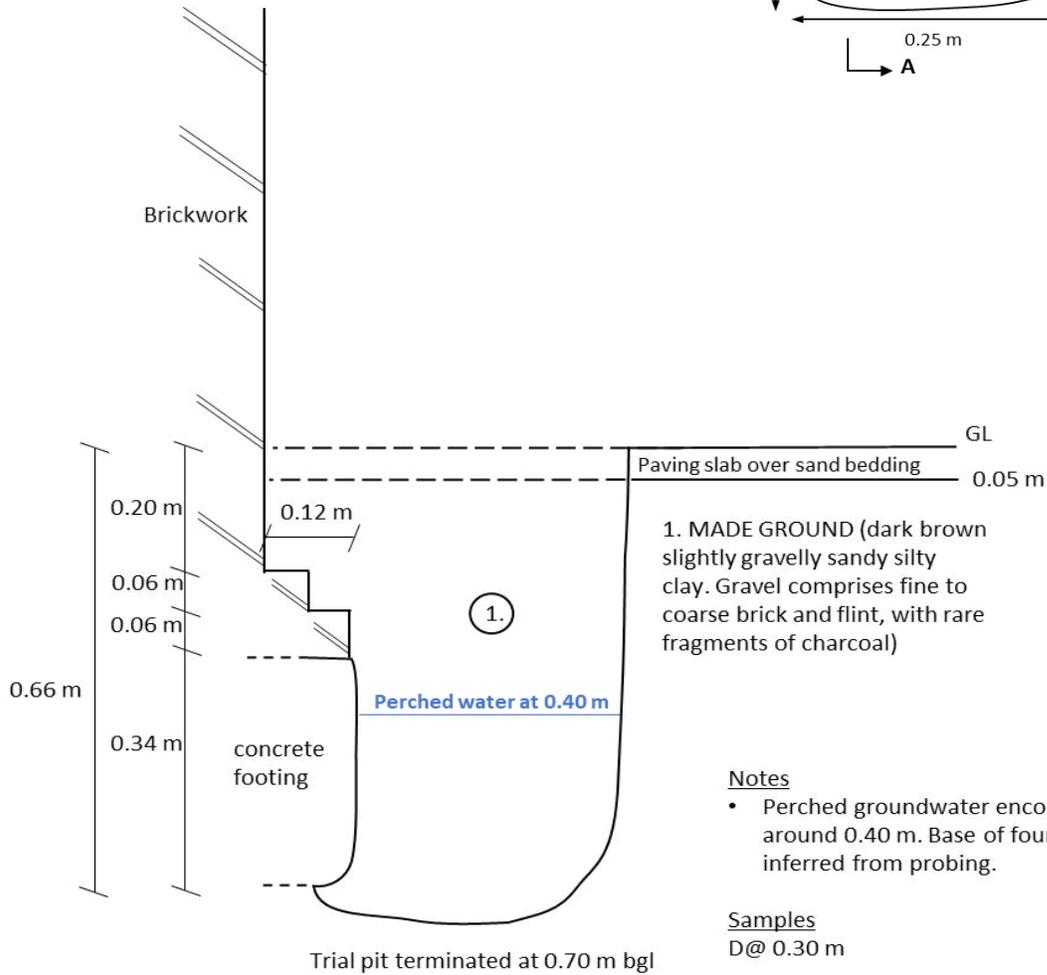
TP1: Section A-A

Remarks:
All dimensions in metres

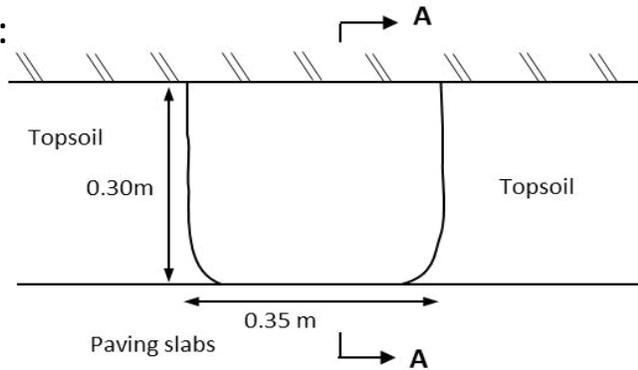
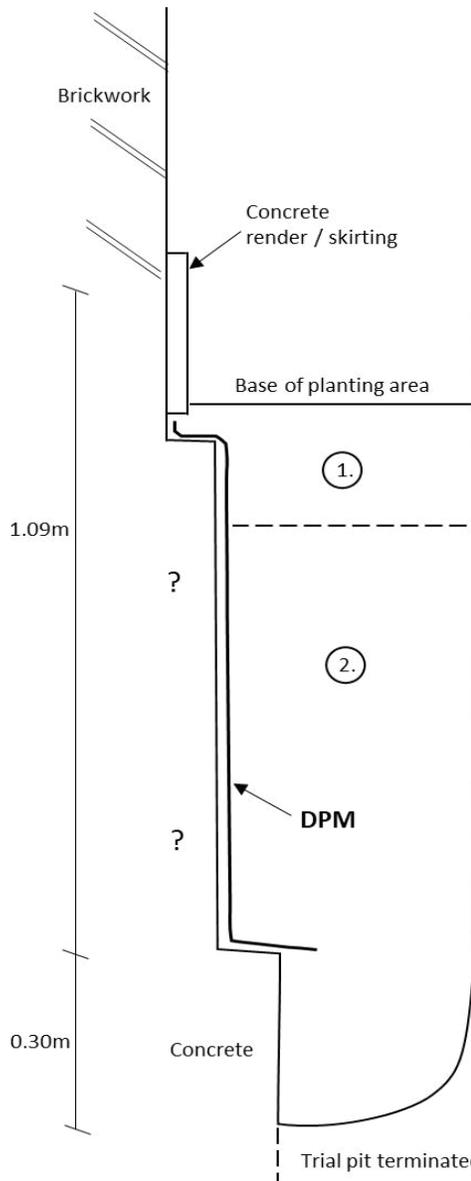
- GL
- Paving slabs 0.04m
- Concrete slab 0.19m
- 1. TOPSOIL (Dark brown organic slightly gravelly to gravelly sandy silty clay. Gravel comprises fine flint. Occasional roots) 0.39m

2. MADE / REWORKED GROUND (Greyish brown slightly sandy silty clay with occasional partings of reddish brown sand, and rare fine fragments of brick and flint)

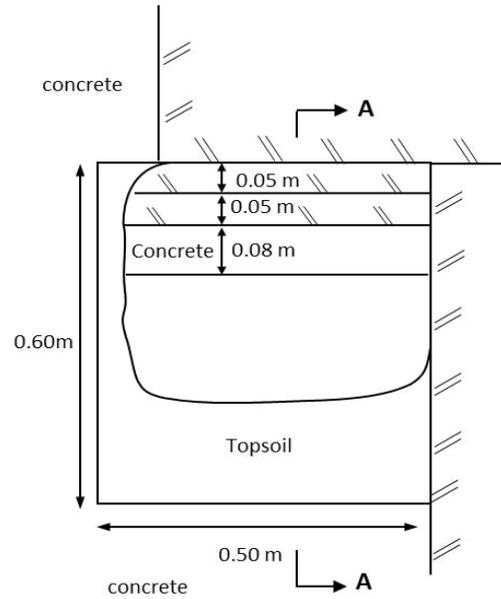
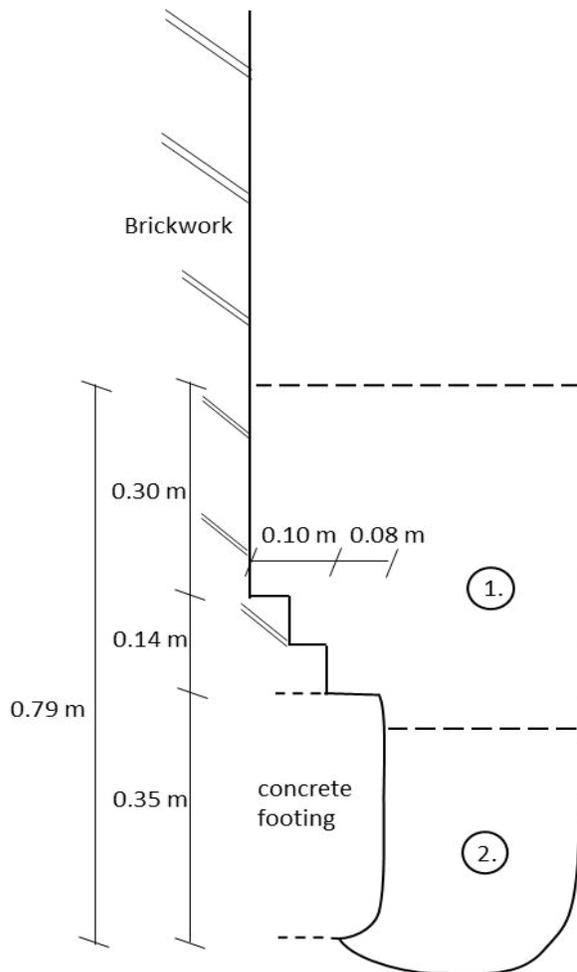
1. MADE GROUND (dark grey organic slightly gravelly silty very sandy clay with frequent roots (< 10 mm). Gravel comprises fine to coarse brick flint concrete and occasional charcoal and clinker fragments)

2. Brown mottled grey silty CLAY with blue grey veining and occasional roots (< 3 mm)

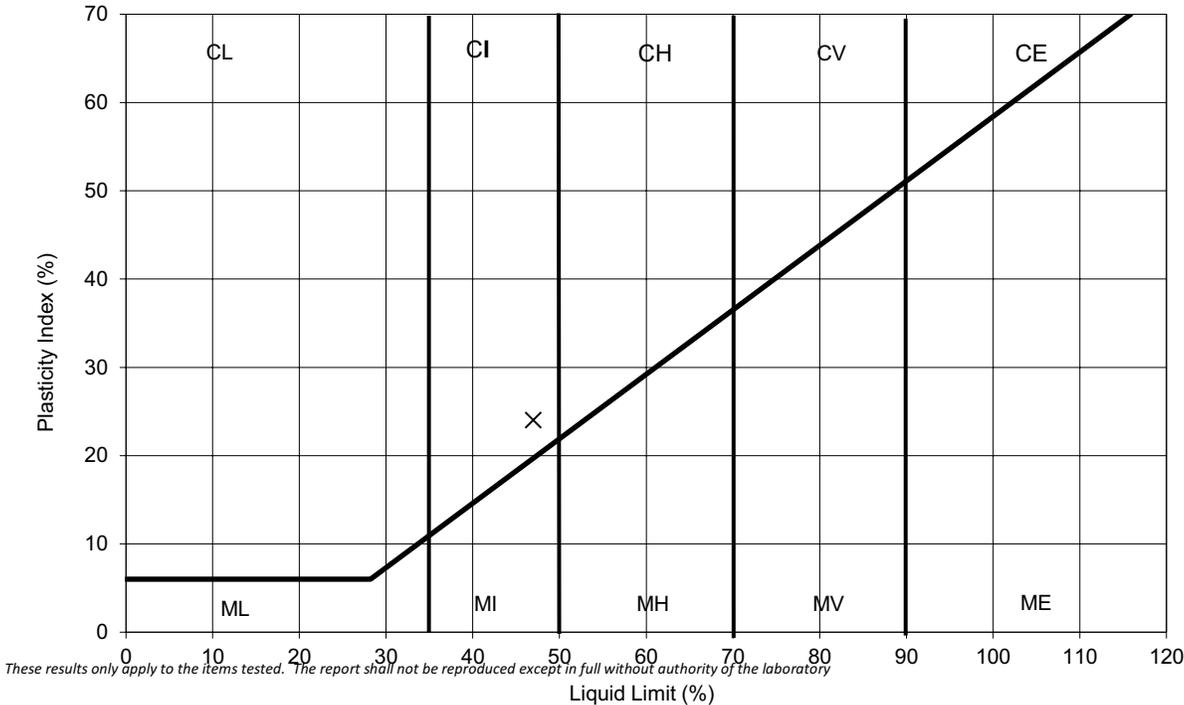
Site Name	16 Pilgrims Lane		
Project No.	J22352	Client	GEA
Soil Description	Orangish brown slightly mottled grey slightly sandy slightly gravelly silty CLAY (gravel is fm and sub-angular to rounded)

NATURAL MOISTURE CONTENT	26	%
% PASSING 425µm SIEVE	94	%
LIQUID LIMIT	47	%
PLASTIC LIMIT	23	%
PLASTICITY INDEX	24	%

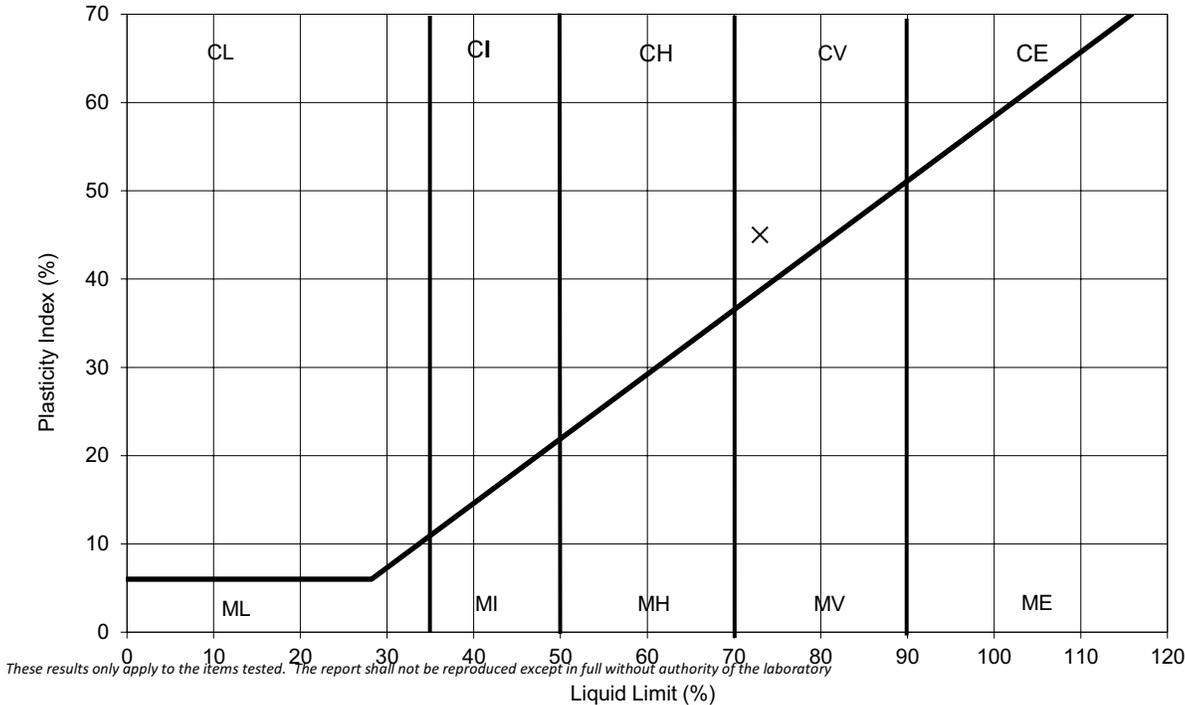
Site Name	16 Pilgrims Lane		
Project No.	J22352	Client	GEA
Soil Description	Orangish brown slightly mottled grey silty CLAY

NATURAL MOISTURE CONTENT	28	%
% PASSING 425µm SIEVE	100	%
LIQUID LIMIT	73	%
PLASTIC LIMIT	28	%
PLASTICITY INDEX	45	%

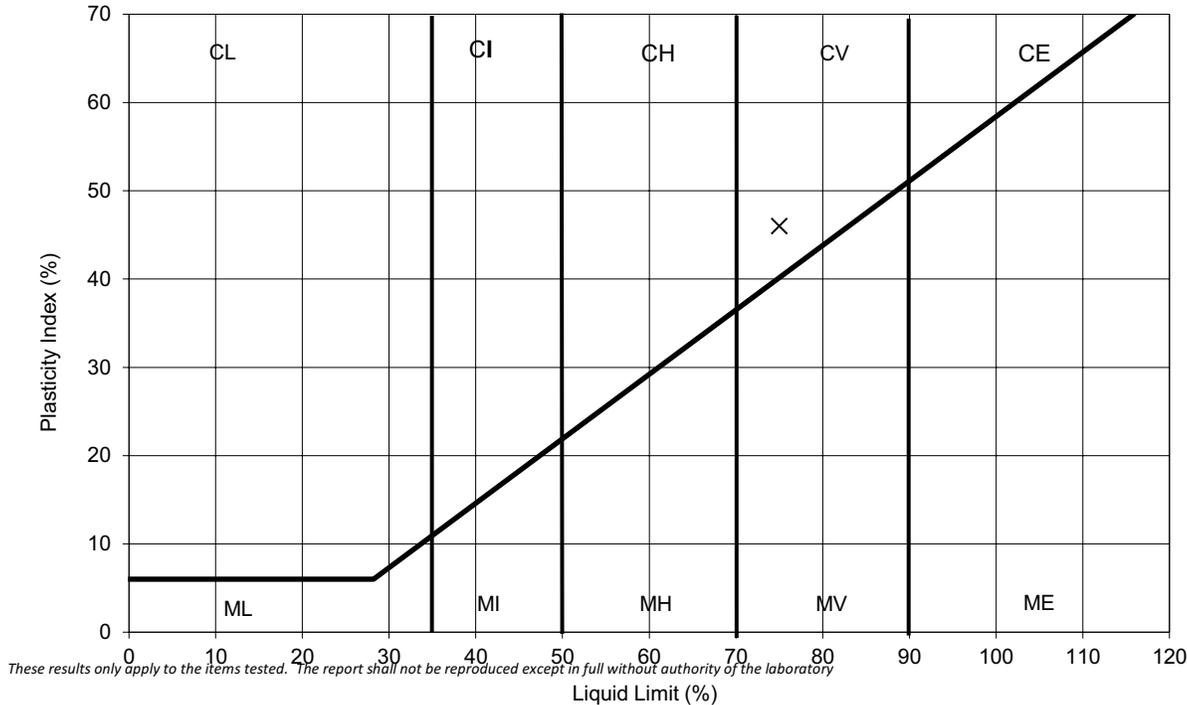
Site Name	16 Pilgrims Lane		
Project No.	J22352	Client	GEA
Soil Description	Orangish brown slightly mottled bluish grey silty CLAY with scattered selenite crystals

NATURAL MOISTURE CONTENT	30	%
% PASSING 425µm SIEVE	100	%
LIQUID LIMIT	75	%
PLASTIC LIMIT	29	%
PLASTICITY INDEX	46	%

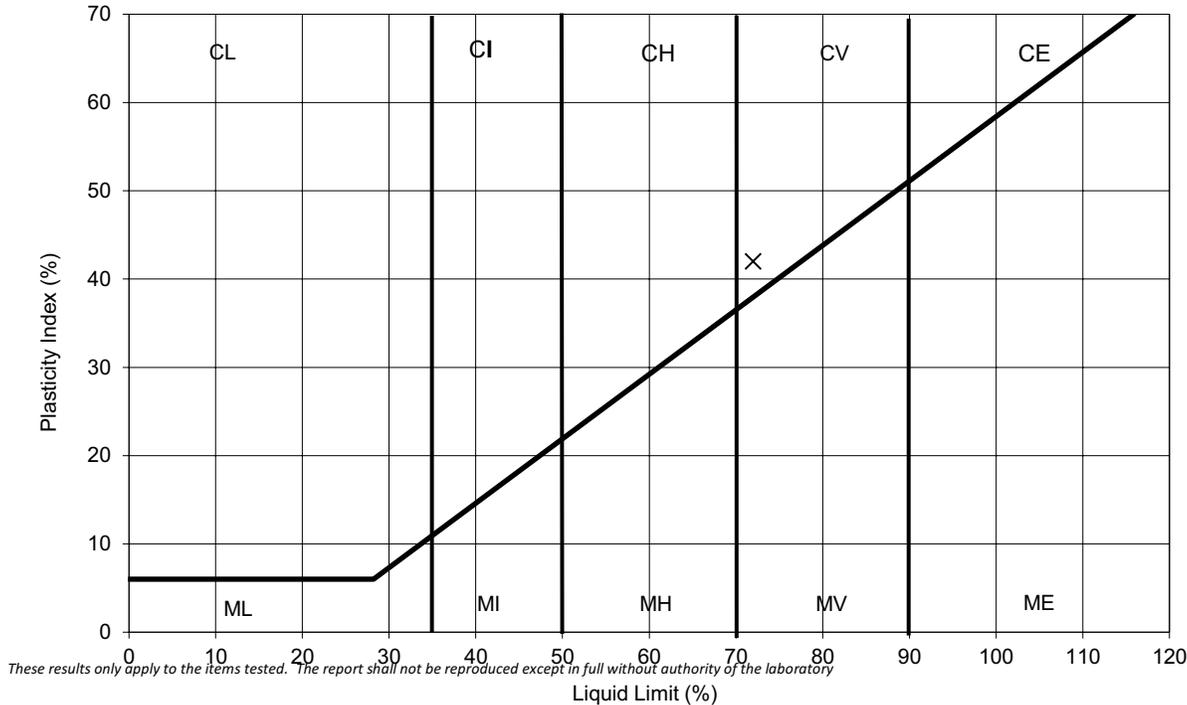
Site Name	16 Pilgrims Lane		
Project No.	J22352	Client	GEA
Soil Description	Brown and occasional bluish grey silty CLAY with scattered selenite crystals

NATURAL MOISTURE CONTENT	30	%
% PASSING 425µm SIEVE	100	%
LIQUID LIMIT	72	%
PLASTIC LIMIT	30	%
PLASTICITY INDEX	42	%

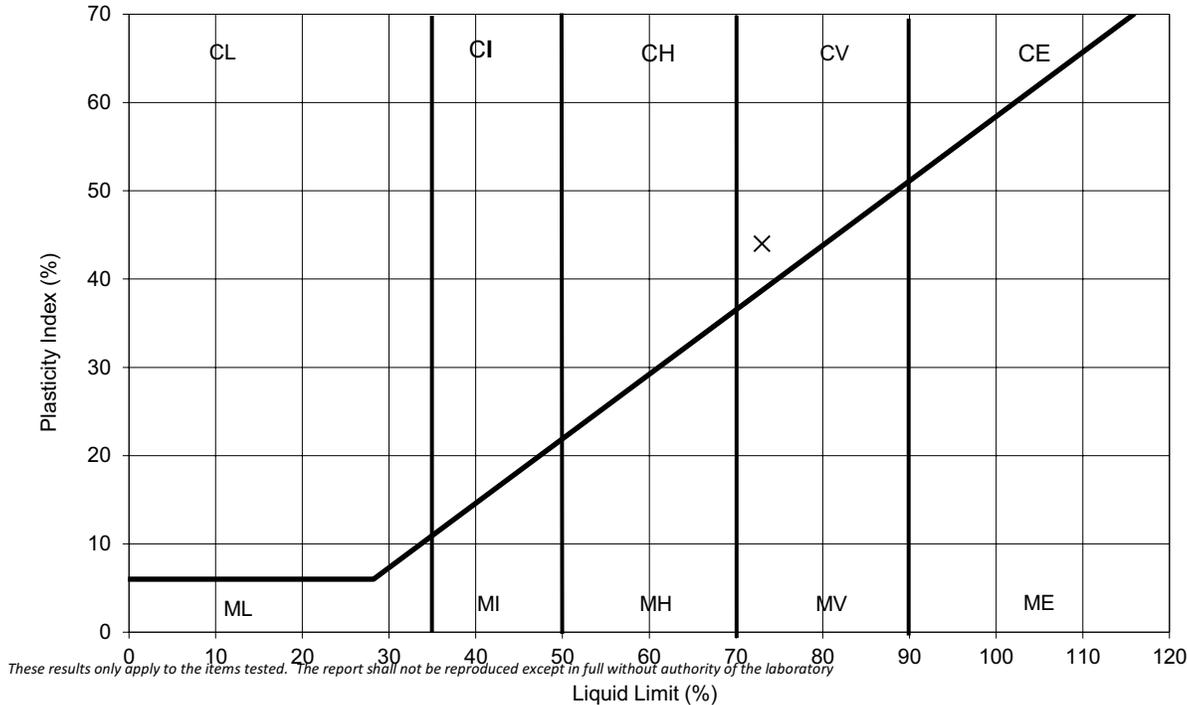
Site Name	16 Pilgrims Lane		
Project No.	J22352	Client	GEA
Soil Description	Dark grey silty CLAY

NATURAL MOISTURE CONTENT	25	%
% PASSING 425µm SIEVE	100	%
LIQUID LIMIT	73	%
PLASTIC LIMIT	29	%
PLASTICITY INDEX	44	%

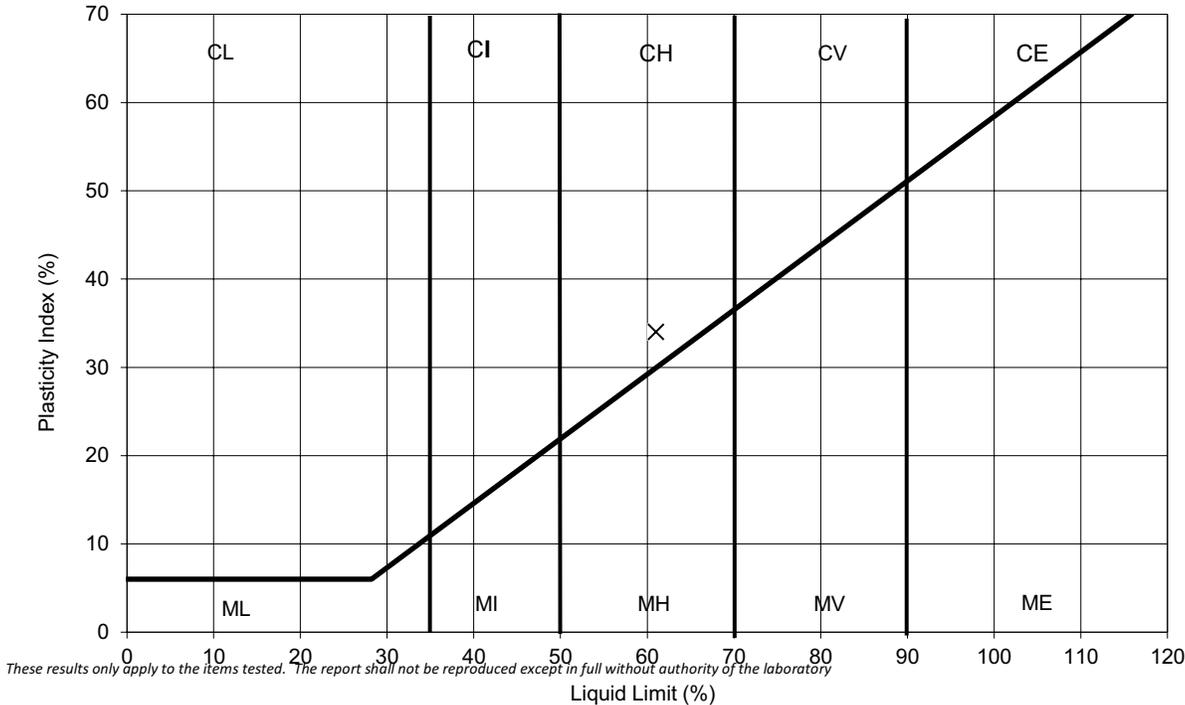
Site Name	16 Pilgrims Lane		
Project No.	J22352	Client	GEA
Soil Description	Dark grey slightly mottled orangish brown slightly gravelly slightly sandy silty CLAY (gravel is fm and sub-angular to rounded)

NATURAL MOISTURE CONTENT	39	%
% PASSING 425µm SIEVE	88	%
LIQUID LIMIT	61	%
PLASTIC LIMIT	27	%
PLASTICITY INDEX	34	%

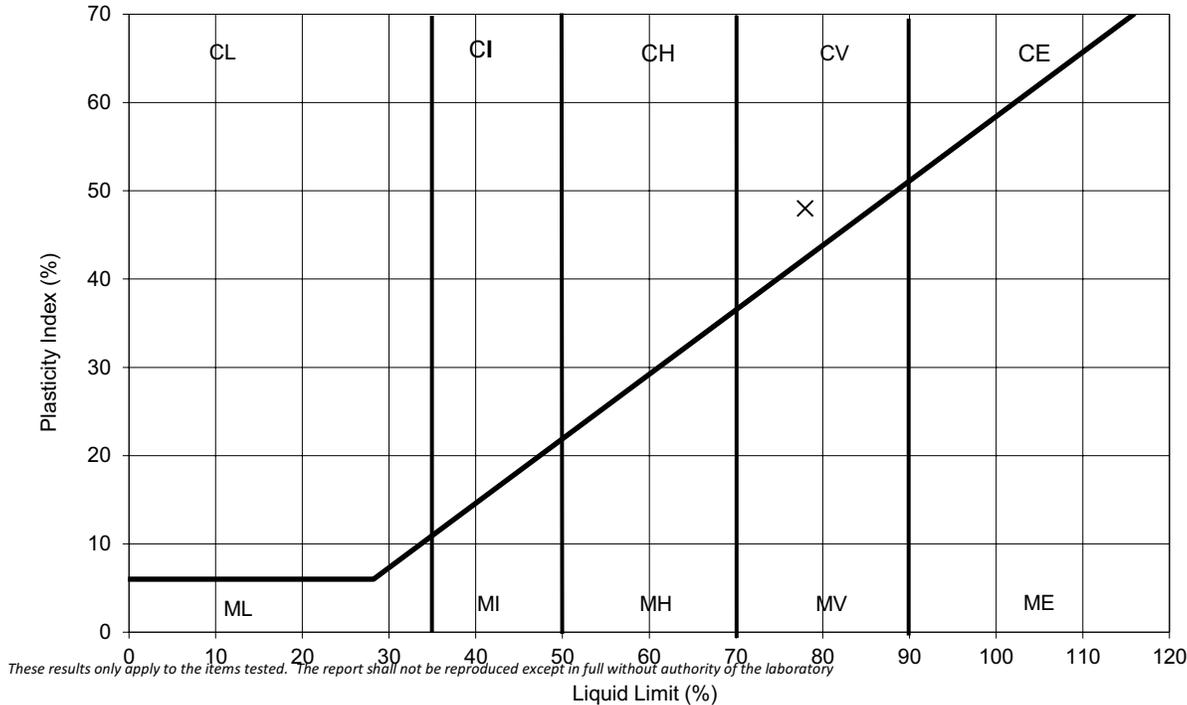
Site Name	16 Pilgrims Lane		
Project No.	J22352	Client	GEA
Soil Description	Orangish brown slightly mottled bluish grey silty CLAY

NATURAL MOISTURE CONTENT	30	%
% PASSING 425µm SIEVE	100	%
LIQUID LIMIT	78	%
PLASTIC LIMIT	30	%
PLASTICITY INDEX	48	%

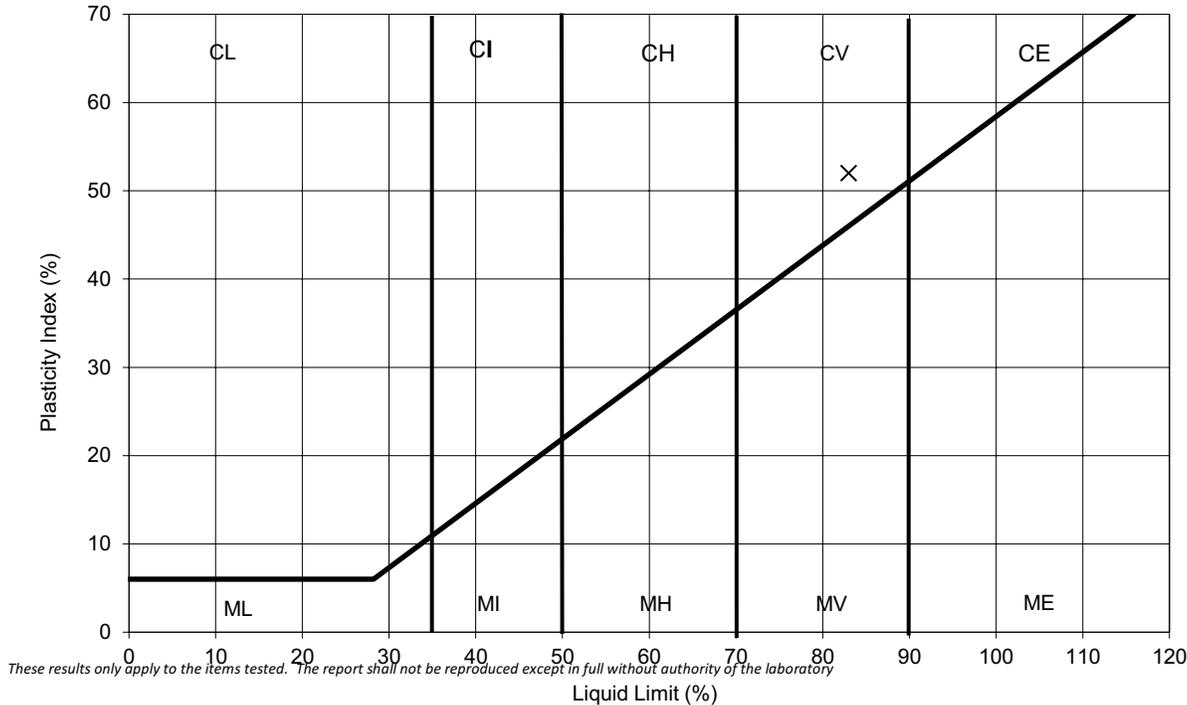
Site Name	16 Pilgrims Lane		
Project No.	J22352	Client	GEA
Soil Description	Orangish brown mottled grey silty CLAY with rare fine gravel

NATURAL MOISTURE CONTENT	36	%
% PASSING 425µm SIEVE	99	%
LIQUID LIMIT	83	%
PLASTIC LIMIT	31	%
PLASTICITY INDEX	52	%

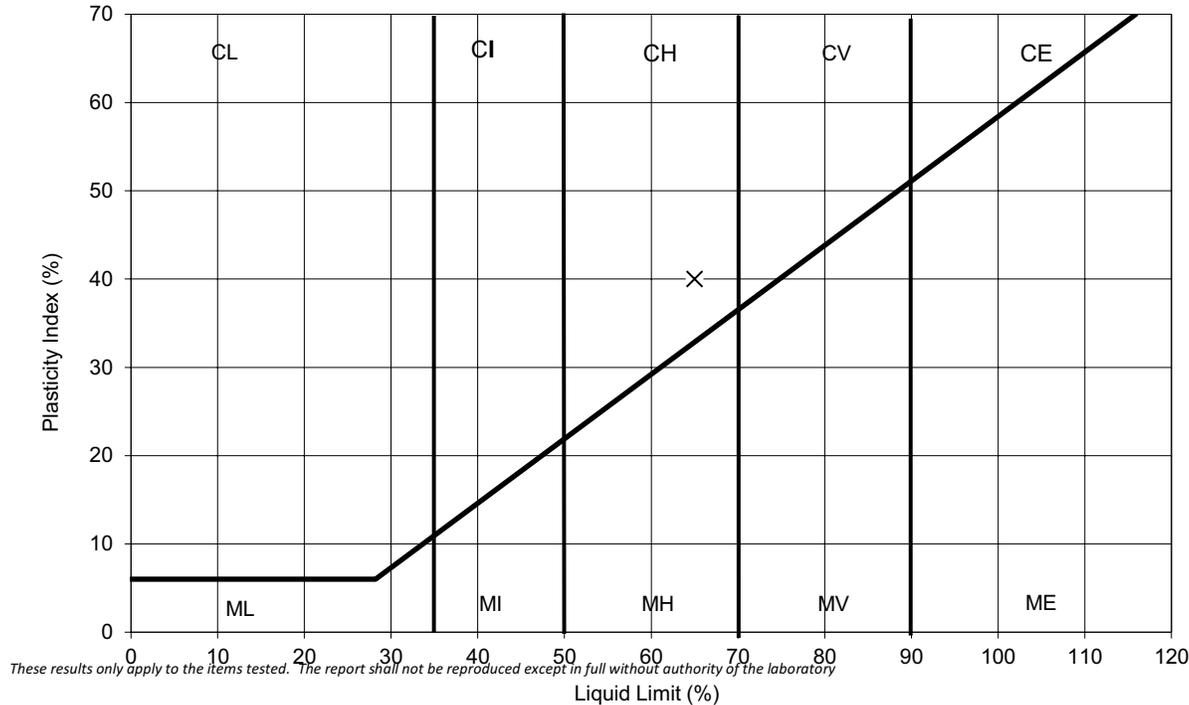
Site Name	16 Pilgrims Lane		
Project No.	J22352	Client	GEA
Soil Description	Brown slightly mottled grey silty CLAY with rare fine gravel

NATURAL MOISTURE CONTENT	25	%
% PASSING 425µm SIEVE	99	%
LIQUID LIMIT	65	%
PLASTIC LIMIT	25	%
PLASTICITY INDEX	40	%

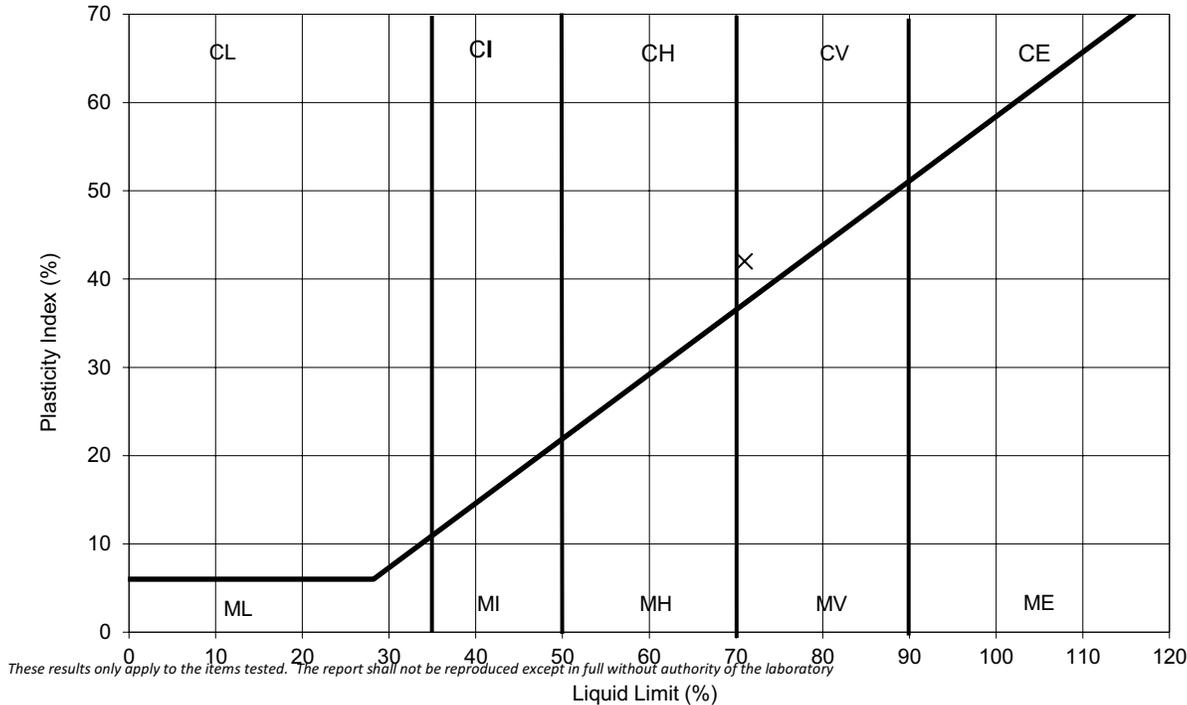
Site Name	16 Pilgrims Lane		
Project No.	J22352	Client	GEA
Soil Description	Brown slightly mottled dark grey and bluish grey slightly gravelly silty CLAY (gravel is fm and angular to sub-angular)

NATURAL MOISTURE CONTENT	32	%
% PASSING 425µm SIEVE	95	%
LIQUID LIMIT	71	%
PLASTIC LIMIT	29	%
PLASTICITY INDEX	42	%

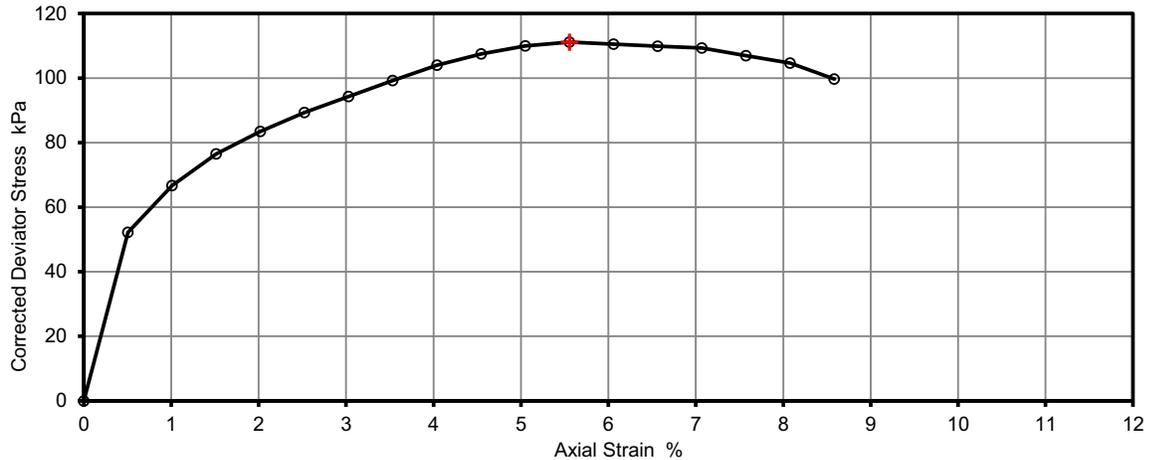
Deviator Stress v Axial Strain

Deviator stress corrected for area change and membrane effects

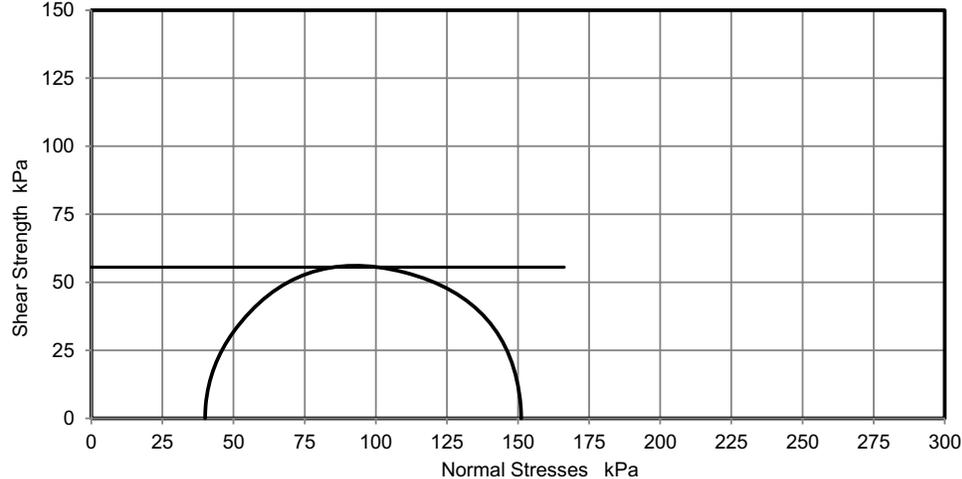
Mohr Circles

Mohr circles and their interpretation is not covered by BS1377. This is provided for information only.

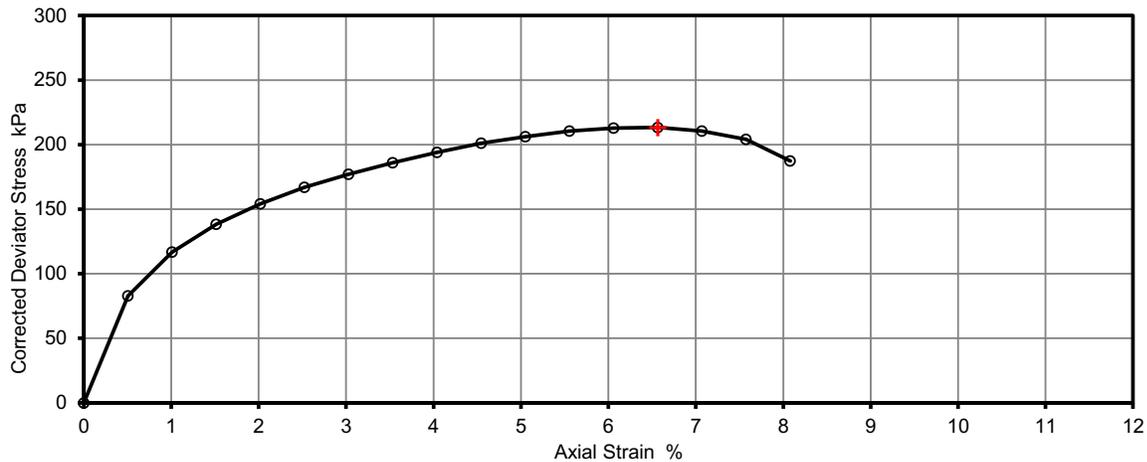
Deviator Stress v Axial Strain

Deviator stress corrected for area change and membrane effects

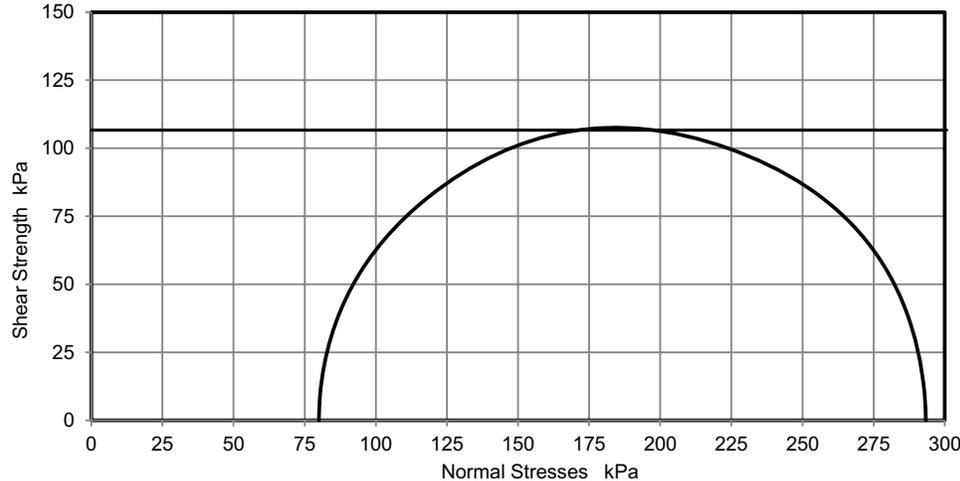
Mohr Circles

Mohr circles and their interpretation is not covered by BS1377. This is provided for information only.

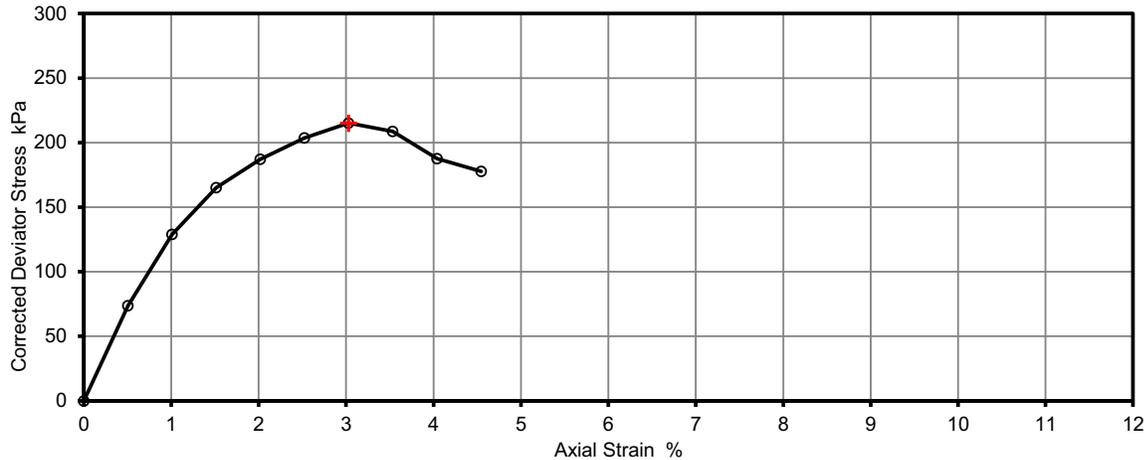
Deviator Stress v Axial Strain

Deviator stress corrected for area change and membrane effects

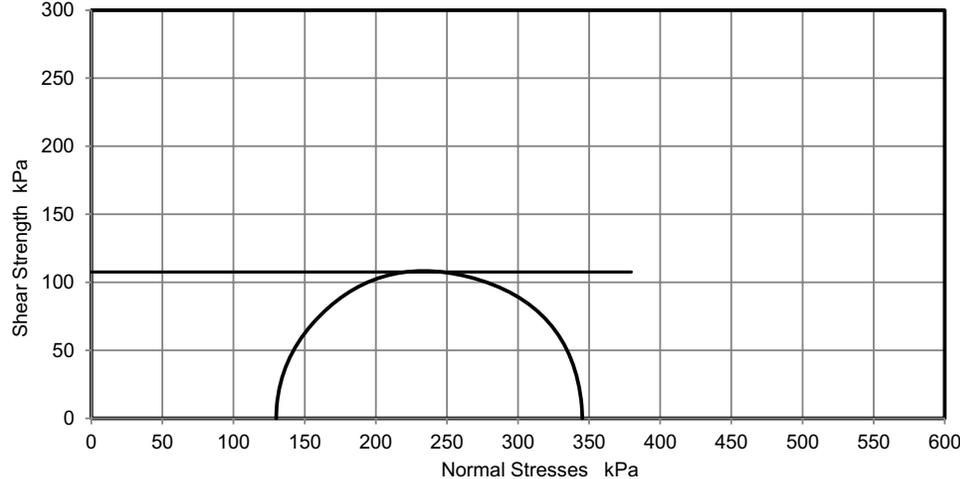
Mohr Circles

Mohr circles and their interpretation is not covered by BS1377. This is provided for information only.

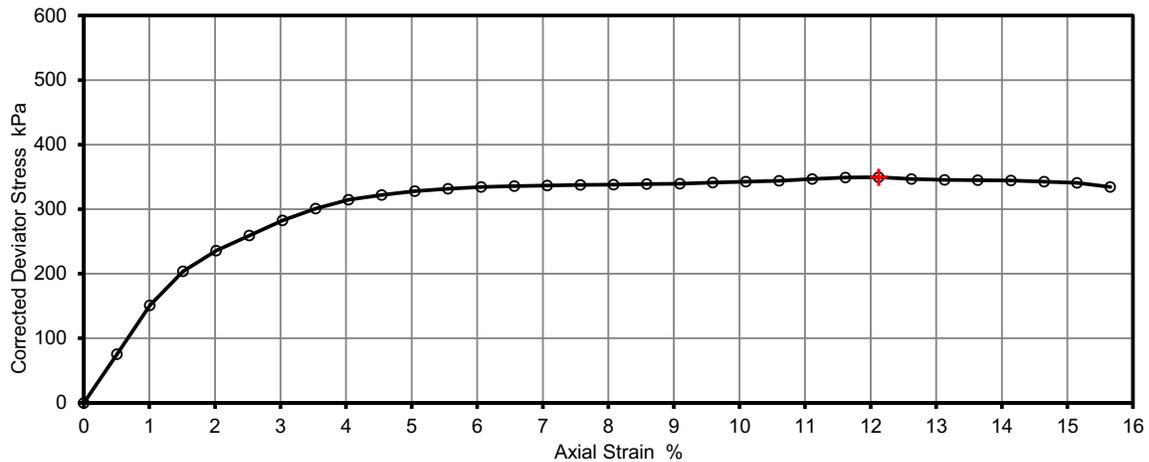
Deviator Stress v Axial Strain

Deviator stress corrected for area change and membrane effects

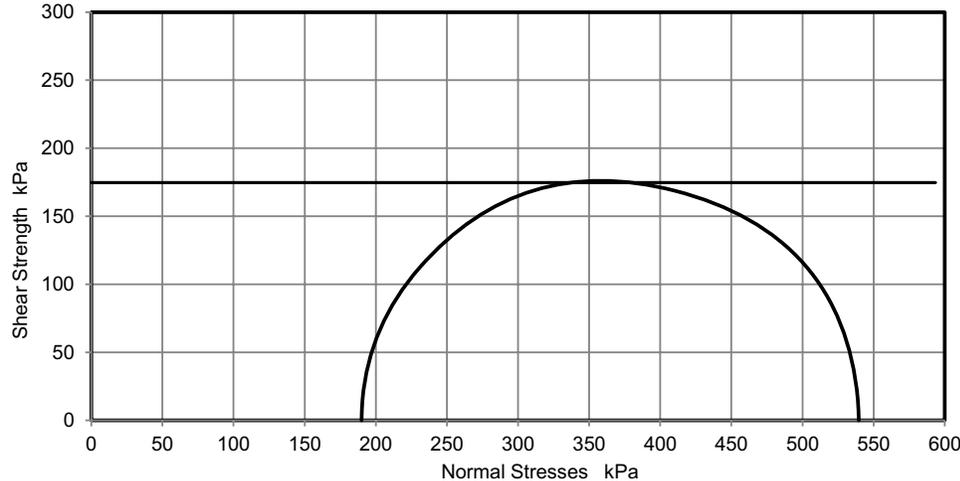
Mohr Circles

Mohr circles and their interpretation is not covered by BS1377. This is provided for information only.

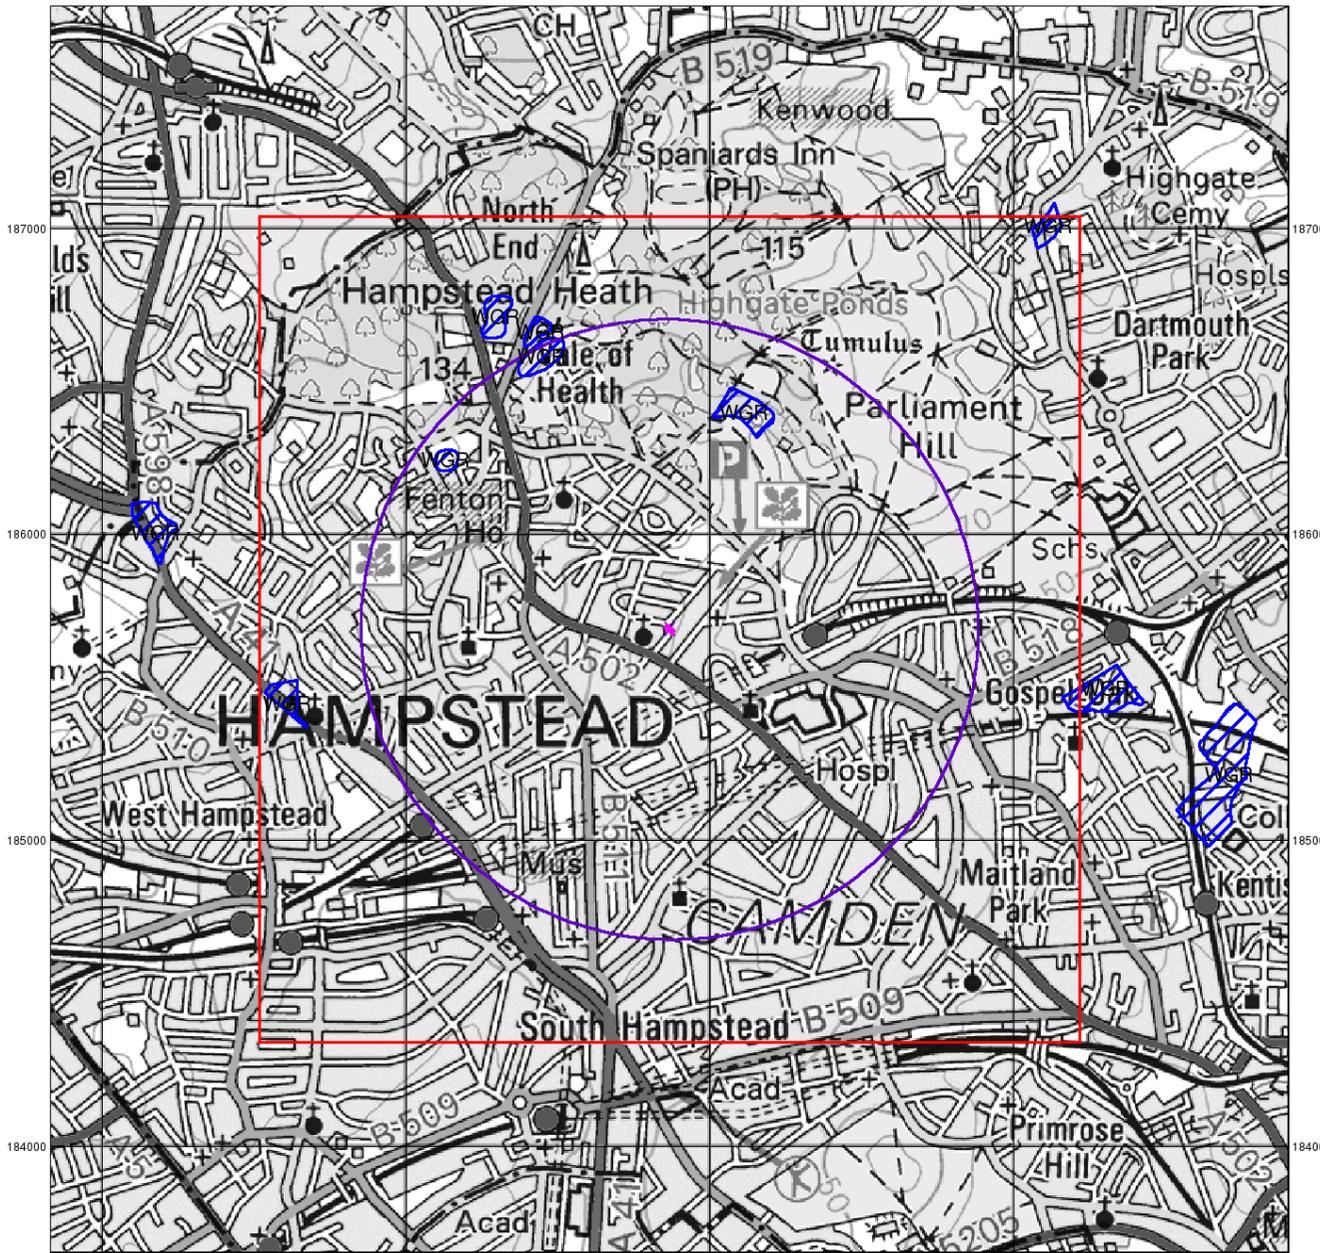
Artificial Ground and Landslip

Artificial ground is a term used by BGS for those areas where the ground surface has been significantly modified by human activity. Information about previously developed ground is especially important, as it is often associated with potentially contaminated material, unpredictable engineering conditions and unstable ground.
