GEOTECHNICAL SURVEY REPORT

**16 Pilgrim's Lane
London
NW3 1SN**

Site Investigation &
Basement Impact Assessment

J22352
Rev 0

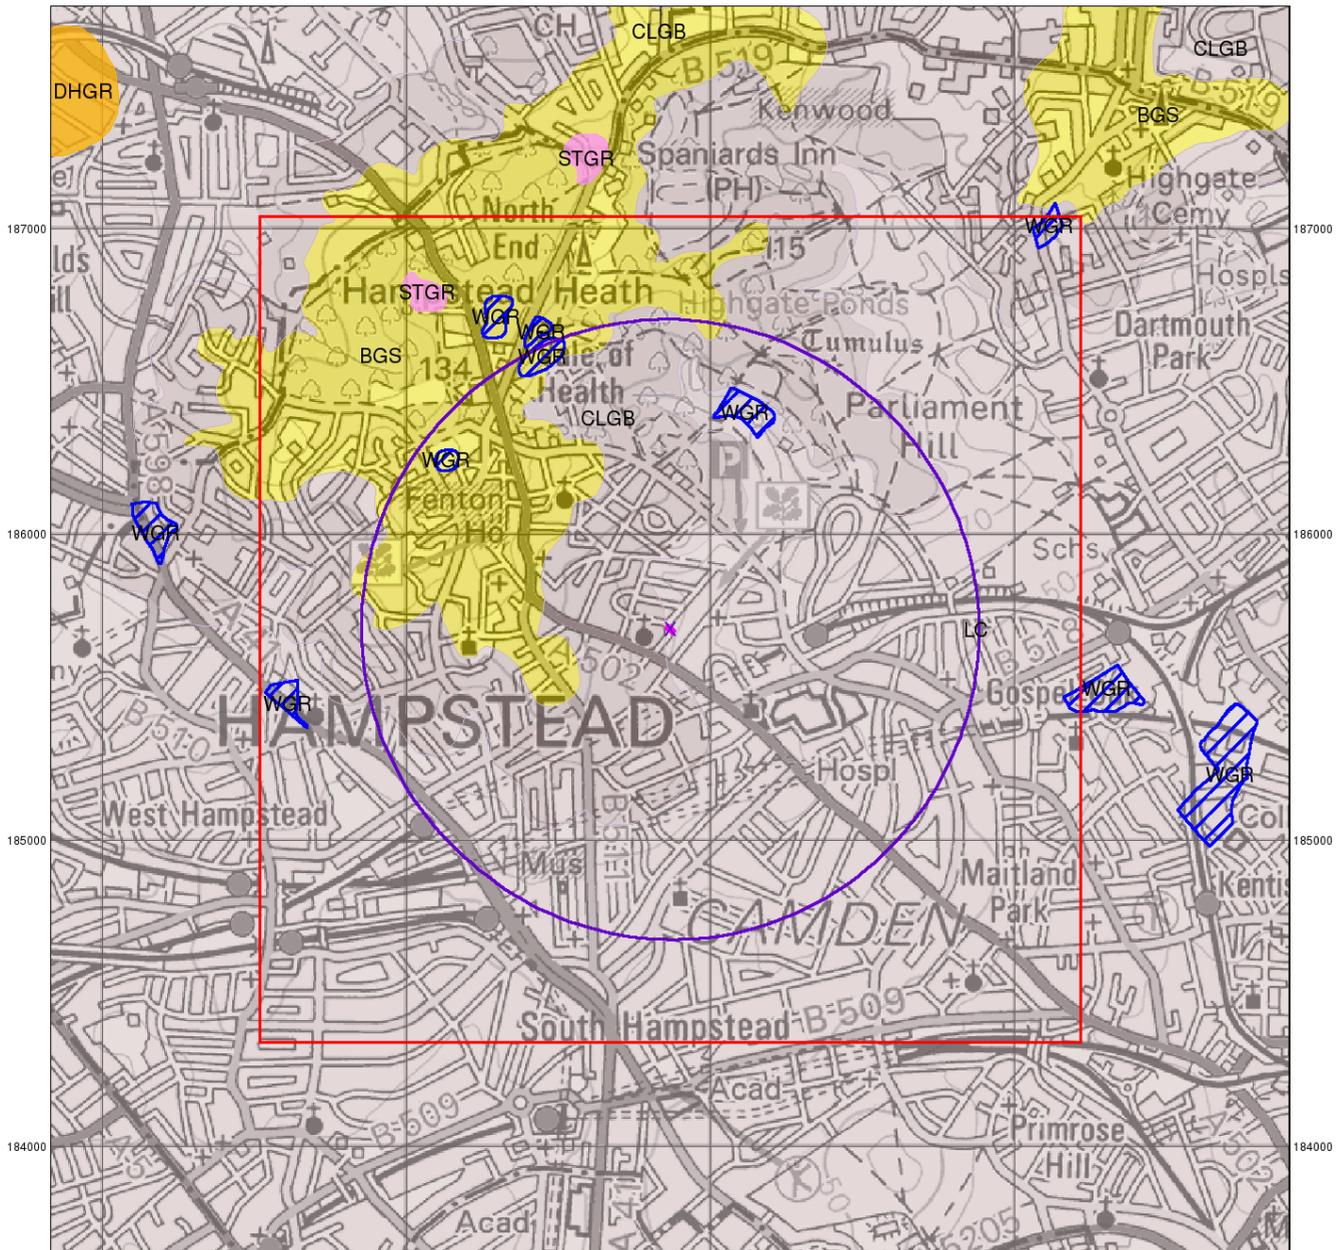
The Combined Surface Geology map combines all the previous maps into one combined geological overview of your site.
