LOWER GROUND FLOOR REAR ELEVATION (2 of 2)

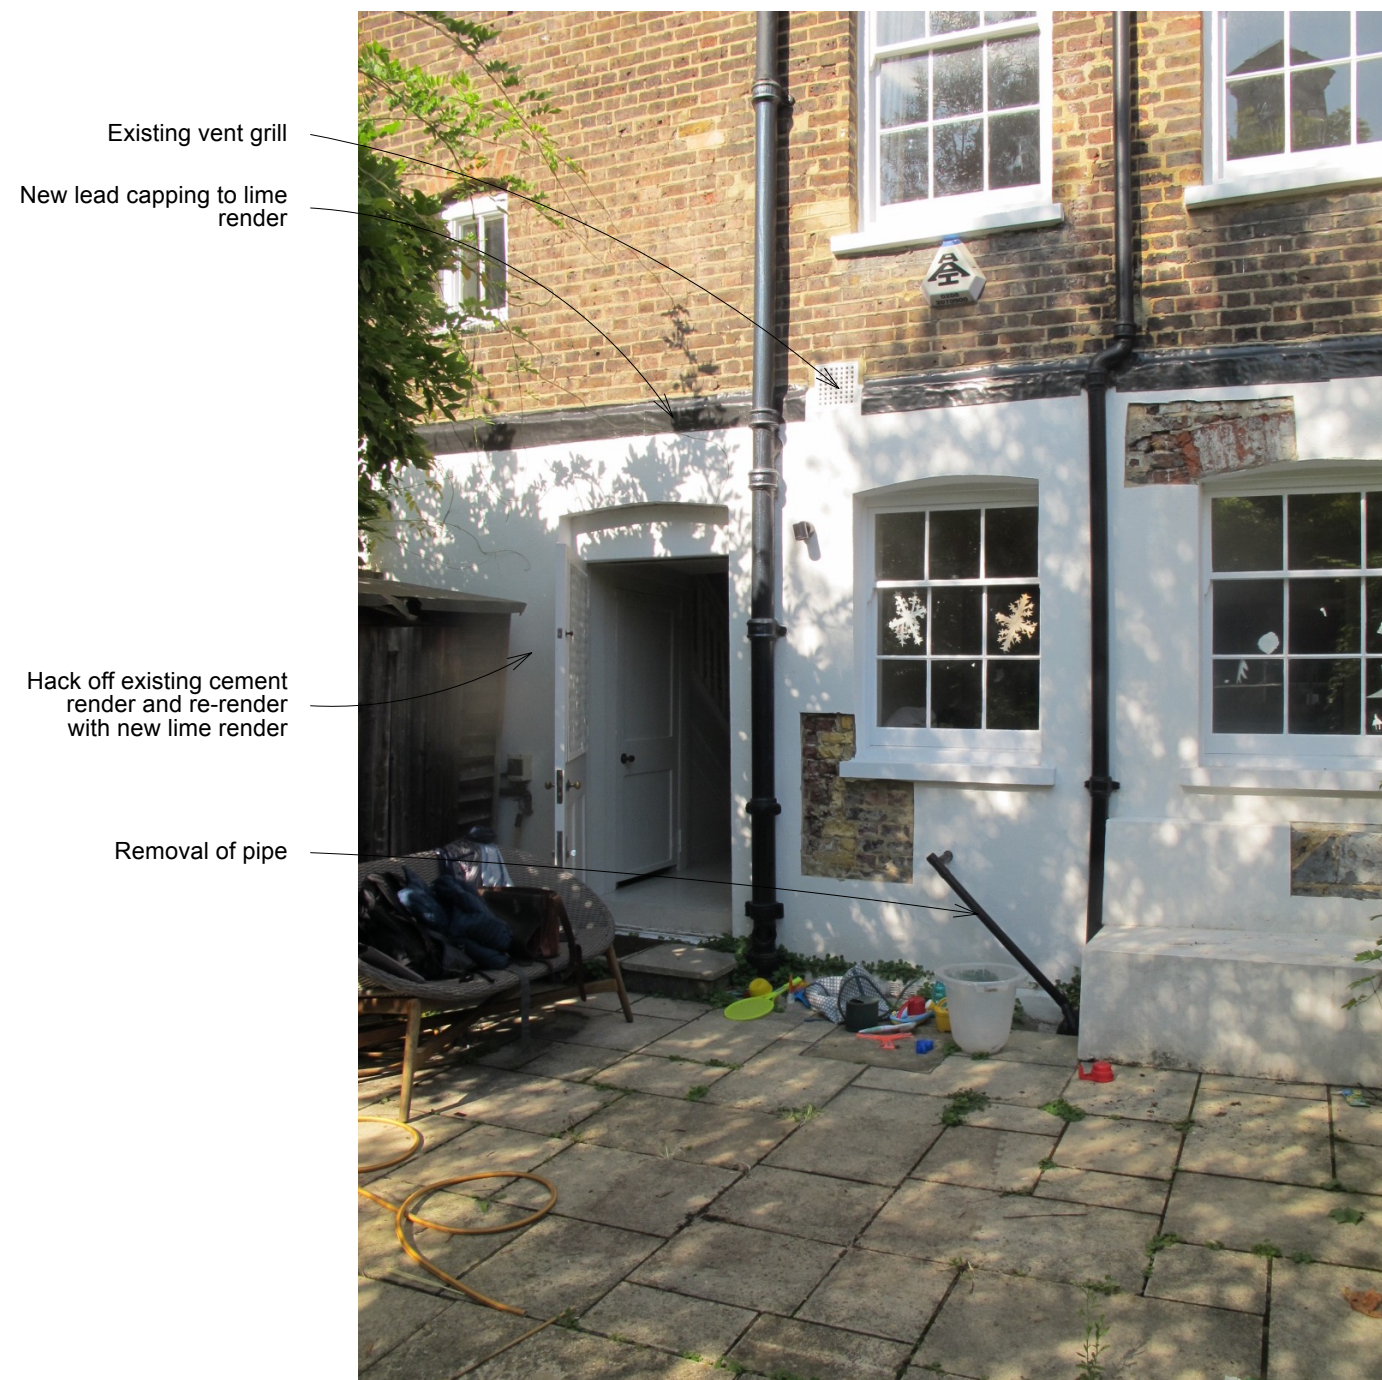
Existing vent grill
New lead capping to lime render

Hack off existing cement render and re-render with new lime render

Removal of pipe

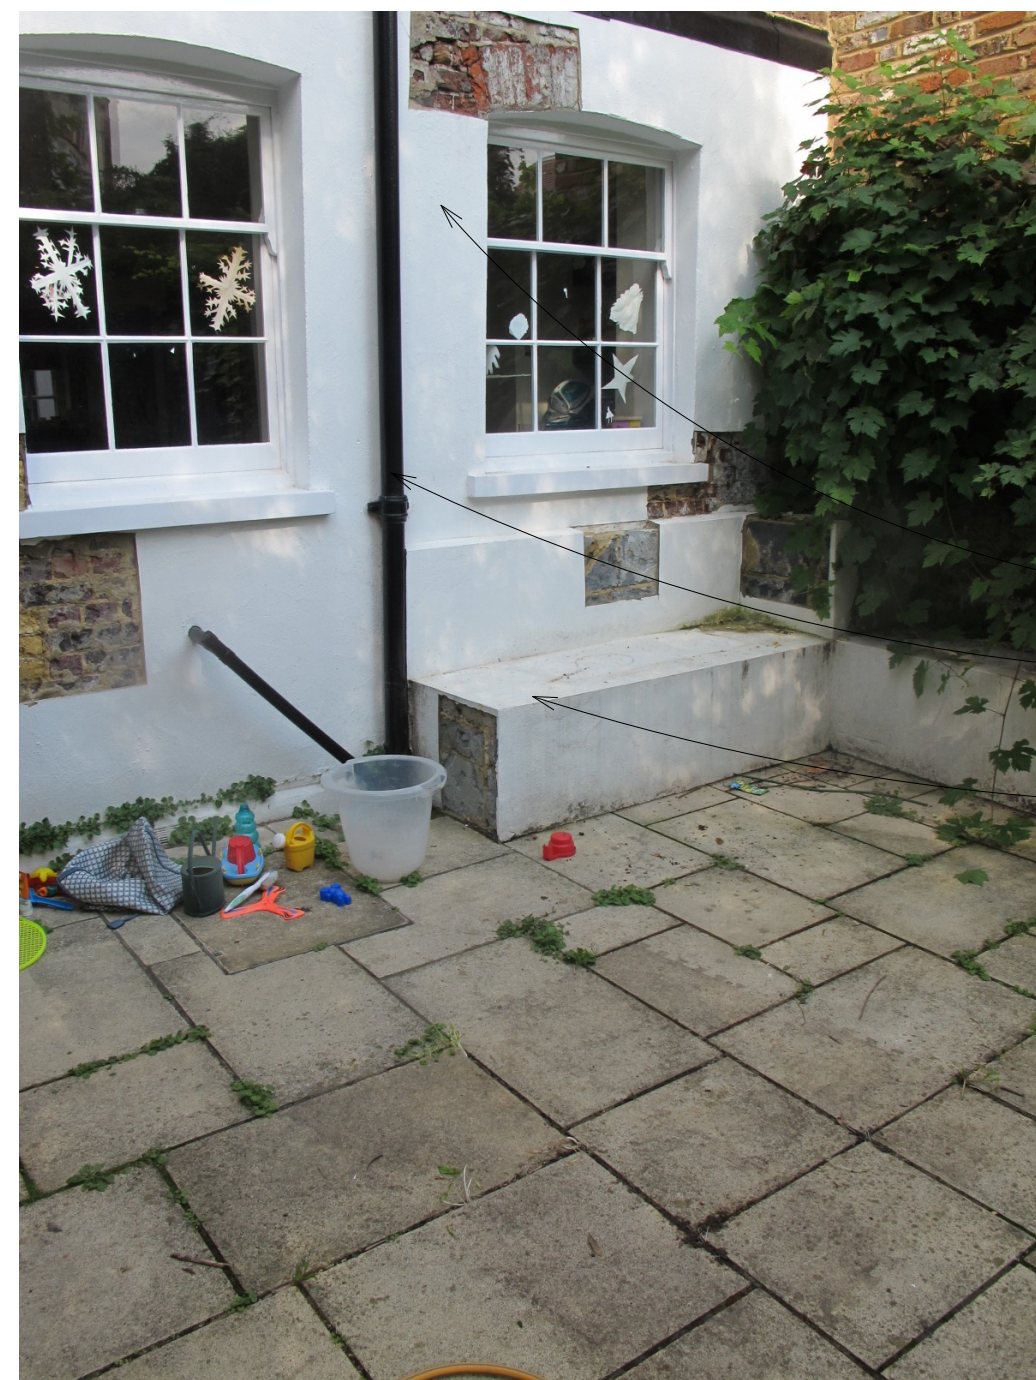
New finish of lime render

Removal of lower part of existing RWP and addition of new RWP and new gulley

Removal of existing 20th cent. terrace seating (painted portland cement render on concrete blockwork), repair brickwork behind seating
