## LEVEL MONITORING - RELATIVE SURVEY READINGS

# LEVEL MONITORING - RELATIVE MOVEMENT SKETCH

Client: Crawford & Co

Client Ref: SU1904991

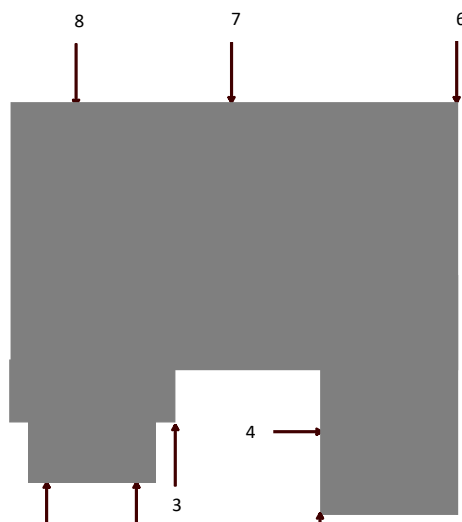
- 18/12/2023
- It was not possible to install all stations within a common brickcourse. Therefore initial readings cannot be interpreted as Distortion Data.
- Rear readings have been made relative to the deep datum. No secondary TBM available.

- No further reads to be taken

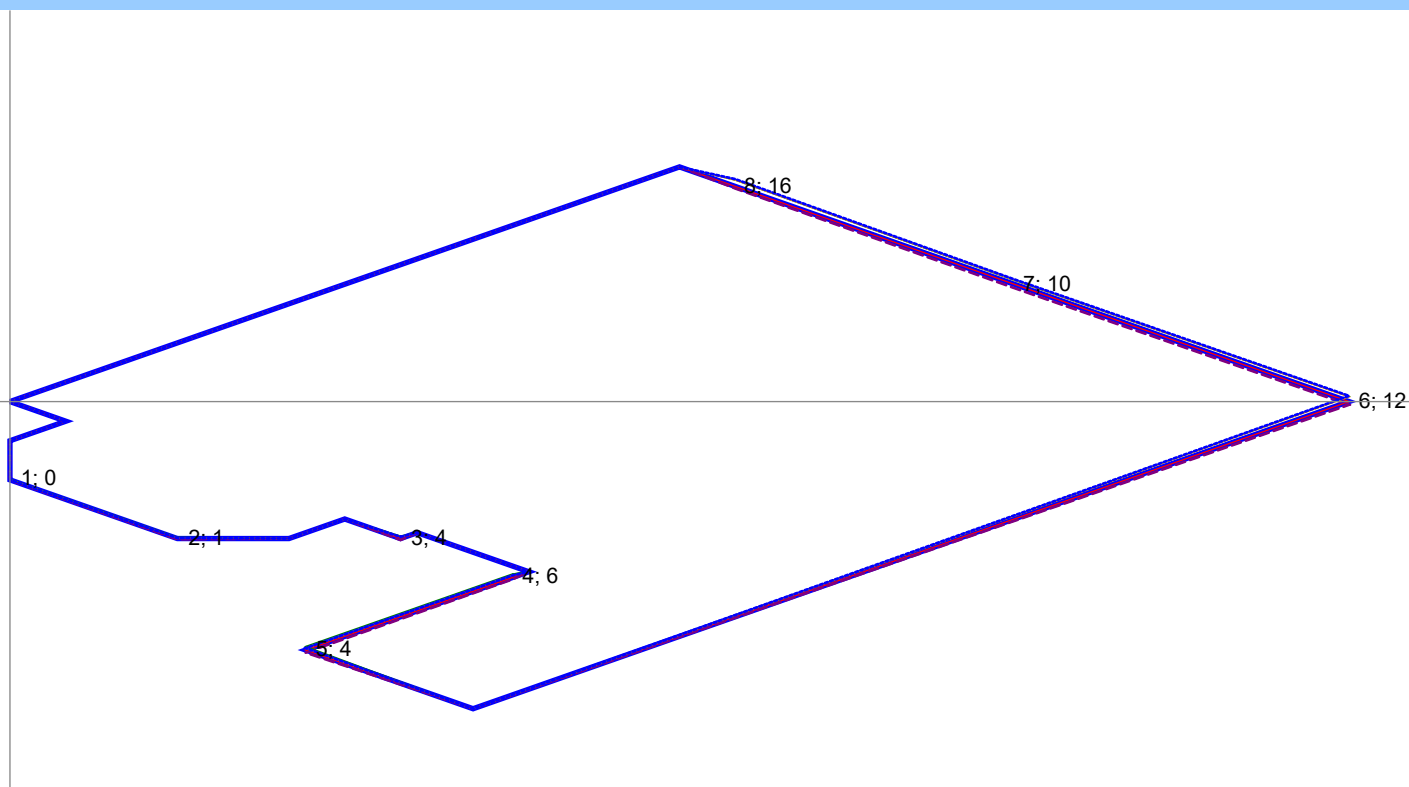
Notes:  
Vertical distorted scale 1: 5

Point labels give level difference of last reading from original datum in mm.
