Works Protection of Cattle Trough 100 Chalk Farm Road, Camden, London

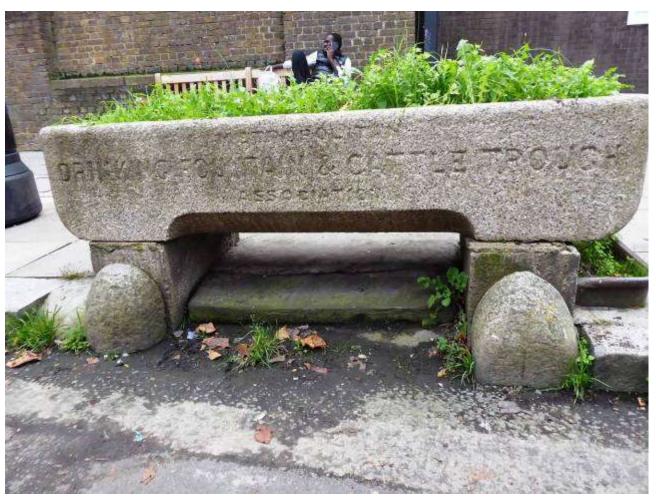
This is a grey granite cattle trough, N° 439, that was installed by the Metropolitan Drinking Fountain and Cattle Trough Association in 1877 and is a listed grade II. It is slightly unusual as it retains a cast iron dog's drinking trough under one end as well as the stone tyre rubbers, or fenders, on the roadside to avoid impact damage and from cart wheels.

Cattle trough

It is a standard size being 6' 6" (1.980 m) long and is supported on two granite blocks and would have been positioned so that the outer side is effectively in line with the edge of the roadside kerb below, but which has been adjusted outwards and upwards in modern times.

The trough has suffered slight recent displacement from the base at the west end and is filled with soil and is being used as a plant tub.
