### PAYE Stonework & Restoration Ltd

Proposal for the Clean, Repair, and Relocation of the Granite Cattle Trough OM-E3289-002

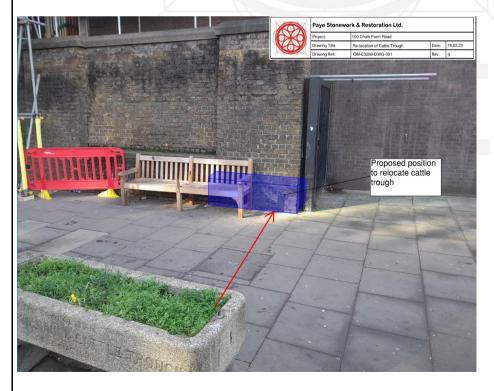
In order to relocate the cattle trough, the planters within the trough must be removed by others. Once this is complete, we can begin the relocation. So long as there is adequate space on site, we propose using a counterbalanced floor crane to lift the basin to the proposed this can be seen below. We anticipate the basin to weigh approximately 600kg, so a 1 tonne counterbalanced floor crane will be required. crane will lift the basin from fixing points/be strapped around the basin and carefully lifted from its current position, to the side. At this stage, we assume that the plinths are not fixed into the pavement, and can therefore be moved to from the existing position to the new area using traditional manual handling techniques or via the floor crane. This will set the base for the basin. The basin can then be from the area where it is set aside, and carefully lowered onto the plinth stones.

The above drawing indicates an indicative postion for the trough to be located to. The location of the trough is subject to a S278 as defined in the approved landscape drawings. The costs attached on the previous sheet are subject to change depending on the location.
