9-12 New College Parade,
Finchley Road

**Camden Geological, Hydrogeological
and Hydrological Study**
Camden Surface Water Features

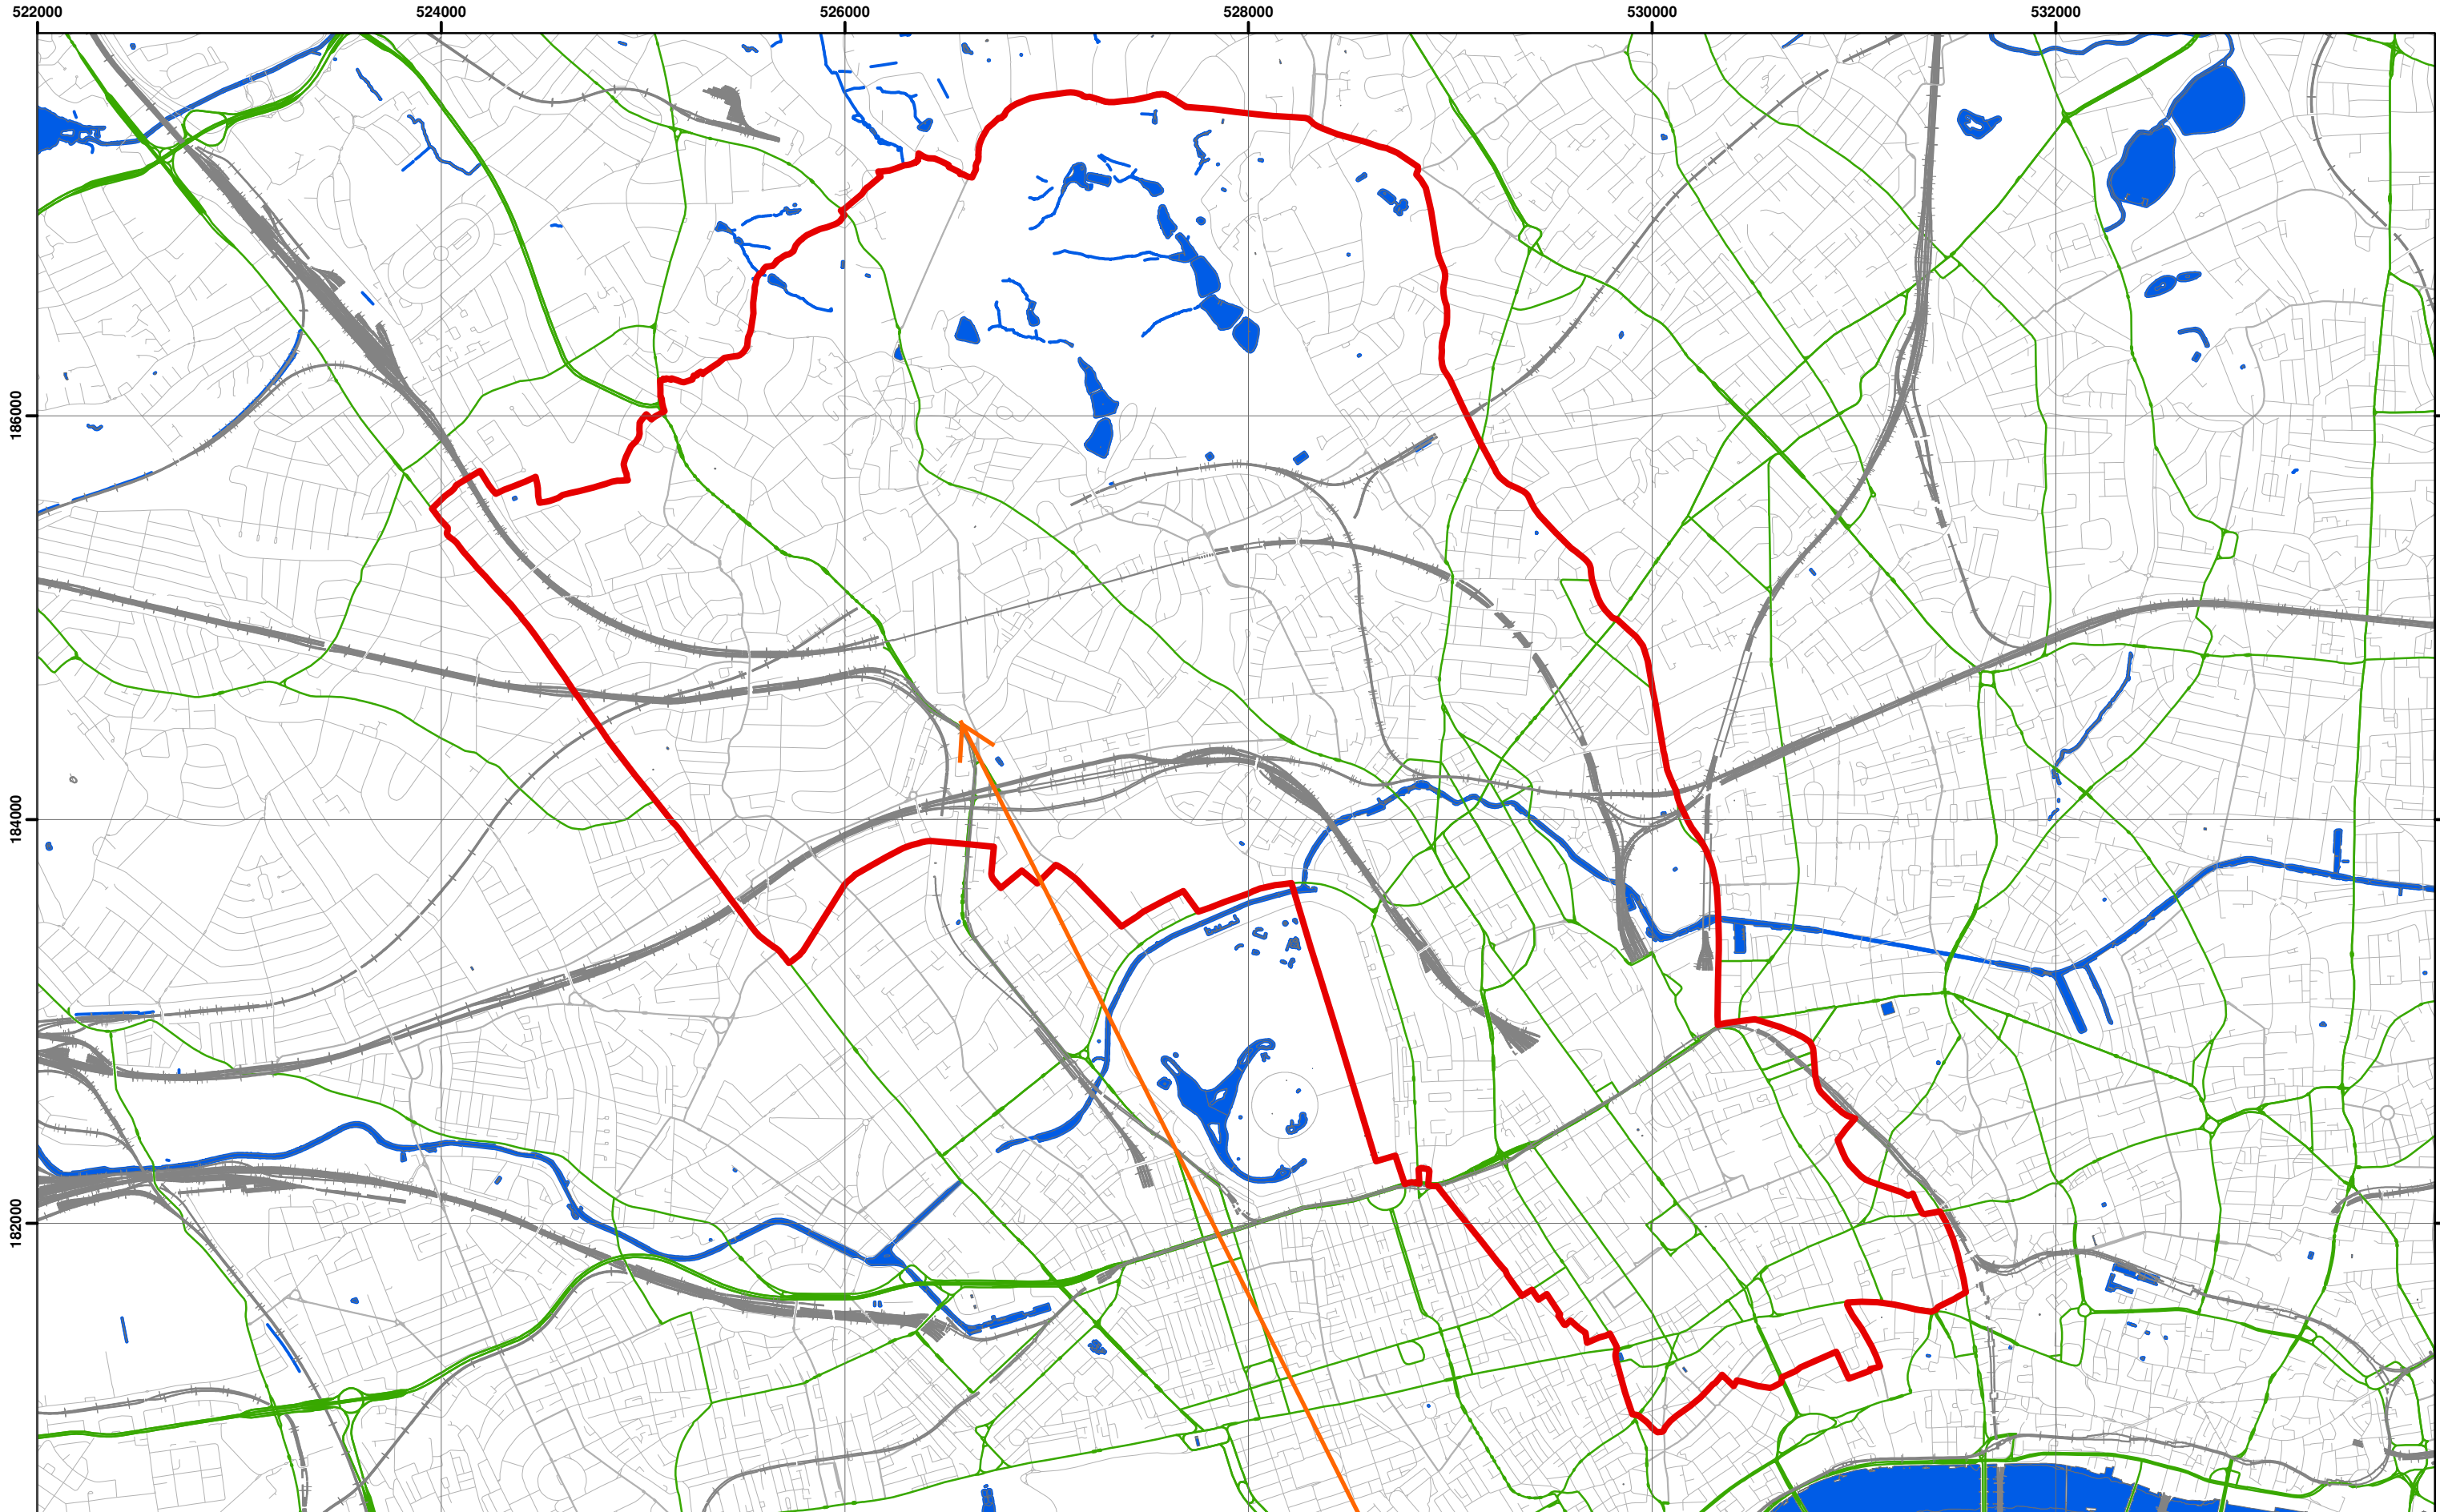
- Legend**
- London Borough of Camden
 - Surface water
 - Railway Lines
 - A Roads
