**Wildwood Lodge
9 North End
Hampstead
London
NW3 7HH**

DESIGN CONSTRUCTION STATEMENT ADDENDUM

- 1.1. This Design Construction Statement Addendum has been prepared by Taylor Whalley Spyra as requested by Canaway Fleming Architects as part of the proposed planning to extend the basement beneath the existing house and steps to access the basement from the rear garden.

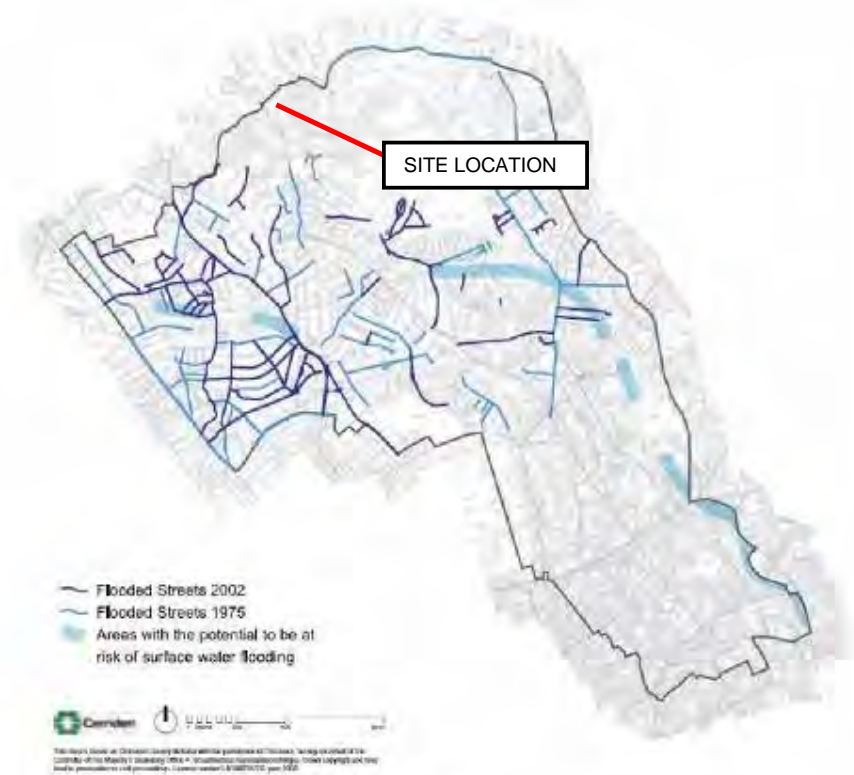
FIGURE 14

FIGURES 14 – HAMPSTEAD HEATH SURFACE WATER CATCHMENTS AND DRAINAGE

- 1.4. The information contained within this Construction Design Statement Addendum has been reviewed against Camden Planning Guidance - Basements and Lightwells (CPG4) and Camden Development Policy DP27 and has indicated the site location on the Camden Geological Hydrogeological & Hydrological Study Extracts Figures 11, 12 ,14, 15 & 16 which confirm the site is outside the influence of these areas (refer to Appendix F).
