DESIGN AND ACCESS STATEMENT 15 Rochester Square London NW1 9SA

The aim of the project is to return 15 Rochester Square, which lies within the Camden Square Conservation Area, into an elegant family house, respecting and enhancing its original features.

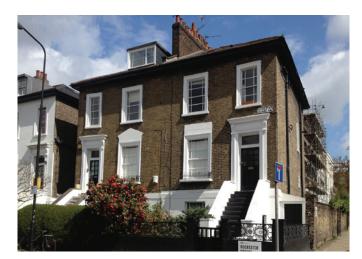
fig1. Front elevation, Rochester Square 30.07.13

The house is a mixed stock brick dwelling with plain stucco to the ground floor storey and stucco moulding to the windows of the Rochester Square (front) elevation (fig 1). The original sash windows are still in place with the exception of a new opening to the first floor rear elevation where an original opening has been filled in and replaced with a much smaller window (fig 3). The original slate roof has been replaced with interlocking concrete tiles. A rather strangely configured dormer window with a sloping rooflight has been added to the rear, and a roolight to the front of the house. The front parapet wall has been rebuilt with flimsy blockwork painted gloss black with lightweight, seemingly plastic-coated railings in what can only be described as a doily pattern (fig 1). The main entrance is from Rochester Square up a flight of 14 steps to the first floor (fig 1).

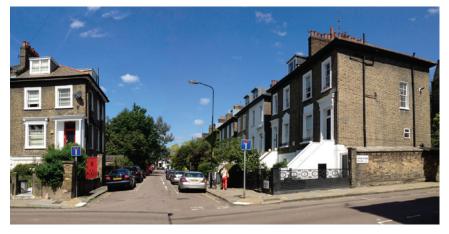
fig 4. View from Stratford Villas along Rochester Square 06.06.13

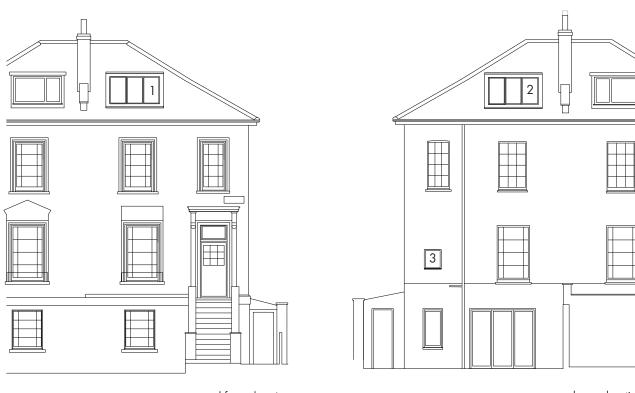
dormer on no16 of existing front elevation

dormers on existing rear elevation Photos 06.06.13

proposed front elevation

proposed rear elevation

The following fenestration is proposed to the front and rear elevations, in accordance particularly with CPG1 and DP24:

1. New dormer to front elevation. (Drawing nos: 00-09 and 01-09)

2. New dormer window to rear elevation to replace existing, awkward rear dormer with its projecting sloped rooflight. (Drawing nos: 00-10 and 01-10)

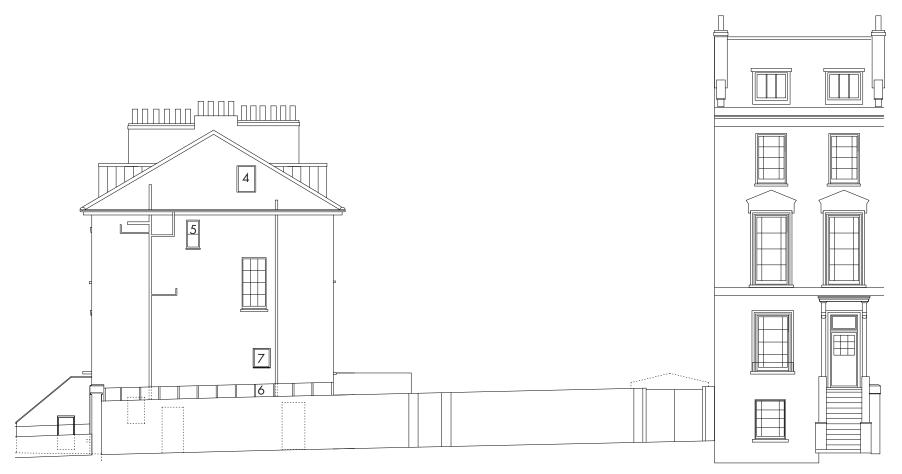
proposed side elevation

- 4. New flush rooflight to Stratford Villas elevation. (Drawing nos: 00-02, 01-02, 00-11 and 01-11)
- 5. New sash window to attic stair to match existing sash window to this elevation. (Drawings as above)
- 6. New glazed roof to side passage to replace existing.(Drawings as above)

<sup>7.</sup> It is proposed either to replace the two small windows to the rear and side elevations with new ones of the same construction or to substitute the existing patterned glazing with plain frosted glass. (Drawings as above)
