PROJECT:
42-45 BELSIZE PARK
LONDON NW3

DRAWING:
PROPOSED FRONT ELEVATION
REPLACEMENT FACADE TO NOS 44 & 45

DRAWING No.: 11-029/AP3-09 REV: D

DRAWING:
PROPOSED FRONT ELEVATION

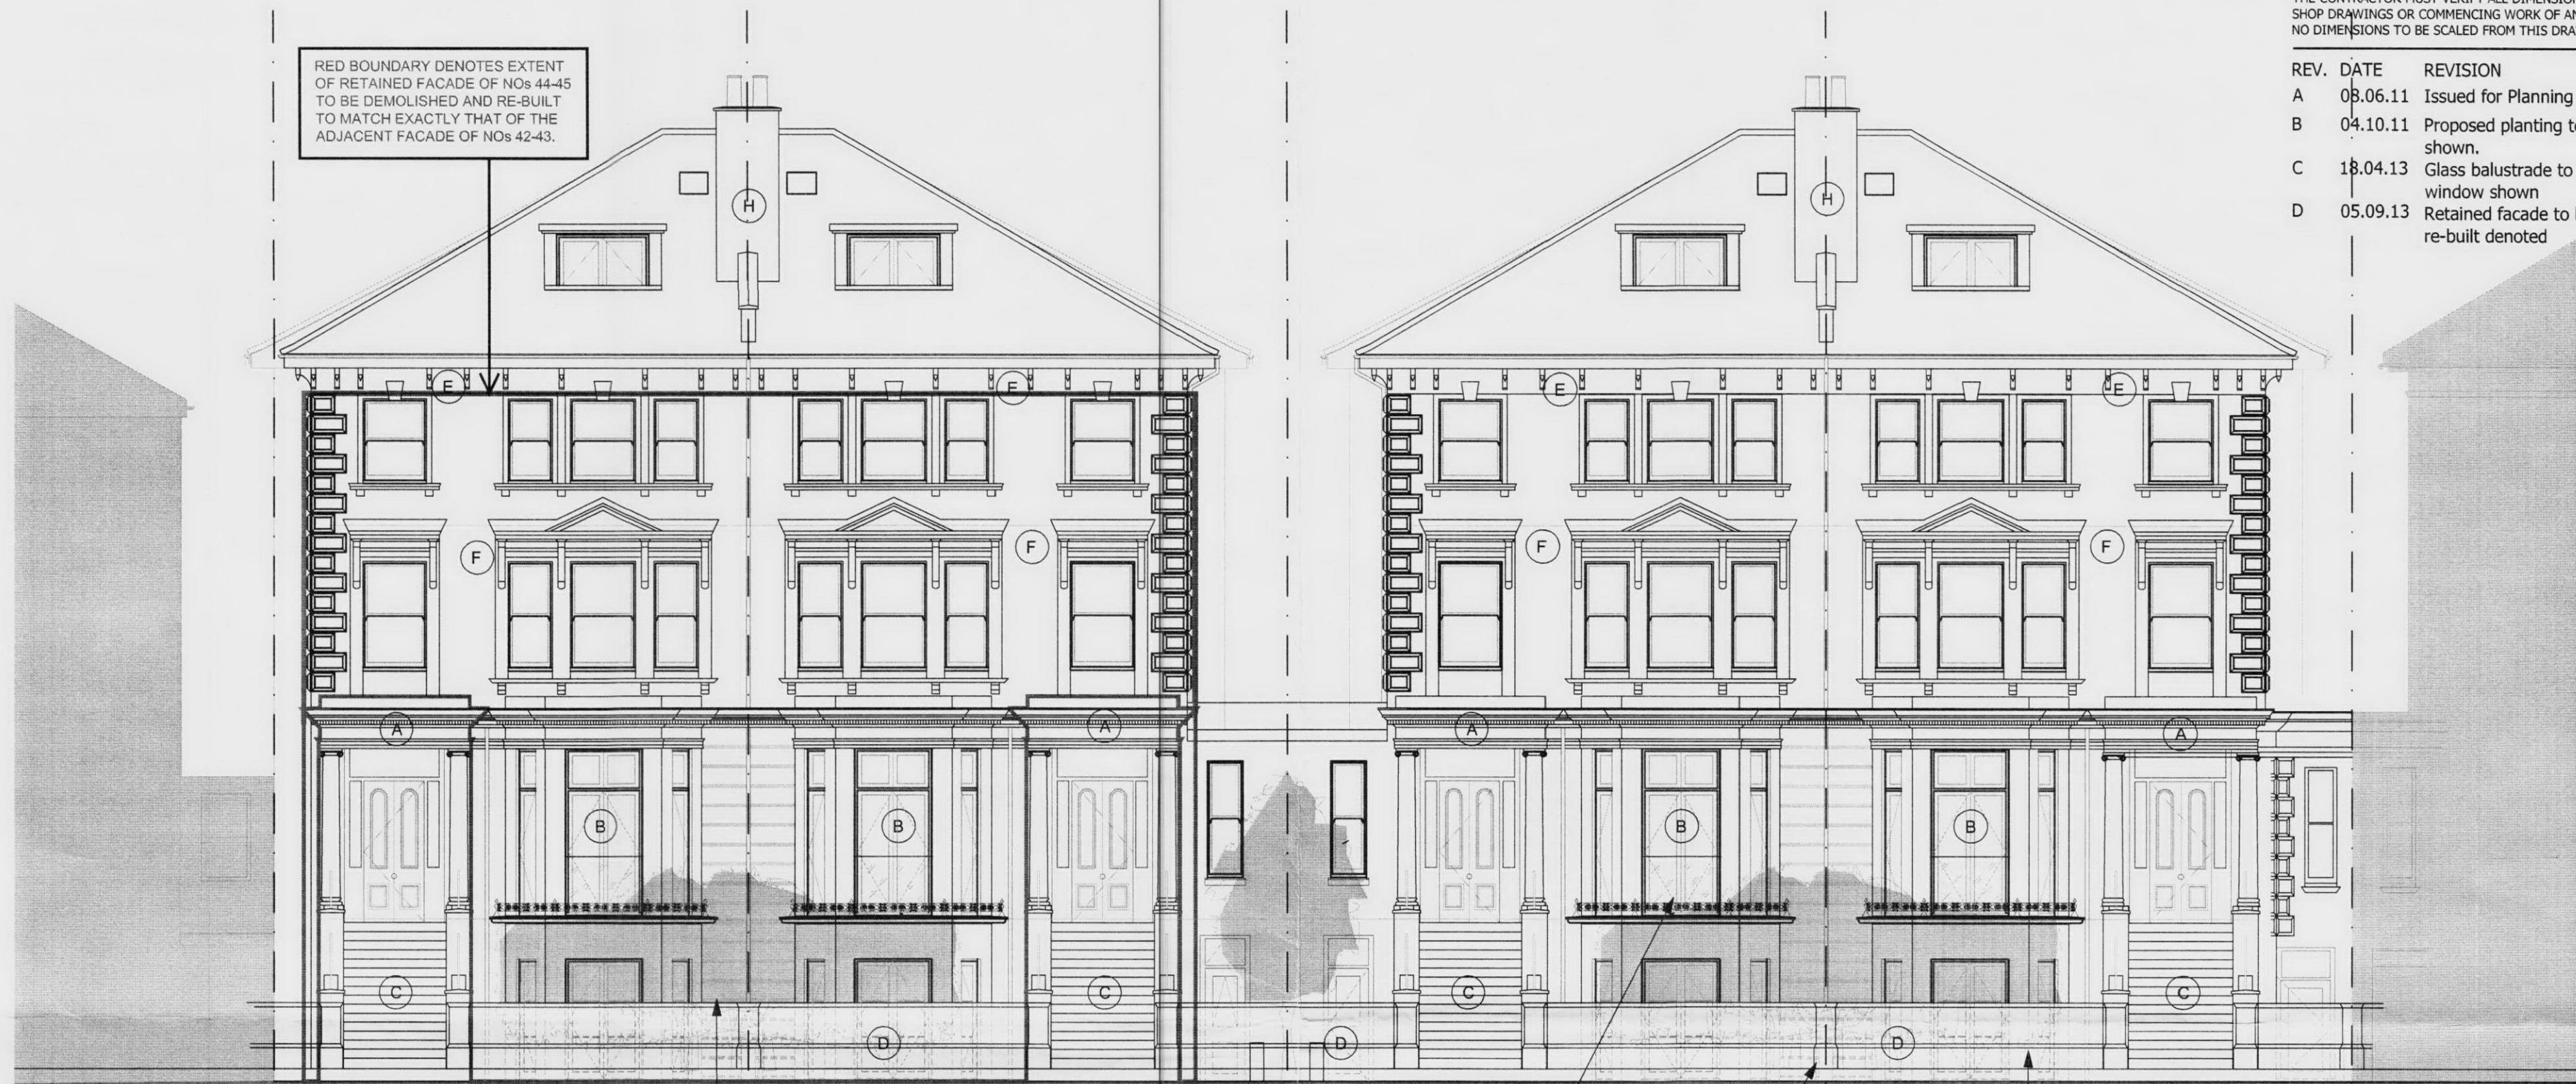
SOUTH ELEVATION

RED BOUNDARY DENOTES EXTENT OF RETAINED FACADE OF NOS 44-45 TO BE DEMOLISHED AND RE-BUILT TO MATCH EXACTLY THAT OF THE ADJACENT FACADE OF NOS 42-43.

Landscaping as per approved condition application no 2013/2735/P

Frame-less glass balustrade to upper ground floor doors

Trees and raised flower beds behind the hedge in front gardens

- (A) DETAIL 1
Entrance Porch modeled on local examples, including:
-New cornice to entrance Porch including dentil mouldings in lime render, new Ionic capitals and new Plinth mouldings to supporting columns.
-New Plinth and capital mouldings to Pilasters around entrance doors in lime render.
-New front door, side lights and fan lights to match 54 Belsize Park

- (B) DETAIL 5 & 11
New bay windows modeled on local examples, including:
-New cornice to bay's windows, including dentil mouldings in lime render.(not shown)
-New capital mouldings to the returns of the bay windows in lime render.
-New rendered window cills and new decorative cast iron cill railings.

- (C) DETAIL 9
Entrance stairs modeled on local examples, including:
-New stone copings to Piers, stone treads and risers. Rendered balustrade with stone copings
-New galvanized steel hollow section handrail.
-New decorative balustrade panels between support columns under front Porch.

- (D) DETAIL 3
Existing front wall to be rebuilt in its entirety and modeled on local examples. Garden walls dividing Properties to be reinstated. New stone copings.

- (E) DETAIL 10
Decorative timber mouldings to underside of roof soffit to match existing.
- (F) DETAIL 2 & 4, and 6,7&8
Cornice and cill detail and rendered mouldings to upper level windows modeled on local examples.

- (G) DETAIL 12
New cornice and coinings to 'link' buildings to match existing.
- (H) Roof
-New rendered chimneys and Redbank clay flue Pots
-New Parapet with coping stone
-Skylights to be Velux conservation roof lights
-New flush glazing above decorative domed skylights above staircase.
-Dormers lined in lead with white painted timber joinery

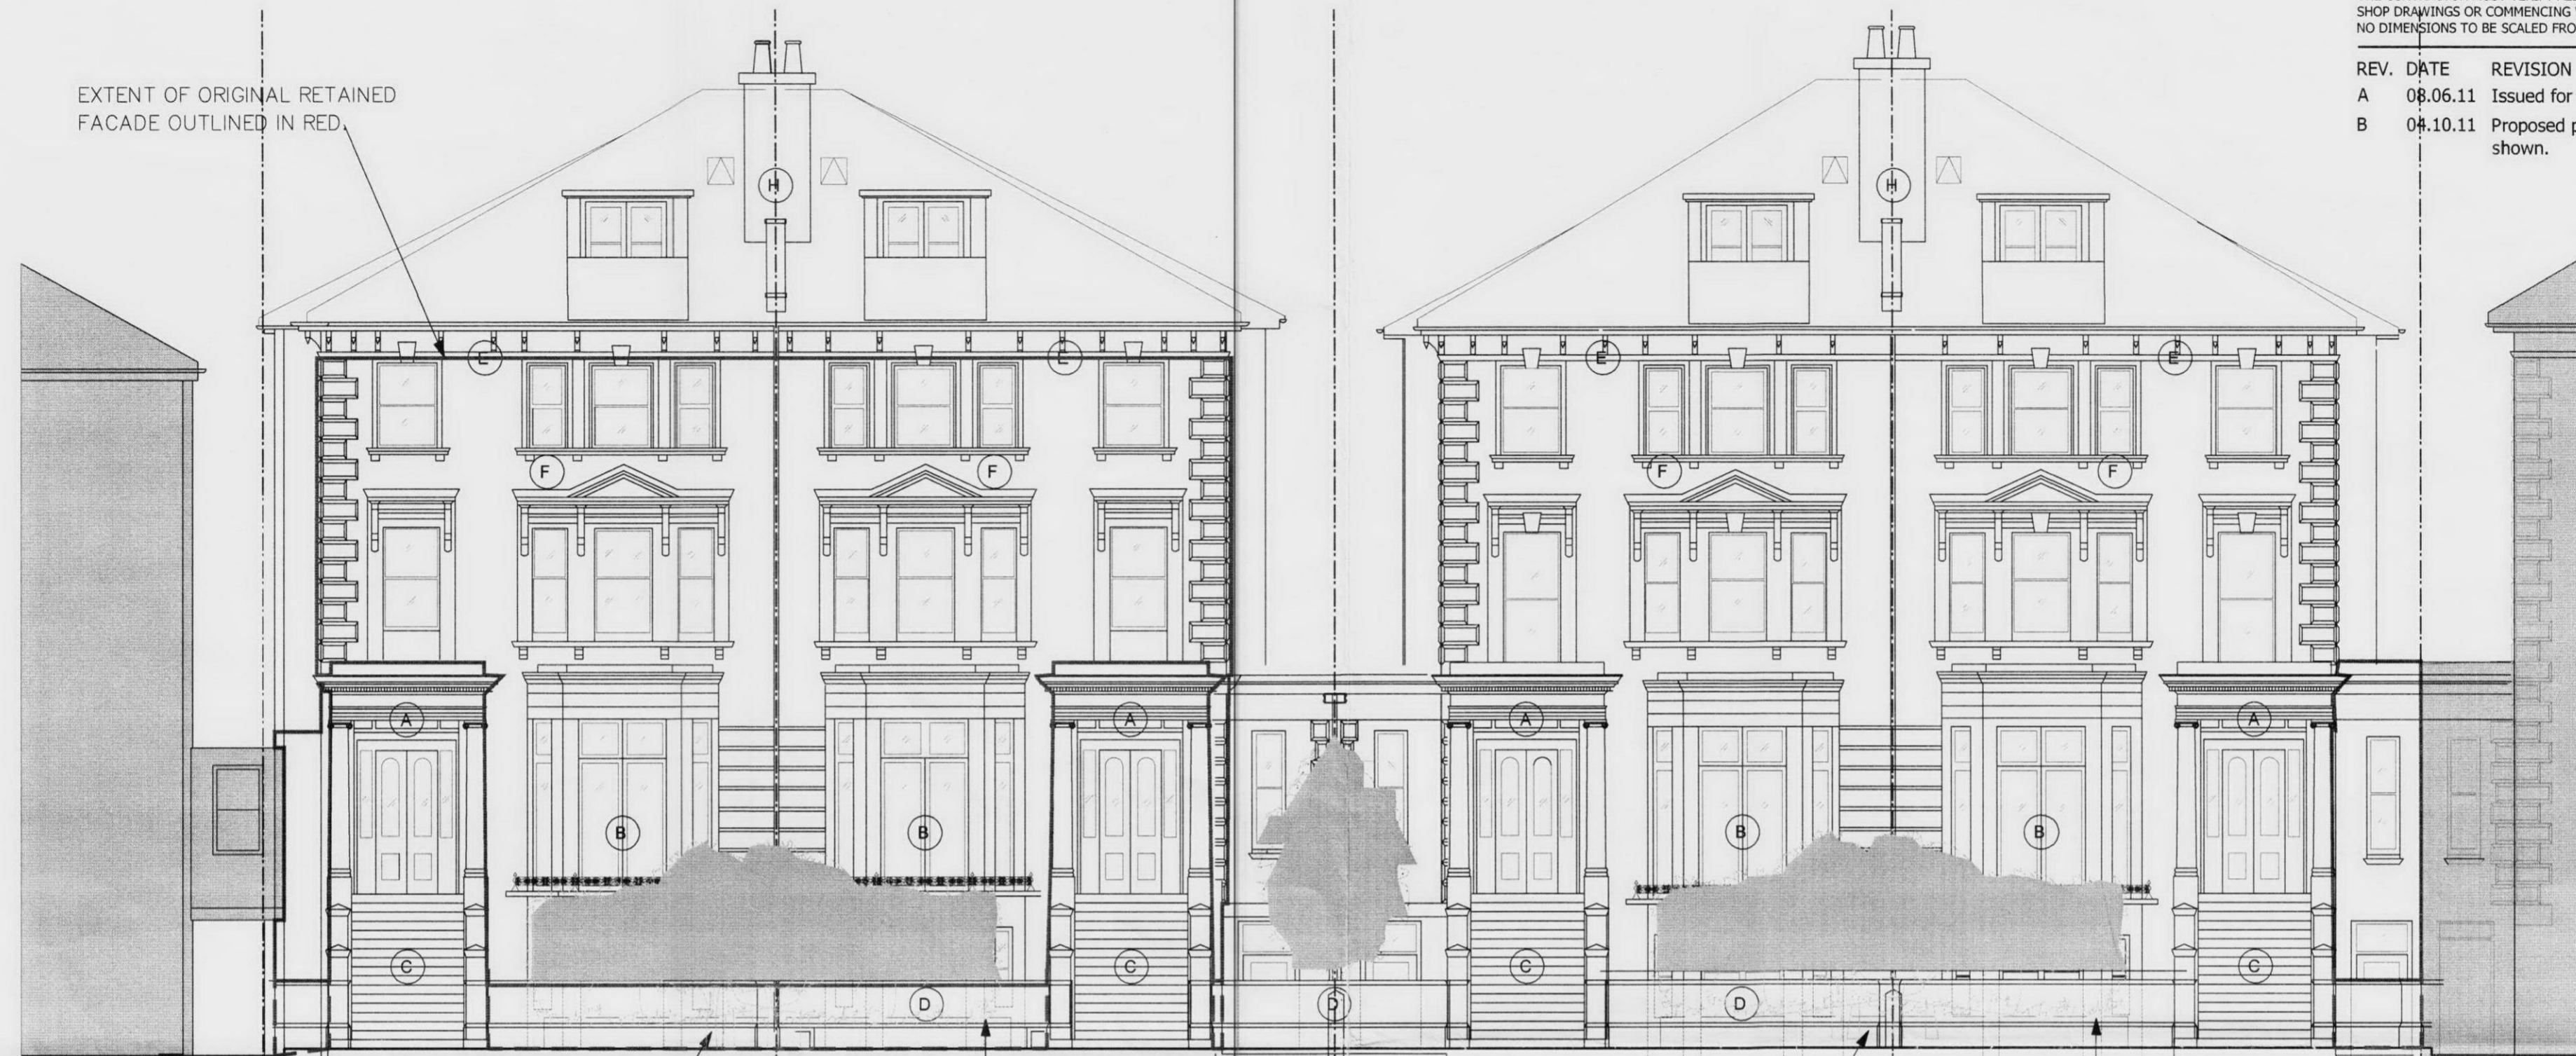
SOUTH ELEVATION

Trees and raised flower beds behind the hedge in front gardens

Evergreen hedge along the boundary wall

- (A) DETAIL 1
Entrance Porch modeled on local examples, including:
-New cornice to entrance Porch including dentil mouldings in lime render, new Ionic capitals and new Plinth mouldings to support columns.
-New Plinth and capital mouldings to Pilasters around entrance doors in lime render.
-New front door, side lights and fan lights to match 54 Belsize Park

- (B) DETAIL 5 & 11
New bay windows modeled on local examples, including:
-New cornice to bay windows, including dentil mouldings in lime render (not shown)
-New capital mouldings to the returns of the bay windows in lime render.
-New rendered window cills and new decorative cast iron cill railings.

- (C) DETAIL 9
Entrance stairs modeled on local examples, including:
-New stone copings to Piers, stone treads and risers. Rendered balustrade with stone copings
-New galvanized steel hollow section handrail.
-New decorative balustrade Panels between support columns under front Porch.

- (D) DETAIL 3
Existing front wall to be rebuilt in its entirety and modeled on local examples. Garden walls dividing Properties to be reinstated. New stone copings.

- (E) DETAIL 10
Decorative timber mouldings to underside of roof soffit to match existing.
