Environmental Noise & Vibration Report

221A Belsize Road London **NW6 4AA**

Reference: 4937

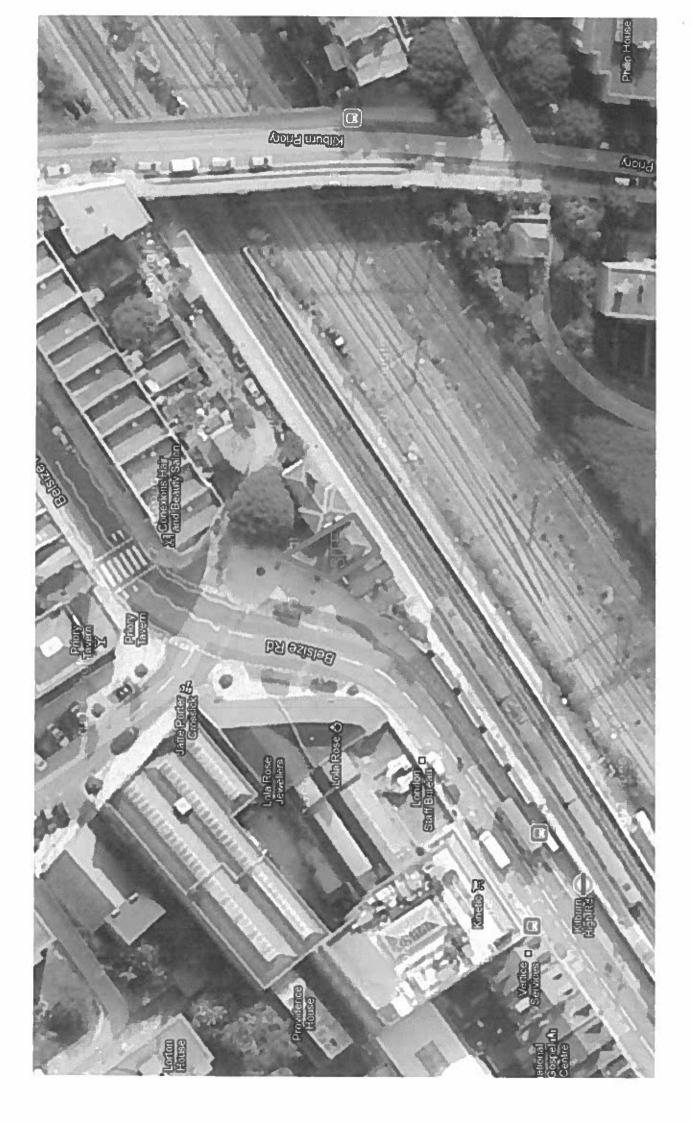
An aerial view of the site can be found in appendix 1, with relevant locations marked.

To the south east and south is a main railway line and Kilburn High Road Railway Station, which is part of the London Overground railway network. A number of railway lines run close to the site as seen in appendix 1.
