Proposed Floor Plan Scale: 1:50

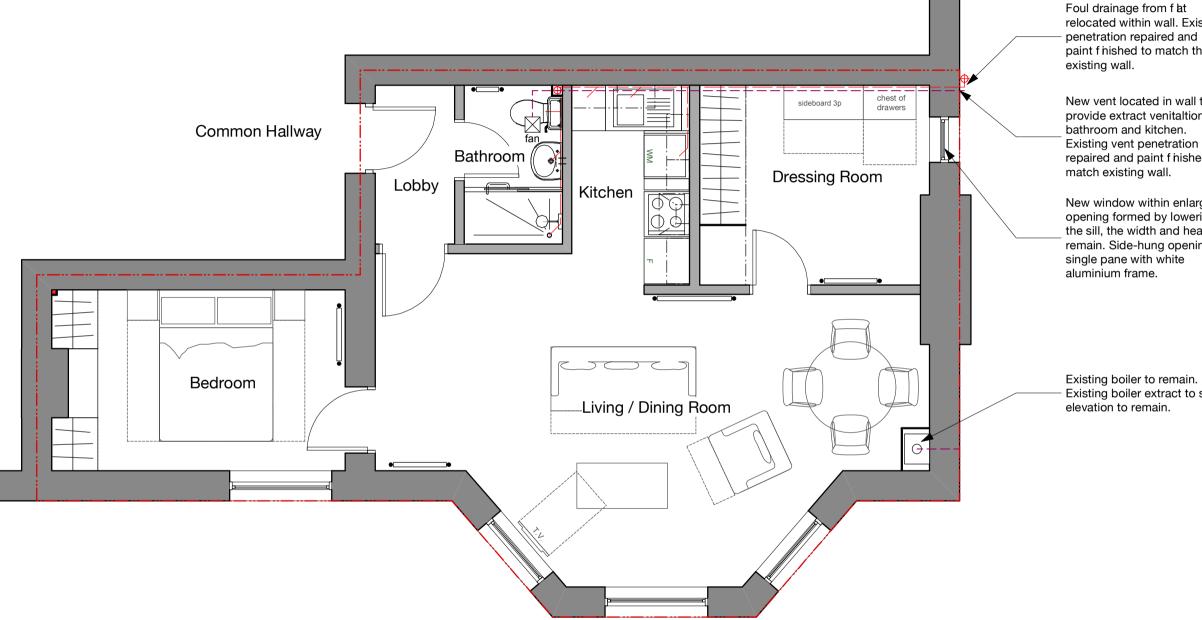
relocated within wall. Existing penetration repaired and paint f hished to match the

New vent located in wall to provide extract venitaltion to Existing vent penetration repaired and paint f hished to

New window within enlarged opening formed by lowering the sill, the width and head to remain. Side-hung opening

Existing boiler extract to side
