Our Ref.: 1214 – Rear Extension- Design and Access Statement

### **Design and Access Statement – 13 Chalcot Square, London, NW1 8YA**

#### **Gauld Architecture – 11/03/2013**

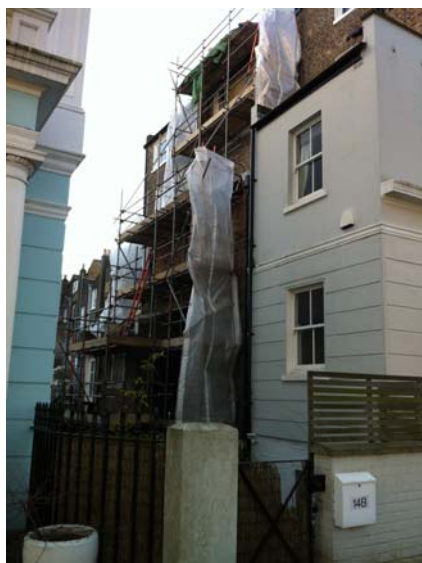
View of rear of No.13 (under scaffolding) from Chalcot Sq. Gardens, looking east

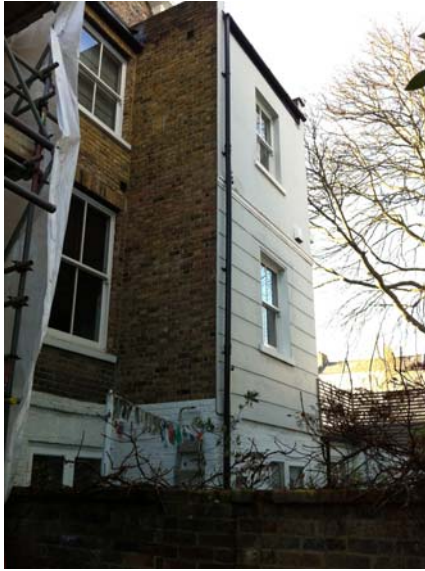
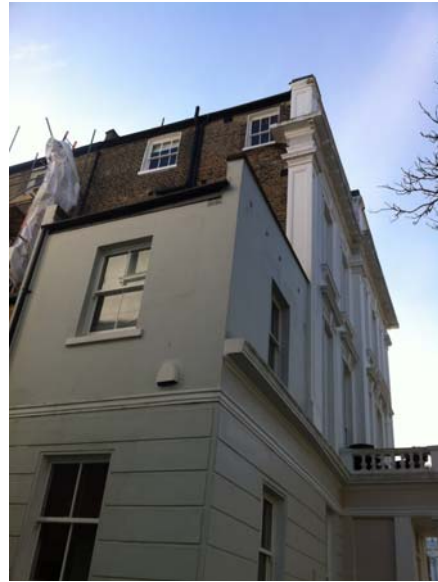
Views of the rear of No.14

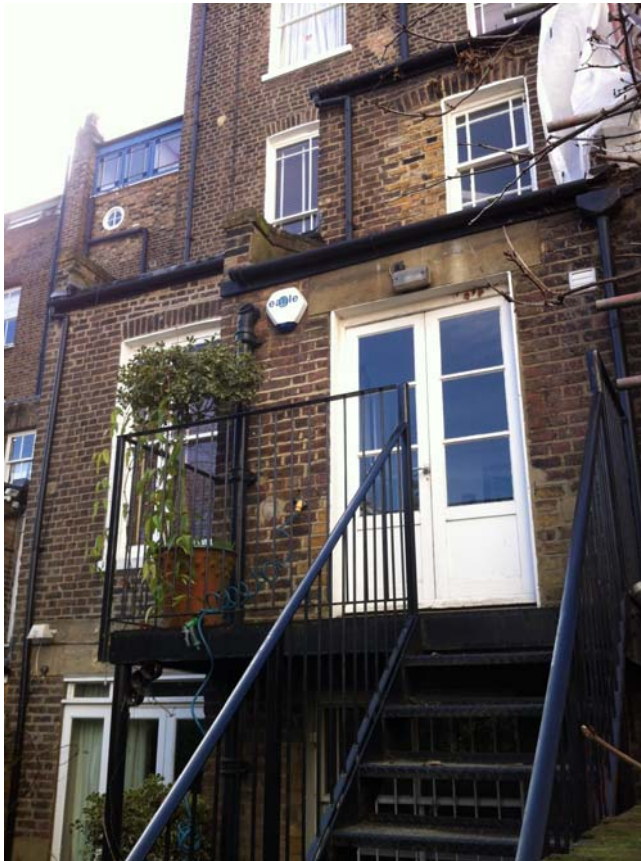
View of the rear of No.12
