1-15 Stedham Chambers

DESIGN AND ACCESS STATEMENT

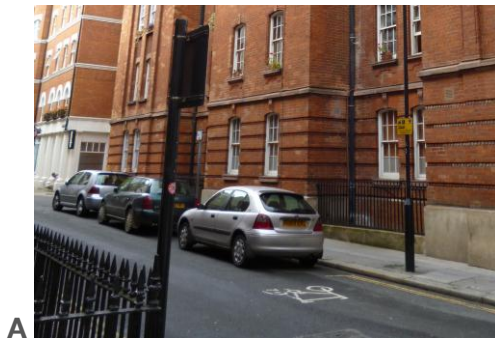
A

- A. Existing railings at Stedham Chambers
- B. Existing British Museum railings, Great Russell Street
- C. Example gate
- D. Gate with proposed mesh

The proposed gate has been designed with consideration to the immediate local context and conservation area. Photo **A** shows the existing railings at Stedham Chambers which are painted black, and photo **B** shows the railings to the British Museum. The railings in the area are black and have decorative finials which top the railings, which we have also included in the design of the proposed gate.

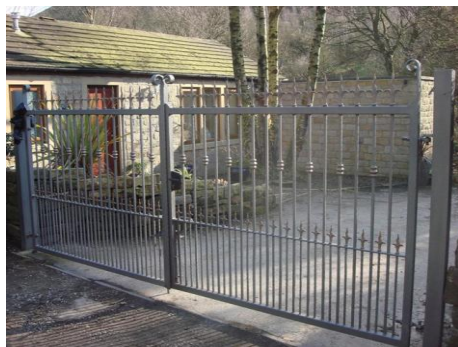
C

Photos **C** is an example of completed work from the contractor. Our proposal, similar to **C**, will be in black with a diamond mesh welded behind the railings as in photo **B**. The proposed gate will be constructed from mild steel and polyester powder coated in textured gloss in black.
