Basement Impact Assessment Report

59 Maresfield Gardens
London NW3

J11251A

December 2012

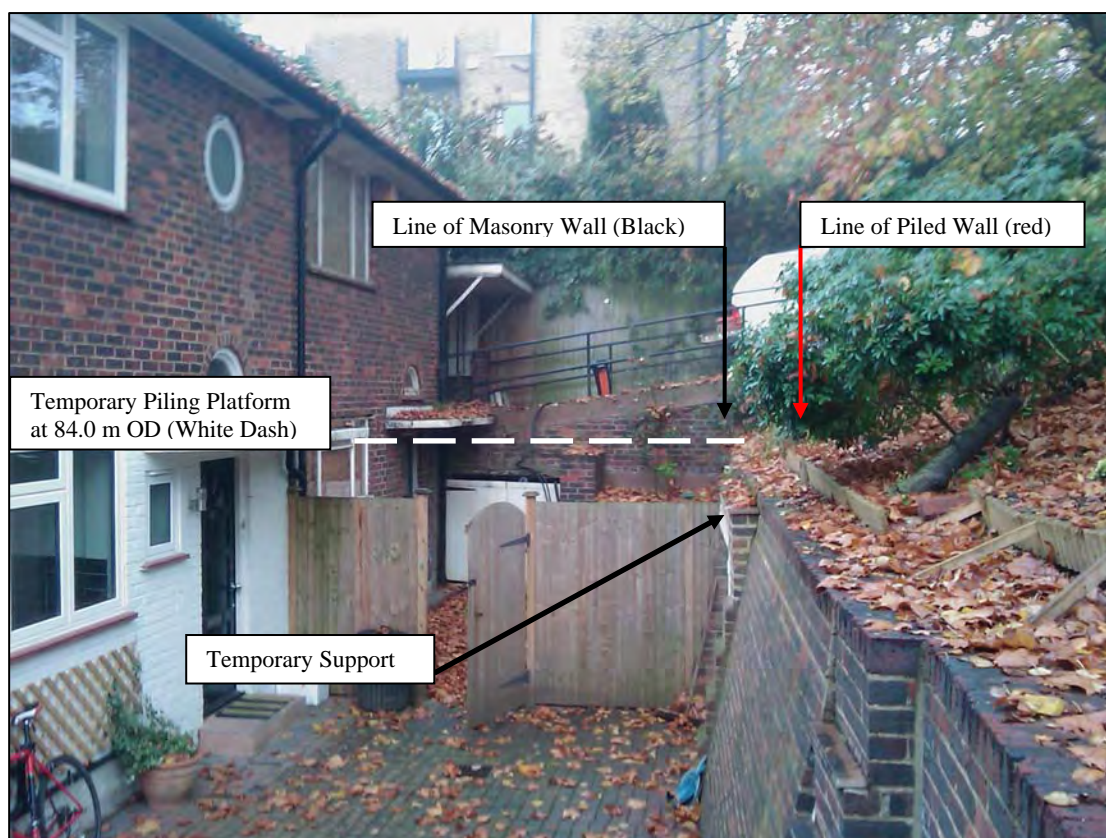
The retaining wall runs parallel with Maresfield Gardens, retaining soils for Nos 55 and 57 in a similar manner as shown in the photograph above.

The line of the proposed piled wall is behind the masonry retaining wall. Installing these piles from the road side of the wall would require the formation of a level platform which would

either require cutting or filling the site and the piling rig would cause additional loading to the retaining wall. This is not desirable but in any case, this part of the site is probably too confined for even a small piling rig to operate.

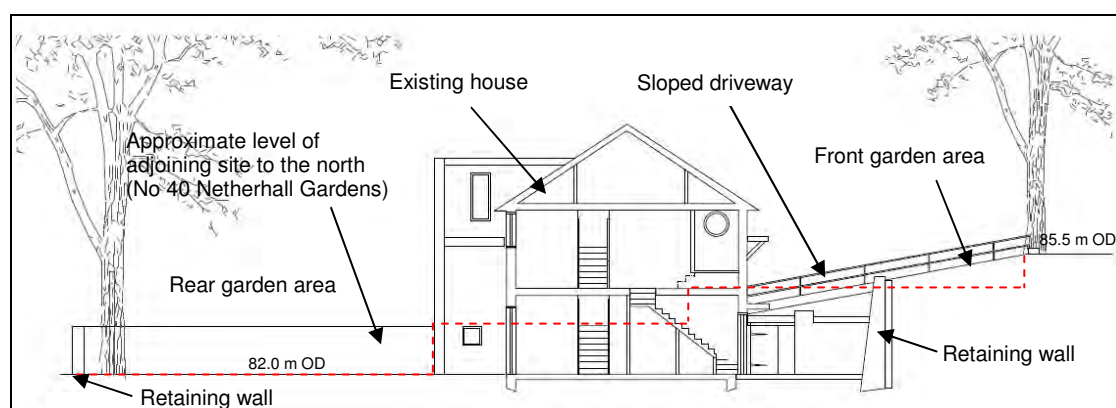
Existing site section

The topography of the surrounding area slopes down to the south and west, although the site itself slopes relatively steeply down to the west, such that the western boundary of the site is at a level of approximately 3.5 m below street level on the eastern part of the site giving an apparent slope angle of 6.7°. However, the house, rear garden and front courtyard area occupy a relatively level area, separated from street level by a 2.0 m to 2.5 m high retaining wall and steeply sloping front garden area, where the slope angle increases to a maximum of approximately 14°. The front driveway slopes down at an average angle of approximately 9.5°, to a car port situated at mid height level of the existing house. The basic layout of the site is shown on the section below. Due to the sloping nature of the area, the site is also situated at a lower level than No 40 Netherhall Gardens to the north, the level of which is shown relative to the site by the dashed red line on the drawing below.

The retaining wall on the eastern part of the site extends to the south beyond the footprint of the site and provides support to the slope in front of the adjoining properties of No 57 and 55 Maresfield Gardens. Retaining structures are also present supporting the higher ground of No 40 Netherhall Gardens to the north and on the southern part of the site, where there is a drop in level to the adjoining access road and private parking area. It is understood that a swimming pool is situated within the rear garden of the property to the north, and at its closest point is approximately 2.0 m from the site boundary. The pool is understood to extend to a maximum depth of approximately 2.0 m, such that its base is likely to be situated at a similar level to the existing ground level of the site.

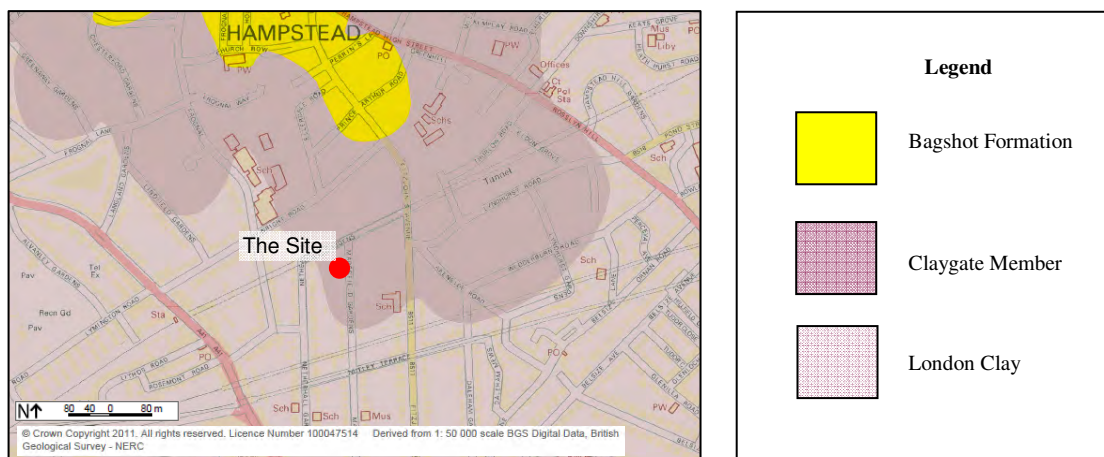
The Geological Survey map of the area (sheet 256) indicates that the site should be underlain by the Claygate Member, which in turn is underlain by London Clay; the Claygate Member forms the youngest part of the London Clay Formation. The geology in this area is generally horizontally bedded such that the boundary between the geological formations roughly follows the ground surface contour lines. The boundary between the Claygate Member and the overlying Bagshot Formation is approximately 300 m to the north of the site, whilst the boundary with the underlying upper facies of the London Clay is less than 50 m to the west of the site, as shown by the geological extract below.

According to the BGS memoir, the Claygate Member in this area is principally a finely interbedded and thinly laminated sequence of clay, silt and fine-grained sand, whilst the underlying London Clay is a much more homogenous slightly calcareous silty clay to very silty clay, with some beds of clayey silt grading to silty fine grained sand.

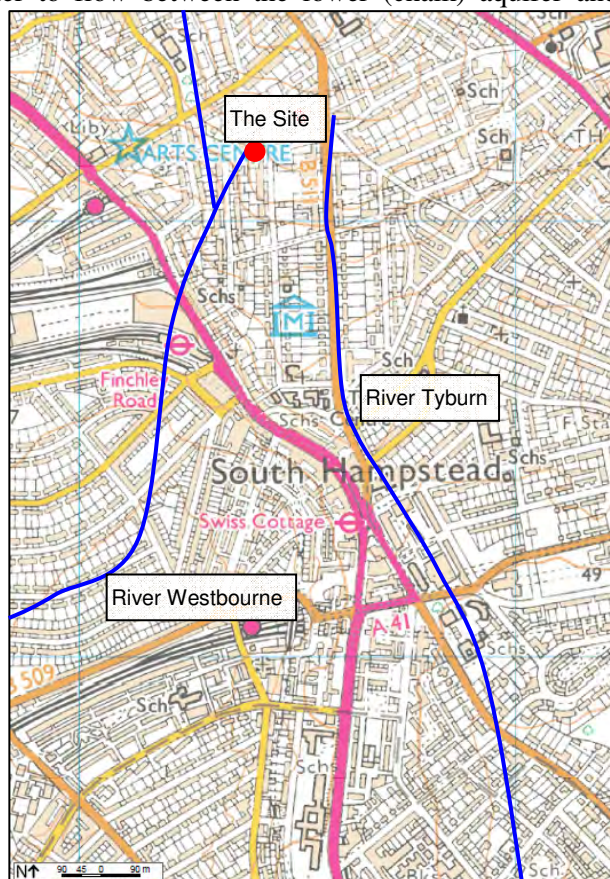
Historically a tributary of the River Tyburn⁵ rose approximately 150 m to the east of the site, as shown on the adjacent map, at the corner of Lyndhurst Road and Fitzjohns Avenue. It is shown on the map dated 1871 rising from a small pond near to what is annotated as Shepherd's Well, although is no longer shown on subsequent maps following the construction of Fitzjohns Avenue.

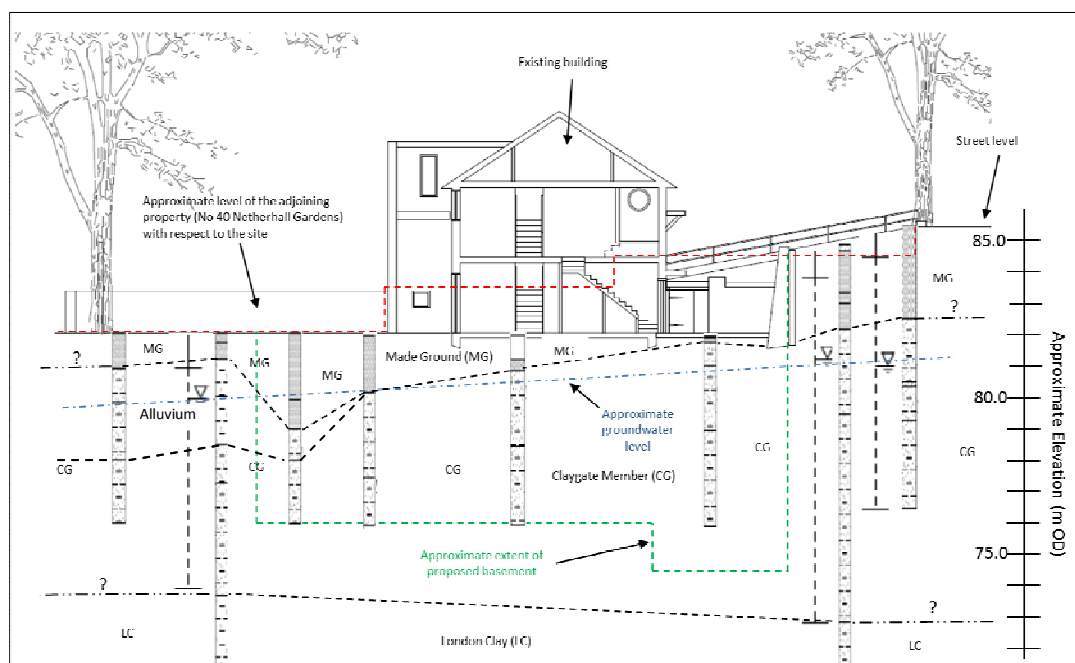
The cross-section below indicates the soil and groundwater conditions beneath the site and their relationship with the existing and proposed site layout. A copy of this idealised cross-section, along with a nominal section constructed using the borehole records are included in the appendix.

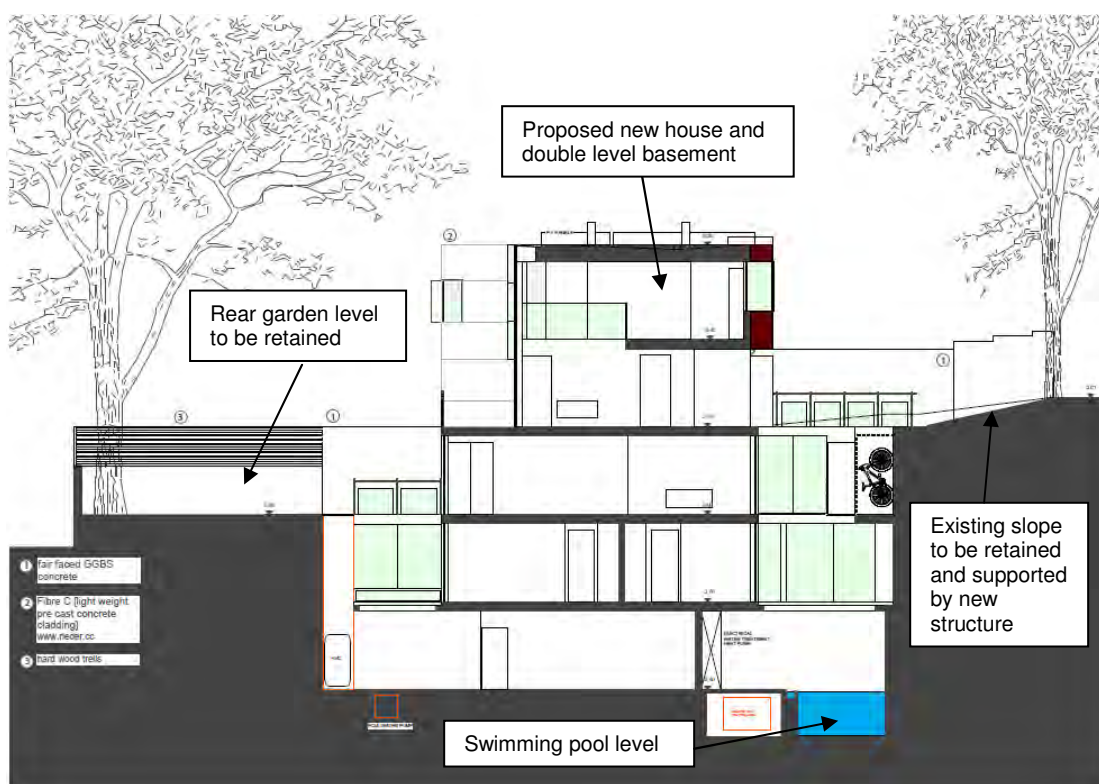
Proposed site section

It is understood that the new basement will be excavated to a depth of approximately 6.0 m below existing ground floor level, to a level of 76.0 m OD, although deeper excavations to a level of 74.5 m OD will be required for the additional swimming pool level. Therefore formation level is likely to be within the firm to stiff clay of the Claygate Member. A section through the proposed development is shown below.

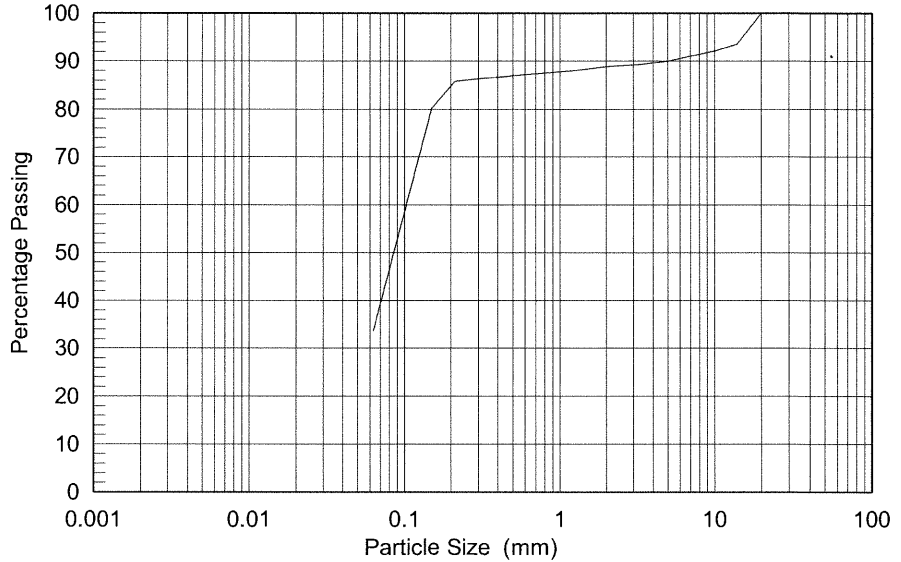
SIEVE	
Sieve	% pass
200 mm	100
125 mm	100
90 mm	100
75 mm	100
63 mm	100
50 mm	100
37.5 mm	100
28 mm	100
20 mm	100
14 mm	94
10 mm	92
6.3 mm	91
5 mm	90
3.35 mm	89
2 mm	89
1.18 mm	88
600 µm	87
425 µm	87
300 µm	86
212 µm	86
150 µm	80
63 µm	34

Particle Proportions	
Cobbles	0.0 %
Gravel	11.1 %
Sand	55.3 %
Silt & Clay	33.6 %

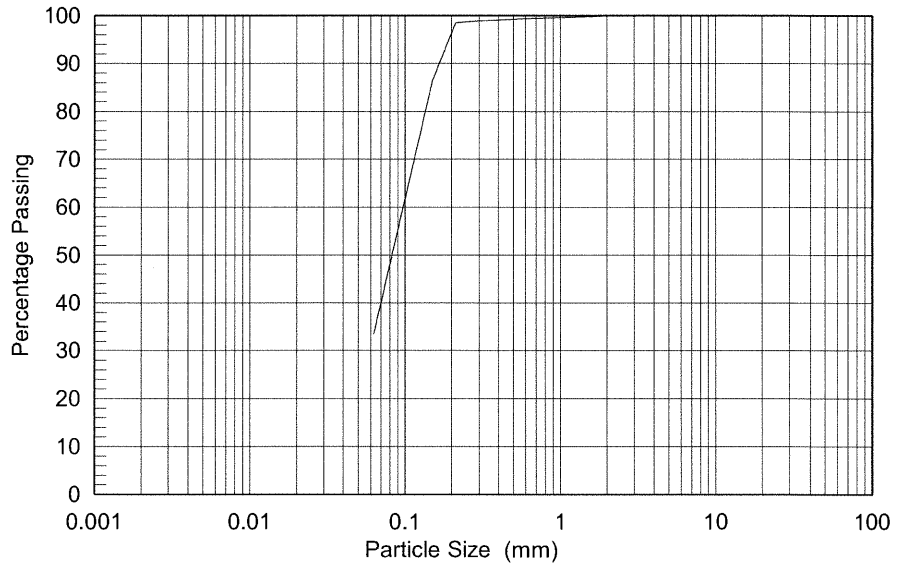
SIEVE	
Sieve	% pass
200 mm	100
125 mm	100
90 mm	100
75 mm	100
63 mm	100
50 mm	100
37.5 mm	100
28 mm	100
20 mm	100
14 mm	100
10 mm	100
6.3 mm	100
5 mm	100
3.35 mm	100
2 mm	100
1.18 mm	100
600 µm	99
425 µm	99
300 µm	99
212 µm	98
150 µm	86
63 µm	34

Particle Proportions	
Cobbles	0.0 %
Gravel	0.1 %
Sand	66.4 %
Silt & Clay	33.5 %
