A GLAZED LOBBY (RESTORATION)

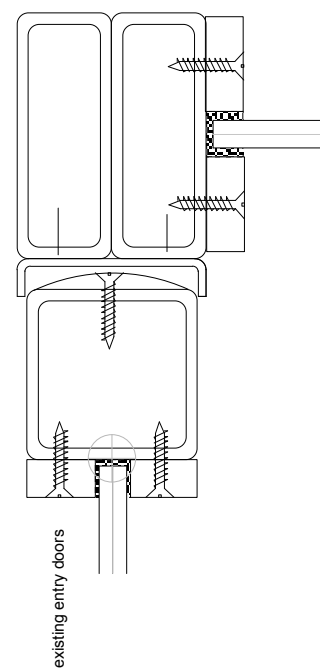
1

steel box transom/mullion
10x20mm glazing beads
'clear georgian' wired fire glass

detail of existing glazed screen 1:2

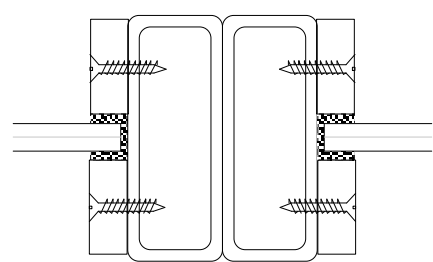
2

existing glazing frame indicated white- removal of non-original sub-divisions (indicated in red) to reinstate 1950's clarity of appearance

- Indicates recent additions to mullions to be carefully removed to reinstate the 1950 proportions.
- Indicates framed fire screen c 1951 with original glass panel sizes reinstated - original black and white decoration to framing renewed.

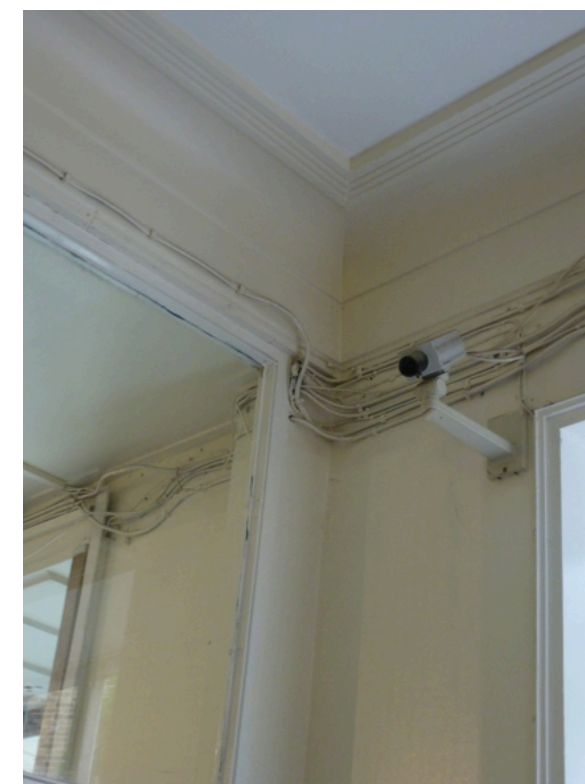
B SURFACE WIRING INSTALLATION

surface wiring and cameras to be incorporated into teh head track of the new screen

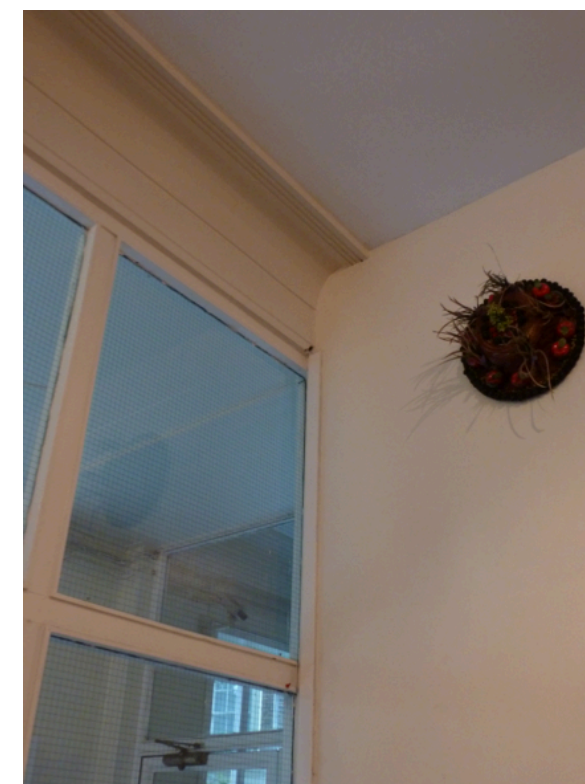
C FIRE WALL-SCREEN/CORNICE JUNCTION

existing plasterboard fire wall junction with screen and cornice, the complete cornice to be visible as part of the proposed screen
