Urbanest UK Limited

103 Camley Street, London
*Updated Remediation Method
Statement – Revision 1*

July, 2012

Reference	CG/5521D	Revision	0	Issue Date July 2012
		Revision	1	Issue Date July 2012

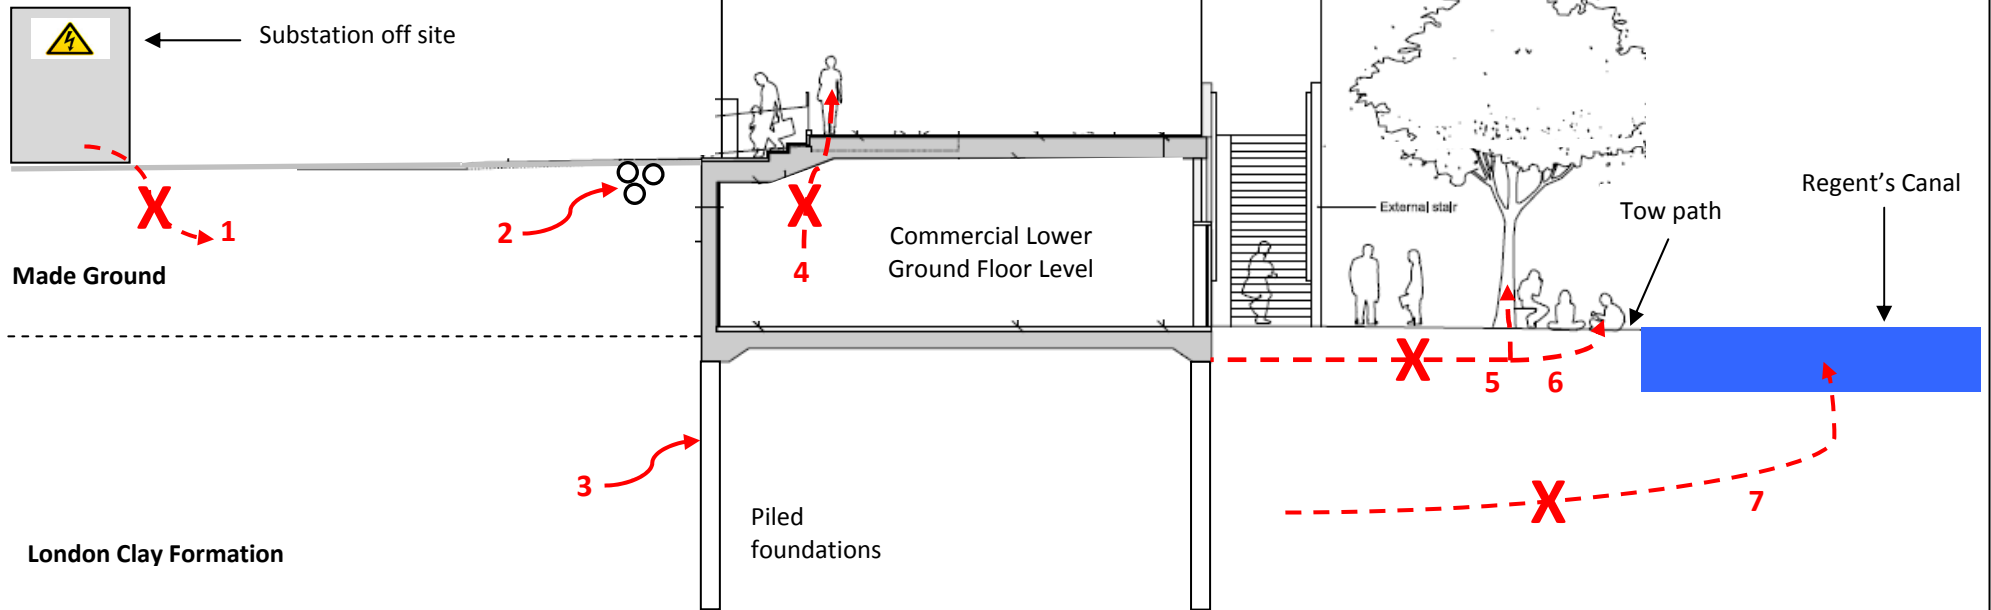
Title	Figure 3
	Updated Conceptual Site Model

1. Negligible concentrations of PCBs detected on site, therefore, no risk from the off-site substation.
2. Potable water supply barrier pipework to prevent permeation of residual hydrocarbons into drinking water from remaining Made Ground.
3. Sulphates in London Clay and remaining Made Ground to be mitigated through the use of an appropriate design class of concrete.
4. Removal of Made Ground will further mitigate risks from soil borne gases/vapour, although a negligible gas regime has been identified on site.

5. Removal of the Made Ground and tanks (sources) from site to allow for the ground floor level will mitigate risks of plant uptake by plants. A capping layer has been recommended to promote healthy plant growth.
6. Removal of the sources will mitigate risks to future occupiers. Site workers will need to employ the use of PPE to mitigate risks of exposure to hydrocarbons, asbestos etc. during ground works.
7. Limited groundwater contamination identified and site is not in an SPZ. Canal is lined and mitigation measures will be undertaken during the development to ensure the canal does not become impacted.

Generally the risk to human health and to controlled waters was considered to be low. A conceptual site model was provided within the earlier *GGIR*, which should be referenced for detailed information. Otherwise, a diagrammatic version of the CSM is provided as Figure 3.
