Stephen Levrant Heritage Architecture Ltd

Camden Lock Village Annex Report

Listed building list

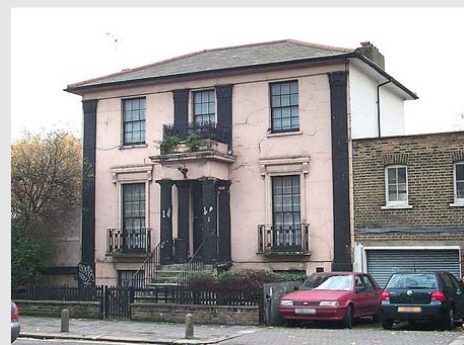
ID	LOCATION	LISTING	YEAR	IoE No	DESCRIPTION	IMAGE
1	1 Hawley Road (South side) CAMDEN TOWN, CAMDEN, GREATER LONDON NW1 8RP	Grade II Listed: 14 May 1974	Early C19	478176	Detached villa. Early C19. Stucco. Slated hipped roof with projecting eaves. Double fronted with 3 windows; 2 storeys and semi-basement. Pilasters rise from ground floor at angles and from 1st floor level flanking central window to carry entablature with egg-and-dart ovolo cornice at eaves level. Central prostyle Doric portico with cornice, blocking course and cast- iron balcony to 1st floor window. Doorway with fanlight and panelled door, approached by steps with attached cast-iron railings. Recessed sashes; ground floor architraved with console bracketed cornices and cast-iron balconies. INTERIOR: not inspected.

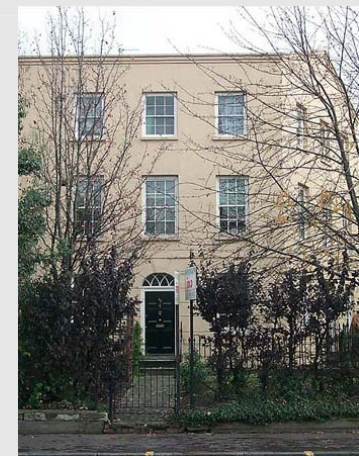
2	46 Kentish Town Road CAMDEN TOWN, CAMDEN, GREATER LONDON NW1 9PS	Grade II Listed: 14/05/1974 Date of Last Amendment: 10/11/2005	Early C19	478602	Formerly known as: Nos.44 AND 46 KENTISH TOWN ROAD. Includes: No.1B, C, D AND E JEFFREY'S STREET. 2 semi-detached houses. Former No.44 (now flats 1B, C, D and E Jeffrey's Street) on the right hand return of No.46; the rear of former No.44 forming No.1 and 1A Jeffrey's Street (qv). Early C19, partly rebuilt in facsimile 1971-2. Stucco with rusticated ground floor and plain 1st floor band. 3 storeys and basements. No.46, 4 windows; former No.44, 3 windows on gabled end. No.46, round-arched doorway with fluted surround, fanlight with intersecting tracery and panelled door; former doorway in left hand bay converted to a window. Recessed sashes. Parapet with moulded coping. Former No.44, square-headed doorway with fanlight and panelled door. Recessed sashes. Gable with moulded coping. INTERIORS: not inspected.

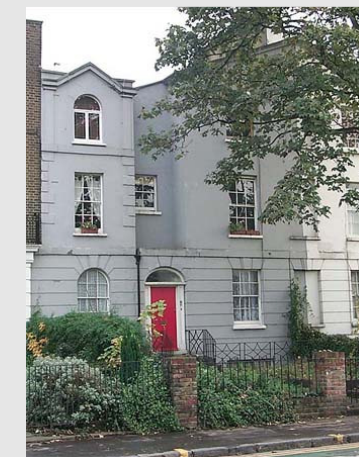
3	48-50 Kentish Town Road CAMDEN TOWN, CAMDEN GREATER LONDON NW1 9PU	Grade II Listed: 14/05/1974 Date of Last Amendment: 14/05/1974	Early C19	478603	2 semi-detached houses. Early C19. Stucco with rusticated ground floor; pitched roof with central slab chimney-stack. 3 storeys and basements. Gabled central section of 3 windows (centre blind) with 1 window entrance bays, recessed at 1st floor level, and later C19 one window extension at North end of No.50. Round-arched doorways with panelled jambs, fanlights and panelled doors. Recessed sashes; extension to No.50 ground floor with round-arched sash and 2nd floor, round-arched casement flanked by pilasters supporting gable. INTERIORS: not inspected. SUBSIDIARY FEATURES: attached wrought-iron railings to areas and steps

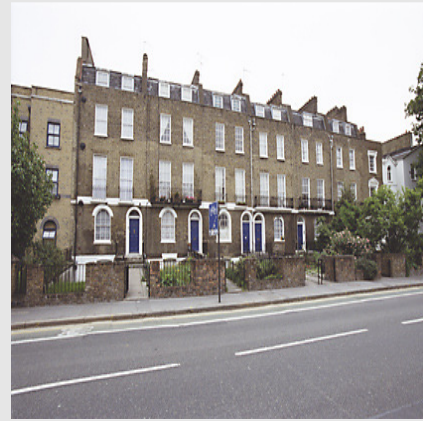
ID	LOCATION	LISTING	YEAR	IoE No	DESCRIPTION	IMAGE
4	52-64 KENTISH TOWN ROAD (East side) CAMDEN TOWN, CAMDEN, GREATER LONDON	Grade II Listed 14 May 1974 Date of Last Amendment: 14 May 1974	Early C19	478604	CAMDEN TQ2884SE KENTISH TOWN ROAD 798-1/65/965 (East side) 14/05/74 Nos.52-64 (Even) GV II Terrace of 7 houses. Early C19. Yellow stock brick with slated mansard roofs and dormers except No.52, yellow stock brick with stucco ground floor. 3 storeys, attics (except No.52) and basements. 2 windows each except No.52 with one. Round-arched ground floor openings; doorways with reeded surrounds, fanlights (Nos 56 & 62 with intersecting tracery) and panelled doors. Gauged brick flat arches to recessed sashes; 1st floor with cast-iron balconies. Parapets. No.52: square-headed doorway; fanlight with pointed lights and panelled door. Entablature at 1st floor level supporting cast-iron balcony to 1st floor architraved sash with console bracketed pediment. 2nd floor sash, architraved with console bracketed cornice. Parapet. INTERIORS: not inspected. (Survey of London: Vol. XIX, Old St. Pancras and Kentish Town (St. Pancras part II): London: -1938: 49).

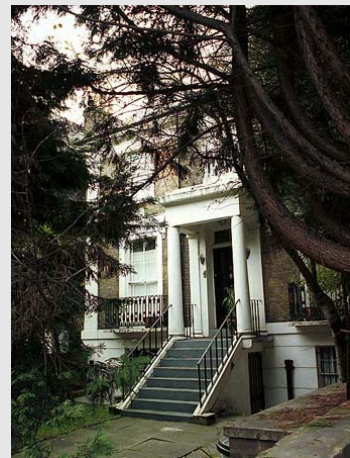
5	55 Kentish Town Road CAMDEN TOWN CAMDEN GREATER LONDON NW1 8NX	Grade II Listed: 14/05/1974 Date of Last Amendment: 14/05/1974	Early C19	478605	Detached villa. Early C19, restored c1979. Yellow stock brick with slated pitched roof with pitched dormers. Double fronted with 3 windows; 2 storeys, attic and semi-basement. Stucco pilasters at angles rise from ground floor level to carry entablature with egg-and-dart ovolo cornice at eaves level. Central prostyle portico; doorway with fanlight and panelled door approached by steps with attached cast-iron railings. Recessed sashes; ground floor architraved with console bracketed cornices and cast-iron balconies. INTERIOR: not inspected.

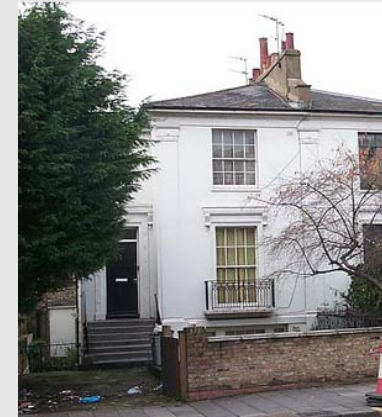
6	57 - 63 Kentish Town Road NUMBERS 57-63 AND ATTACHED GARDEN RAILINGS, WALL, PILLAR AND GATE 57-63 CAMDEN TOWN CAMDEN GREATER LONDON NW1 8NX	Grade II Listed: 14/05/1974 Date of Last Amendment: 14/05/1974	Early C19	478606	2 pairs of semi-detached villas. Early C19. Stucco with slated hipped roofs and central slab chimney-stacks. 2 storeys and semi-basements. 1 window each and 1-window recessed entrance bay each side. Pilasters rise from ground floor at angles and centrally to carry an entablature with egg-and-dart ovolo cornice at eaves level. Square-headed doorways with fanlights and panelled doors; Nos 57 & 59 with floating console bracketed cornices; Nos 61 & 63 with rosette decorated architraves and console bracketed cornices. Recessed sashes; ground floors architraved with console bracketed cornices, Nos 57, 61 & 63 with cast-iron balconies. INTERIORS: not inspected. SUBSIDIARY FEATURES: No.63 with attached cast-iron garden railings on stone capped sleeper wall with stone capped pillar and cast-iron gate.

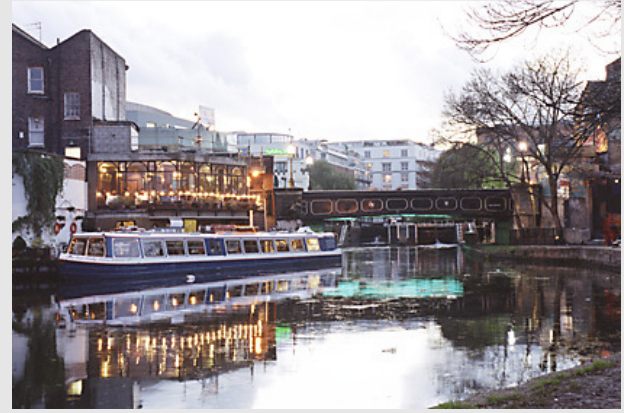
ID	LOCATION	LISTING	YEAR	IoE No	DESCRIPTION	IMAGE
7	HAMPSTEAD ROAD BRIDGE OVER GRAND UNION CANAL, CAMDEN HIGH STREET	Grade II Listed 11/01/1999 Date of Last Amendment: 11/01/1999	1876	476806	CAMDEN TQ2884SE CAMDEN HIGH STREET 798-1/65/151 Hampstead Road Bridge over Grand Union Canal GV II Public road bridge over the Grand Union Canal and towpaths. 1876, replacing an earlier inadequate brick bridge of c1815. Provided by the St. Pancras Vestry and the Metropolitan Board of Works. Slightly cambered cast-iron girder bridge. Cast-iron panelled parapets with relief moulded rectangles; similar parapets on bridge deck provide pedestrian walkways. Brick abutments with stone coping. Stone plaque in North-East abutment recording the rebuilding.

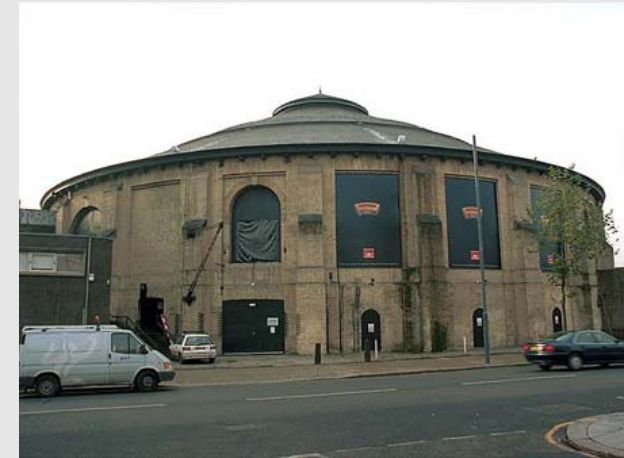
8	ROUNDHOUSE (South West side) Chalk Farm Road	Grade II* Jun 10 1954	1846-7	798-1- 19464	Formerly known as: Warehouse of W & A Gilbey Ltd CHALK FARM ROAD. Goods locomotive shed, now theatre. 1846-7. By Robert B Dockray. For the London and North Western Railway. Built by Branson & Gwyther. Converted for use as a theatre 1967 and 1985. Yellow stock brick. Low pitched conical slate roof having a central smoke louvre, now glazed, and bracketed eaves. Circular plan 48m in diameter. Buttresses with offsets mark bays each having a shallow, recessed rectangular panel. Former entrances and windows with round-arched heads. INTERIOR: roof carried on 24 cast-iron Doric columns (defining original locomotive spurs) and a framework of curved ribs. Believed to retain original flooring, turn table and fragments of early railway lines. Wooden gallery probably added by Gilbeys, late C19. HISTORICAL NOTE: the building did not last long as an engine shed; by the 1860s the engines had become too long to be turned and stored there so it was leased to W & A Gilbey Ltd as a liquor store until converted to a theatre in the 1960s. (Survey of London: Vol. XXI, Tottenham Court Road and Neighbourhood, St. Pancras III: London: -1949: 114).

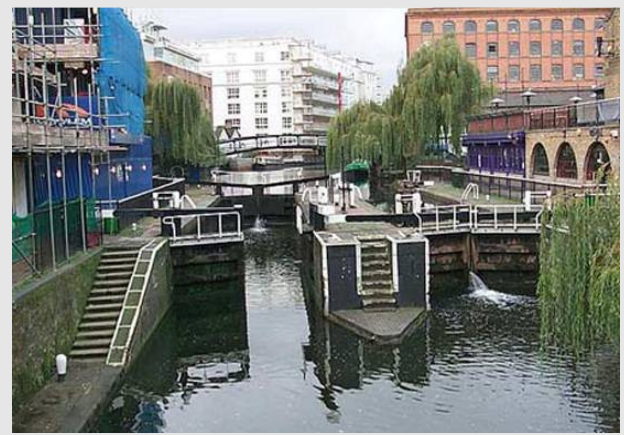
9	HAMPSTEAD ROAD LOCK Location: Hampstead Road Lock on the Grand Union Canal Street: Camden High Street	Grade II Jan 9 1992		798-1- 15265	Pair of canal locks. c1818-20 with C20 alterations. Brick chambers with stone coping. Central island platform. Each lock has 2 sets of double wooden gates with wood and steel balance beams. Ground paddle gearing at top, gate paddle gearing at bottom. Walls have steps down to lower level. Brick paved lockside surfaces. HISTORICAL NOTE: the Regent's Canal arm of the Grand Union Canal was constructed 1812-20, engineered by James Morgan, supervised by John Nash.

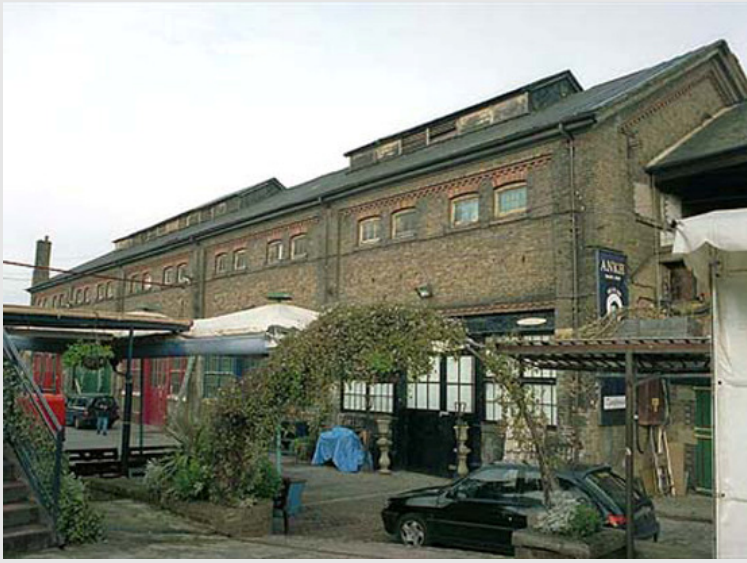
ID	LOCATION	LISTING	YEAR	IoE No	DESCRIPTION	IMAGE
10	HORSE HOSPITAL (West side) Stanley Sidings, stables with ramp and boundary wall at North of site Street: Chalk Farm Road	Grade II listing: Sep 30 1981	c1883	798-1-19264	<p>Stable building, known as the 'Horse Hospital', now garages and workshops, also roadway to its North and boundary wall along Chalk Farm Road. Western portion of building 1883, eastern portion c1895, both by the London and North-Western Railway's Engineer's Department. Stock-brick with red-brick dressings. Broad pitched and slated roofs with two sets of ventilating louvres raised above western portion. EXTERIOR: one and 2 storeys, stepping up hill westwards and northwards. North elevation of 29 windows towards road fairly regular, the western portion divided by pilaster strips into panels of plain brickwork relieved by pairs of small segment-headed windows high up under coggled brick cornice. Western end has oculus under a broad gable, with windows and door below and contemporary spiral horse ramp in brick leading round to southern end of building. South elevation irregular, with many breaks and recessions; broad opening for casts with iron stanchions and girders and centre-opening windows along ground storey of western portion, tiers of segment-headed industrial windows to both storeys of eastern portion. INTERIOR: upper storey of western portion has iron columns and capitals supporting timber roof trusses and complete surviving timber and iron partitions for stabling with mangers and troughs along walls. Groups of harness hooks. SUBSIDIARY FEATURES: ramped road to North of building with heavy stone kerbs and setts raised on brick walls, and high brick boundary wall with piers parallel to building and separating former Camden Goods Yard from Chalk Farm Road. Underneath, a tunnel of brick construction formerly linked the horse hospital with the Interchange Warehouse, Oval Road and railway at Primrose Hill (qqv). This is of round-arched brick construction with cast-iron ventilators at regular intervals. HISTORICAL NOTE: the Goods Yard at its height was worked by some 400 horses, and this was how they were moved around. Included as the outstanding architectural survival from the Camden Goods Yard, itself a rare complex of industrial stabling. It forms a group with Blocks A to D to the South-East (qv). The western portion was planned to house 92 horses and originally had ramps at both ends, the eastern ramp having disappeared when the building was lengthened c1895.</p>

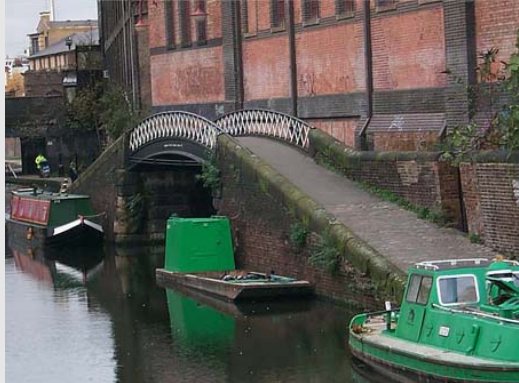
11	THE INTERCHANGE CANAL TOWPATH Location: (North side) The Interchange canal towpath bridge over private canal entrance Street: Oval Road	Grade II May 14 1974		798-1-126165	<p>Towpath bridge, situated between Southampton Bridge, Oval Road (not included) and Hampstead Road Lock, Camden High Street (qv), carrying path over canal inlet to a private dock within The Interchange (qv). 1848-56. Manufactured by J Deeley and Co, Newport, Monmouthshire, whose name appears on the bridge. Single span of cast-iron with stone capped abutments; granite setts on approach ramps relaid 1978. Many tow rope grooves on handrail, iron strapping and stone capping.</p>

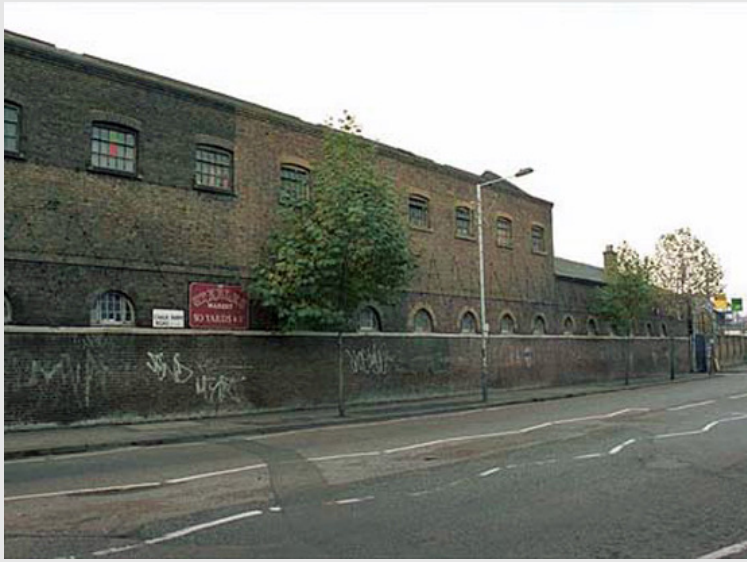
ID	LOCATION	LISTING	YEAR	IoE No	DESCRIPTION	IMAGE
12	STANLEY SIDINGS (West side) Stanley Sidings, stables to East of Bonded Warehouse Chalk Farm Road	Grade II Sep 30 1981		798-1- 19365	<p>Four blocks of industrial stabling, now workshops and warehousing. C.1855-1870, with later Victorian additions. For the London and North-Western Railway Company's Camden Goods Yard. Stock brick, with hipped slate roofs, some stone lintels. Some iron columns internally, but floors and roofs generally of timber. EXTERIOR: mostly of 2 storeys. Northernmost block (A) abutting on Chalk Farm Road, c1855, with upper storey of c1895. Long curved front road, mostly of 2 storeys with eaves cornice but western end of one and a half storeys, somewhat altered, with chimney on roof. Round-headed half windows for stabling on ground storey, segment-headed industrial windows in upper storey (eastern end only). Elevation towards yard irregular. Eastern portion has cantilevered open balcony at first-floor level retaining some concrete horse troughs and connected by bridge to Block B and separately to ramp on Block C. Ceilings of ground storey have jack-arch iron and brick construction. INTERIOR of upper storey has separate compartments and paving for horses but no stalls. Block B immediately to North of North London railway line. 3 storeys. Ground storey c1868, originally provender store, with round-headed half-windows for stabling on long elevations; upper storeys c1881, with round-headed windows at first-floor level and segment-headed windows above. Tiers of loft openings for hoists, much altered and renewed. Connected by narrow bridge at East end to Block A. Block C between Blocks A and B and parallel to Block B. 2 storeys. Ground storey c1868, upper provender store, with round-headed half-windows for stabling on long elevations; upper storeys c1881, with round-headed windows at first-floor level and segment-headed windows above. Tiers of loft openings for hoists, much altered and renewed. Connected by narrow bridge at East end to Block A. Block C between Blocks A and B and parallel to Block B. 2 storeys. Ground storey c1868, upper storey 1881; horse ramp on North side of block c1895, connected with balcony on Block A. Round-headed windows on ground storey, segment-headed industrial windows above on ground storey, segment-headed industrial windows above on both North and South sides. South side formerly had another horse ramp, of 1881, and covered bridge connecting with Block B, demolished in 1980s. Ground storey has iron and brick jack-arch construction and iron stanchions against walls stamped 'Norton and Son Darlaston'. Block D at right-angles and to West of Blocks B and C. 2 storeys. Ground storey c1868, upper storey c1881. Main elevation faces eastwards, with return northwards. Round-headed half windows for stabling at ground level, some segment-headed sash windows above. Tall brick chimneys. INTERIOR with original timber benching, one timber partition and some harness hooks. Said to have been formerly the Tack Room for the stabling. Formerly connected by a bridge at South end to Block B. Included as a rare example of substantial industrial stabling and a major surviving portion of the former Camden Goods Yard. Forms a group with the 'Horse Hospital' to North-West (qv) and with further remnants of stabling and warehouses West of Block D (qv). A tunnel (now blocked) South of the North London line connects the complex with further LNWR buildings and the Regent's Canal south of the North London Line.</p>

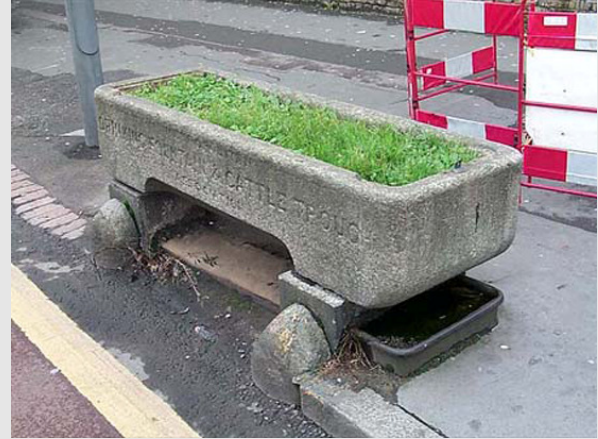
ID	LOCATION	LISTING	YEAR	IoE No	DESCRIPTION	IMAGE
13	CATTLE TROUGH (South West side) Cattle Trough opposite debouchment of Belmont Street, SE of the Roundhouse Street: Chalk Farm Road	Grade II Jul 1 1998		798-1-176564	Single cattle trough, opposite debouchment of Belmont Street and 20 metres south-East of the Roundhouse (qv). Late C19. Granite. Placed by the Metropolitan Cattle Trough and Drinking Fountain Association in memory of the Christian Socialist Charles Kingsley. Initials of donors largely obscured. Large and bold inscription along long flank identifying it as the work of the Metropolitan Cattle Trough and Drinking Fountain Association. Forms a pair with the adjoining drinking fountain (qv) and a group with the Roundhouse (qv).

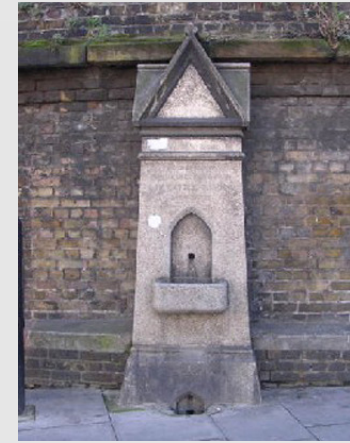
14	DRINKING FOUNTAIN Location: (South West side) Drinking Fountain set in wall next to the Roundhouse Street: Chalk Farm Road	Grade II Jul 1 1998		798-1-176664	Drinking fountain. Late C19. Presented by the Metropolitan Cattle Trough and Drinking Fountain Association. Granite. Approximately two metres in height, rectangular in plan and treated as a Gothic buttress with pointed arch recess for drinking bowl. Forms a pair with the adjoining cattle trough (qv) and a group with the Roundhouse (qv).

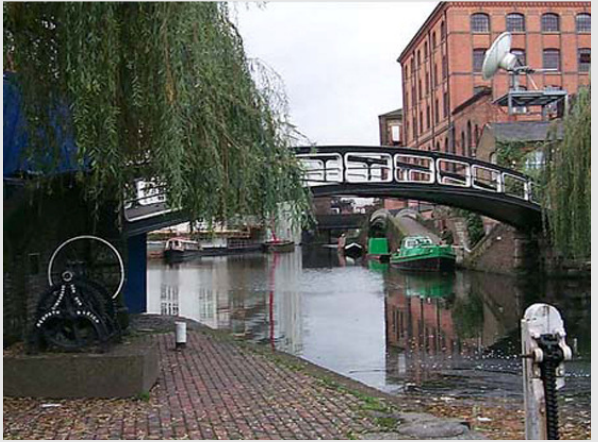
15	ROVING BRIDGE Location: Roving bridge over Grand Union Canal West of Hampstead Road Lock Street: Camden High Street	Grade II		798-1-15365	Roving bridge. Early/mid C19, restored late C20. Cast-iron single span skew cross-over bridge originally with wrought-iron tension stays but now restored with steel tension cables; decking renewed. Approached on both sides by steep ramps with granite setts and stone parapets with many rope markings. The stone and metal approaches to the bridge are scarred by the tow ropes of barges drawn out of the lock and under the bridge which takes the towpath back onto the northern side of the canal. HISTORICAL NOTE: going down hill the horses could get back onto the towpath by crossing Hampstead Road Bridge (qv) and entering by the ramp West of the bridge opposite the lock-keeper's cottage, now the Regents Canal Information Centre (qv).

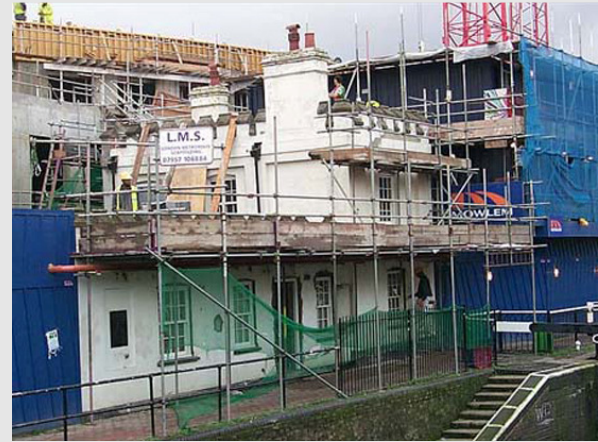
ID	LOCATION	LISTING	YEAR	IoE No	DESCRIPTION	IMAGE
16	REGENT'S CANAL INFORMATION CENTRE Location: (West side) No.289 Regent's Canal Information Centre Street: Camden High Street	Grade II May 14 1974		798-1- 14965	Lock keeper's cottage, now the Regent's Canal Information Centre. Early C19 with additions and alterations c1975. Stucco. 2 storeys, 1 window with single storey 3-window entrance wing. Segmental arched doorway and panelled door facing canal; left return with similar doorway and double glazed doors. Segmental arched sashes; 1st floor in large shallow rectangular recess. Plain stucco band at cornice level. Crenellated parapet and 2 tall slab chimney-stacks. INTERIOR: not inspected. The building was extended, stuccoed and crenellated c1975.

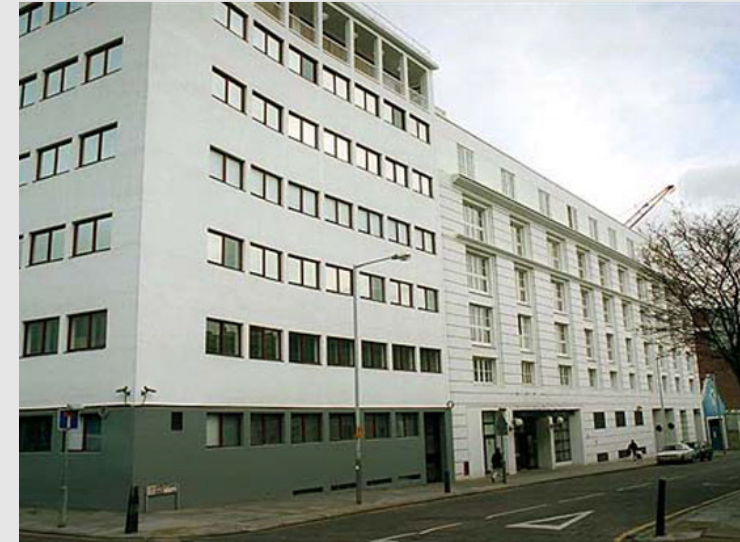
17	24, 26, 28 OVAL ROAD THEY ARE ART CORNER WITH JAMESTOWN ROAD Location: (East side) Nos.24, 26 AND 28 Street: Oval Road	Grade II Jul 6 1981		798-1- 125876	Formerly known as: Gilbey House OVAL ROAD. Includes: Nos.38-46 JAMESTOWN ROAD. Factory, store and offices. 1894 by William Hucks with addition of 1937 by Mendelsohn and Chermayeff; for wine importers and gin distillers Gilbey's. Original block to south-East: of concrete reinforced with hoop iron. Exterior rendered; channelled rustication to ground floor and channelled pilaster strips rising from 1st to 4th floor. 5 storeys plus attic and basement. 10 bays to Jamestown Road. Plain, square-headed entrances to ground floor including 2 vehicle entrances to left. Square-headed, recessed metal framed windows, most with small panes. Subsidiary cornice above 3rd floor, main cornice above 4th floor. INTERIOR: not inspected. HISTORICAL NOTE: an early example of reinforced concrete construction. 1937 block: of reinforced concrete frame filled with concrete panels; ground floor brown glazed tiles, upper floors rendered. Corner site; 7 storeys, with 6 bays to Oval Road and 7 bays to slightly concave Jamestown Road facade. International Modern idiom. Recessed main entrance to left of Oval Road facade with full height projecting square-sided bay window above with floor to ceiling glazing (emphasising the position of executive offices). Other windows form horizontal strips separated by vertical mullions. Teak 2-light window frames, plate glass. To Jamestown Road, the 6th floor rooms are recessed to incorporate a loggia with cast-iron railings. Projecting cornice above 6th floor. INTERIOR: not inspected. HISTORICAL NOTE: the building incorporates technical innovations by consulting engineer Felix Samuely, e.g. the foundations are floated on cork insulation to protect the wine from the vibration of nearby trains. Air conditioning too was incorporated. Until recent years known as Gilbey House. Gilbey's, formed in 1857, by 1914 occupied 20 acres in Camden.

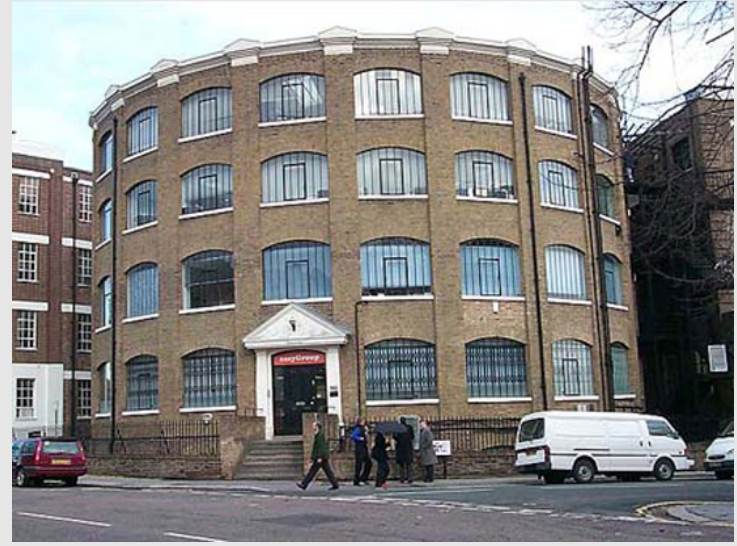
ID	LOCATION	LISTING	YEAR	IoE No	DESCRIPTION	IMAGE
18	PIANO FACTORY BUILDING Location: (East side) Piano Factory Building Street: Oval Road	Grade II May 23 1989		798-1- 125976	Piano factory, now offices. 1852. By Thomas and William Piper. For piano manufacturers Messrs Collard and Collard. English bond yellow stock brick; roof not visible. Circular plan. EXTERIOR: 5 storeys. 22 bays, each bay divided by raised pilaster continued to moulded stucco entablature and gablet projecting beyond splayed stucco cornice. Stucco pilasters flank segmental-arched 1st floor doorway. Segmental brick arches over wood and iron casements. Rectangular addition, dating from before 1868 and housing staircase to rear. INTERIOR: cast-iron columns and beams to vaulted brick ceilings; cast-iron columns, each with moulded plinth and capital, surround blocked-in central well; iron king post trusses radiate from central well; addition houses open-well staircase with simple iron balustrade and cantilevered stone treads, and has stone flag flooring. HISTORICAL NOTE: the open well was used for moving the pianos from floor to floor, with a former hoist, during the manufacturing process. The lowest floor was used for drying, the next for upright pianos, the second floor for cleaning, the third for polishing the cases and those above for "belly" manufacture and finishing off. Collard and Collard were the oldest of the well-known piano manufacturing firms of the St. Pancras area, having patented a form of upright "square" piano in 1811. This building replaced a similarly shaped one which was destroyed by fire a year after it was built in 1851.

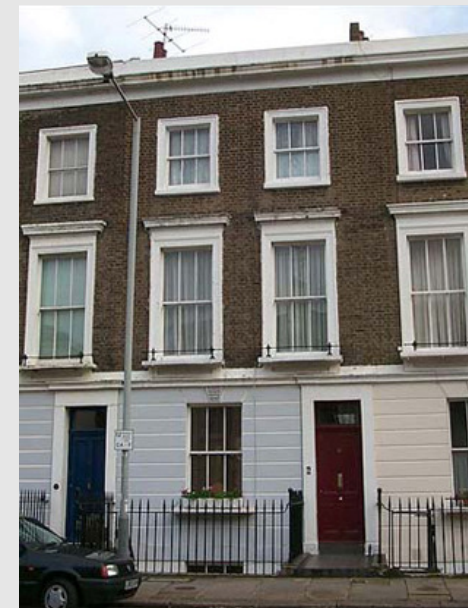
19	2-10 OVAL ROAD Location: (East side) Nos.2- 10 (Even) and attached railings Street: Oval Road	Grade II May 14 1974		798-1- 125776	Terrace of 5 houses. c1835. Yellow stock brick with rusticated stucco ground floor and plain 1st floor band. Symmetrical terrace with projecting end houses. 3 storeys and basements. 2 windows each. Plain stucco surrounds to doorways with fanlights, cornice-heads and panelled doors. Nos. 2 and 10 with pilasters forming doorways and to ground floors carrying entablatures and cast-iron balconies. Nos. 4-8 ground floor sashes with vermiculated keystones. Architraved sashes to upper floors; 1st floor with cornices and cast-iron window guards. End houses with stucco 2nd floor sill band continuing around the returns. Cornice and blocking course. INTERIORS: not inspected. SUBSIDIARY FEATURES: attached cast-iron railings with foliated finials to areas.

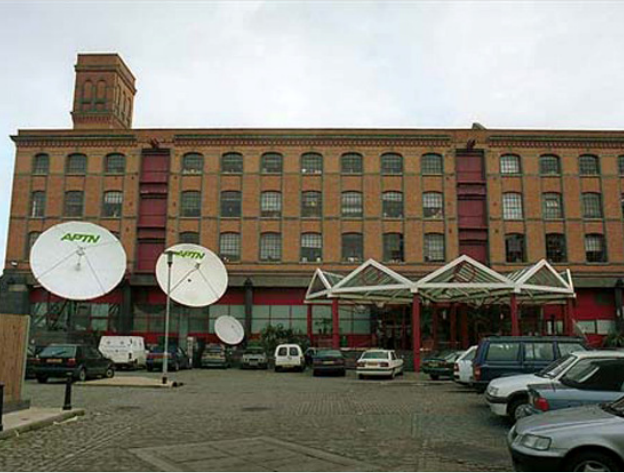
ID	LOCATION	LISTING	YEAR	IoE No	DESCRIPTION	IMAGE
20	THE INTERCHANGE Location: (North side) The Interchange on North side of Grand Union Canal Street: Oval Road	Grade II May 14 1974		798-1-126065	<p>Formerly known as: Interchange Warehouse GRAND UNION CANAL. Warehouse converted to offices. c1896, cleaned and refurbished c1989. Multi-coloured stock brick with blue engineering brick dressings. Rectangular main block of 6 windows facing canal and 24 window returns. 4 storeys and basement dock access. Single storey flanking extensions, running the length of the building, with 3 round-arched lights each to canal facade being the enclosing ends to railway tracks and platforms. Above and to each side, top lit floors for storage. Cast-iron windows with small panes; ground floor round-arched, upper floors segmental-arched in recessed vertical bays. Dentil cornice and blocking course. INTERIOR: retains brick-arched fireproof construction. Particularly impressive is the enclosed inlet from the canal from which goods were transferred, with cast-iron rivetted columns set in the water supporting large beams. The upper floors also retain original features. To one side of this a large area of basement storage extends under forecourt, this is of brick arched construction; to the other a gin store, with steel doors in thick, canted openings. From the corner of the Interchange warehouse a ventilated tunnel connected the building with the railway at Primrose Hill and with the stabling at Stanley Sidings, Chalk Farm Road (qqv). This tunnel for the movement of horses survives, though it is now blocked at several points. It is of round-arched brick construction, with cast-iron ventilation grilles placed regularly in the roof. West of the Interchange Building it ascends via broad steps to ground level. HISTORICAL NOTE: built on the site of a previous warehouse. A private canal inlet runs under the building, entered under the towpath bridge (qv). Railway lines entered the warehouse from the sidings at high level, enabling direct transfer of goods between train and barge. Some 400 horses worked in the sidings, helping the transfer of goods.</p>
