EXISTING FRONT STEPS & PORTICO

PROPOSED REPAIRED FRONT STEPS & PORTICO

Client	STANLEY SIDINGS		
Project	No1 HAWLEY ROAD		
Job No	N1853		
Dwg	EXISTING & PROPOSED		
Dwg No	FRONT PORTICO DETAILS		
Dwg Type	HR_N1853_010		
Status	LBC		
Scale	Size	Rev	Date
1:50 @ A3	A3	*	SEPT 2012

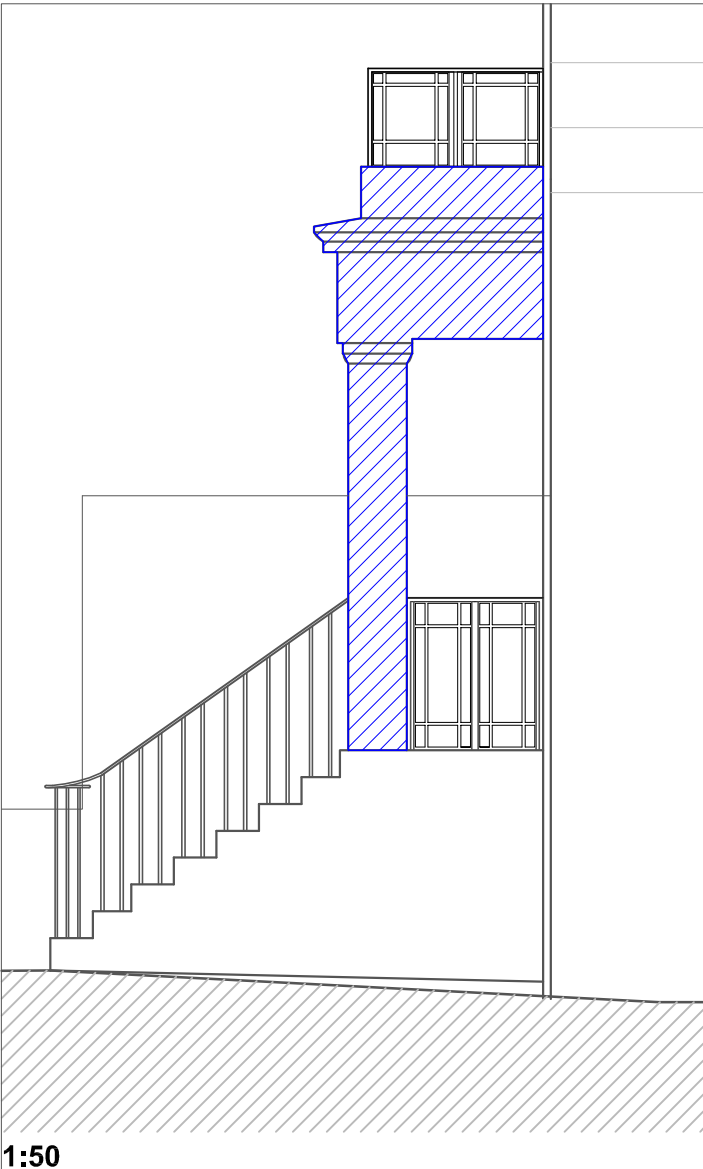
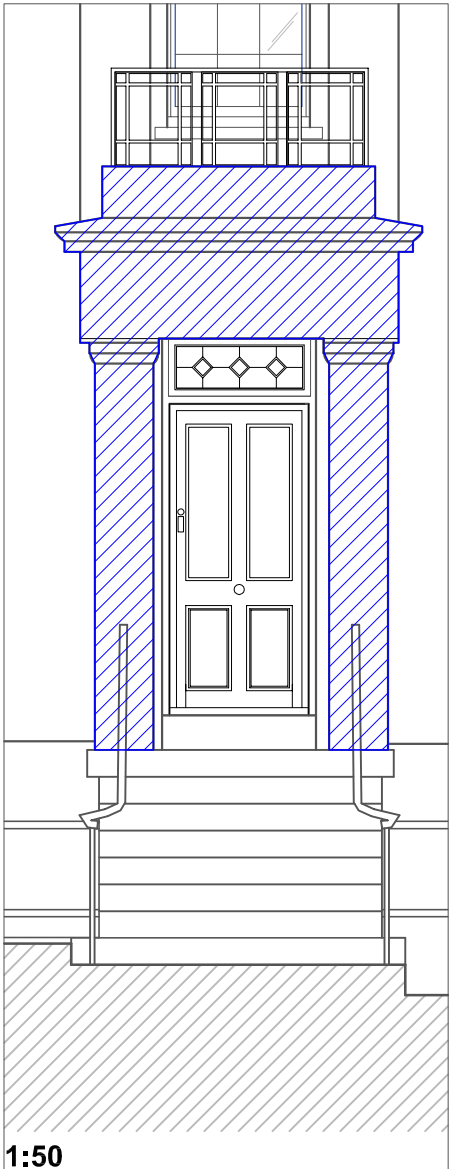
- Balcony
- Balcony to be repaired using like for like materials using traditional construction techniques
 - Balcony railings to be restored and decorated
- Glazing
- All glazing to be refurbished, or replaced to match existing
- Render
- All render to be repaired to match original
- Door
- Four panelled traditional styled door
- Railings
- All railings and balustrade to be refurbished and painted black
