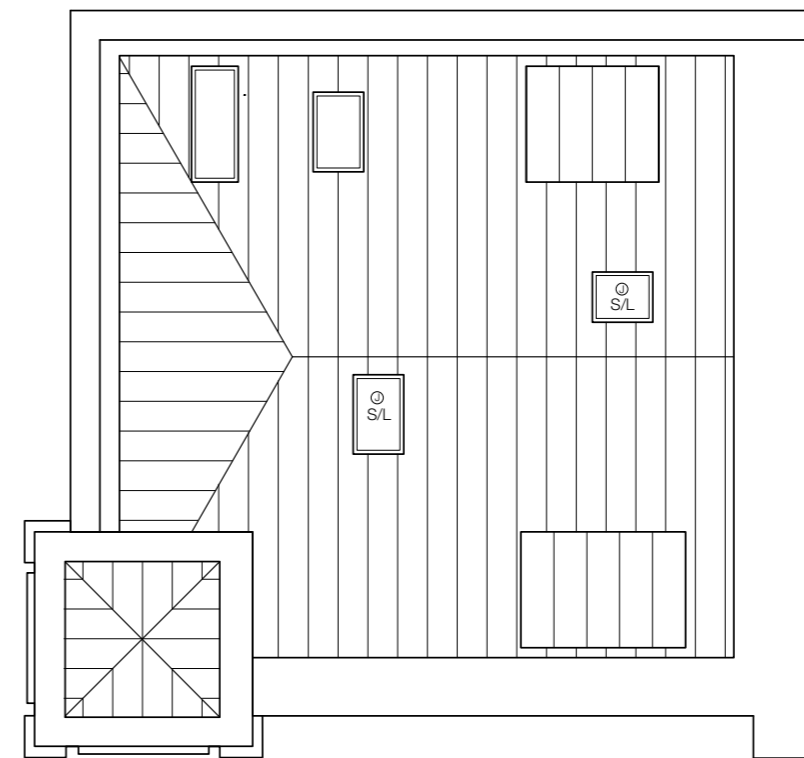
Roof Plan

- C EXISTING DOOR LOCKED SHUT. ARCHITRAVES REMOVED ON BATHROOM SIDE AND BOARDED OVER.
- D NEW WINDOW ON WEST ELEVATION TO MATCH EXISTING WINDOW ON SOUTH ELEVATION PRECISELY
- E EXISTING DOOR MOVED
- F OPENING IN INTERNAL NON-STRUCTURAL WALL WIDENED
- G BATHROOM PARTITIONS NOT FULL HEIGHT
- H DOOR RELOCATED FROM EXISTING POSITION.
- J EXISTING DOORWAY INFILLED
- K NEW 'HERITAGE STYLE' SKYLIGHT - FLUSH TO EXISTING FINISHES
- L WALLS TO SHOWER ROOM RE-CONFIGURED
