3 STAR YARD
Sections through windows

1 : 20 @ A3
1817-pp-SK05

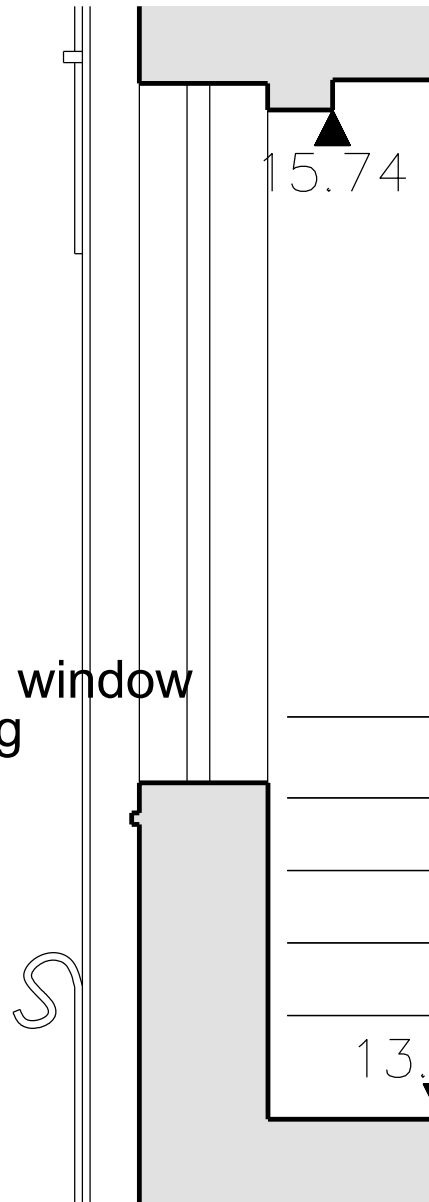
typical section of
front elevation metal window
remaining as existing
behind mullion line

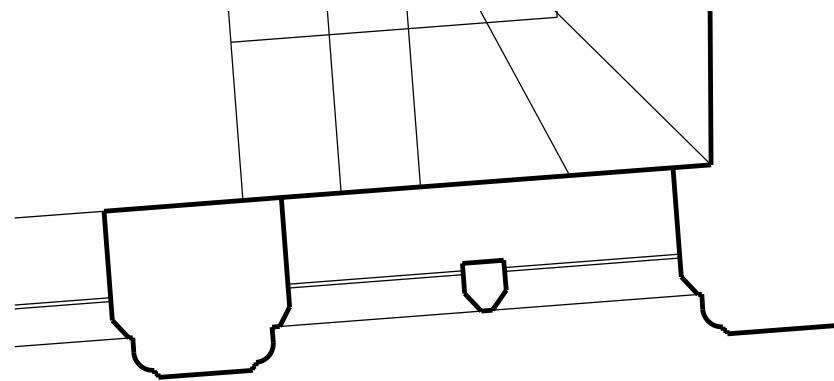
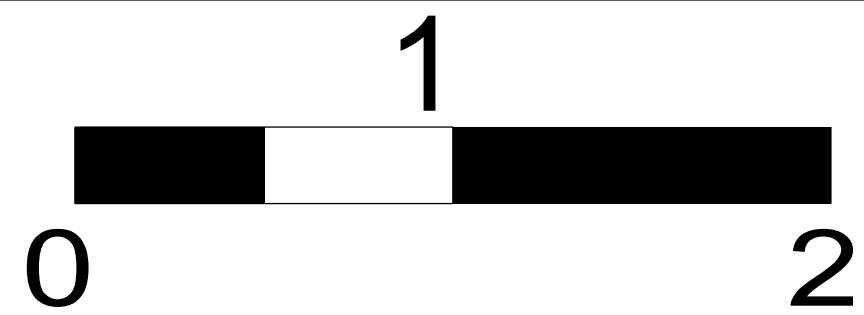
typical plan of
front elevation metal window
remaining as existing
behind mullion line

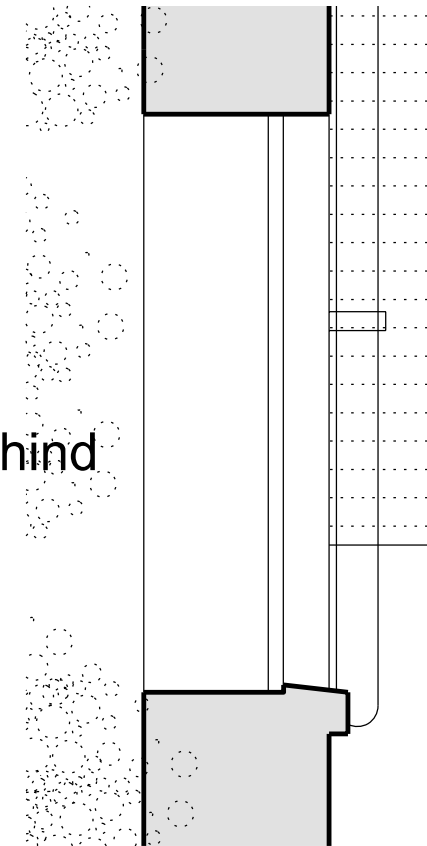
typical section of
rear elevation window
showing glass panel behind
existing reveal

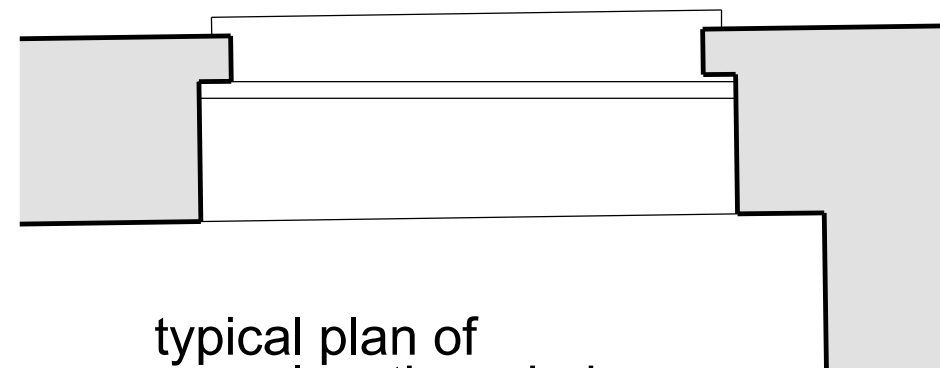
typical plan of
rear elevation window
showing glass panel behind
existing reveal
