2 Antrim Grove

rev: a	date: 7/12	notes: Revisions for planning resubmission	dwg title: Proposed Rear Elevation (North West)
project title: 2 Antrim Grove, London NW3 4XR	paper size: A1	file: 103 antrim grove elevations 1.50.vwx	scale: 1:50
	date: 02/12	dwg nos: 103/P/207a

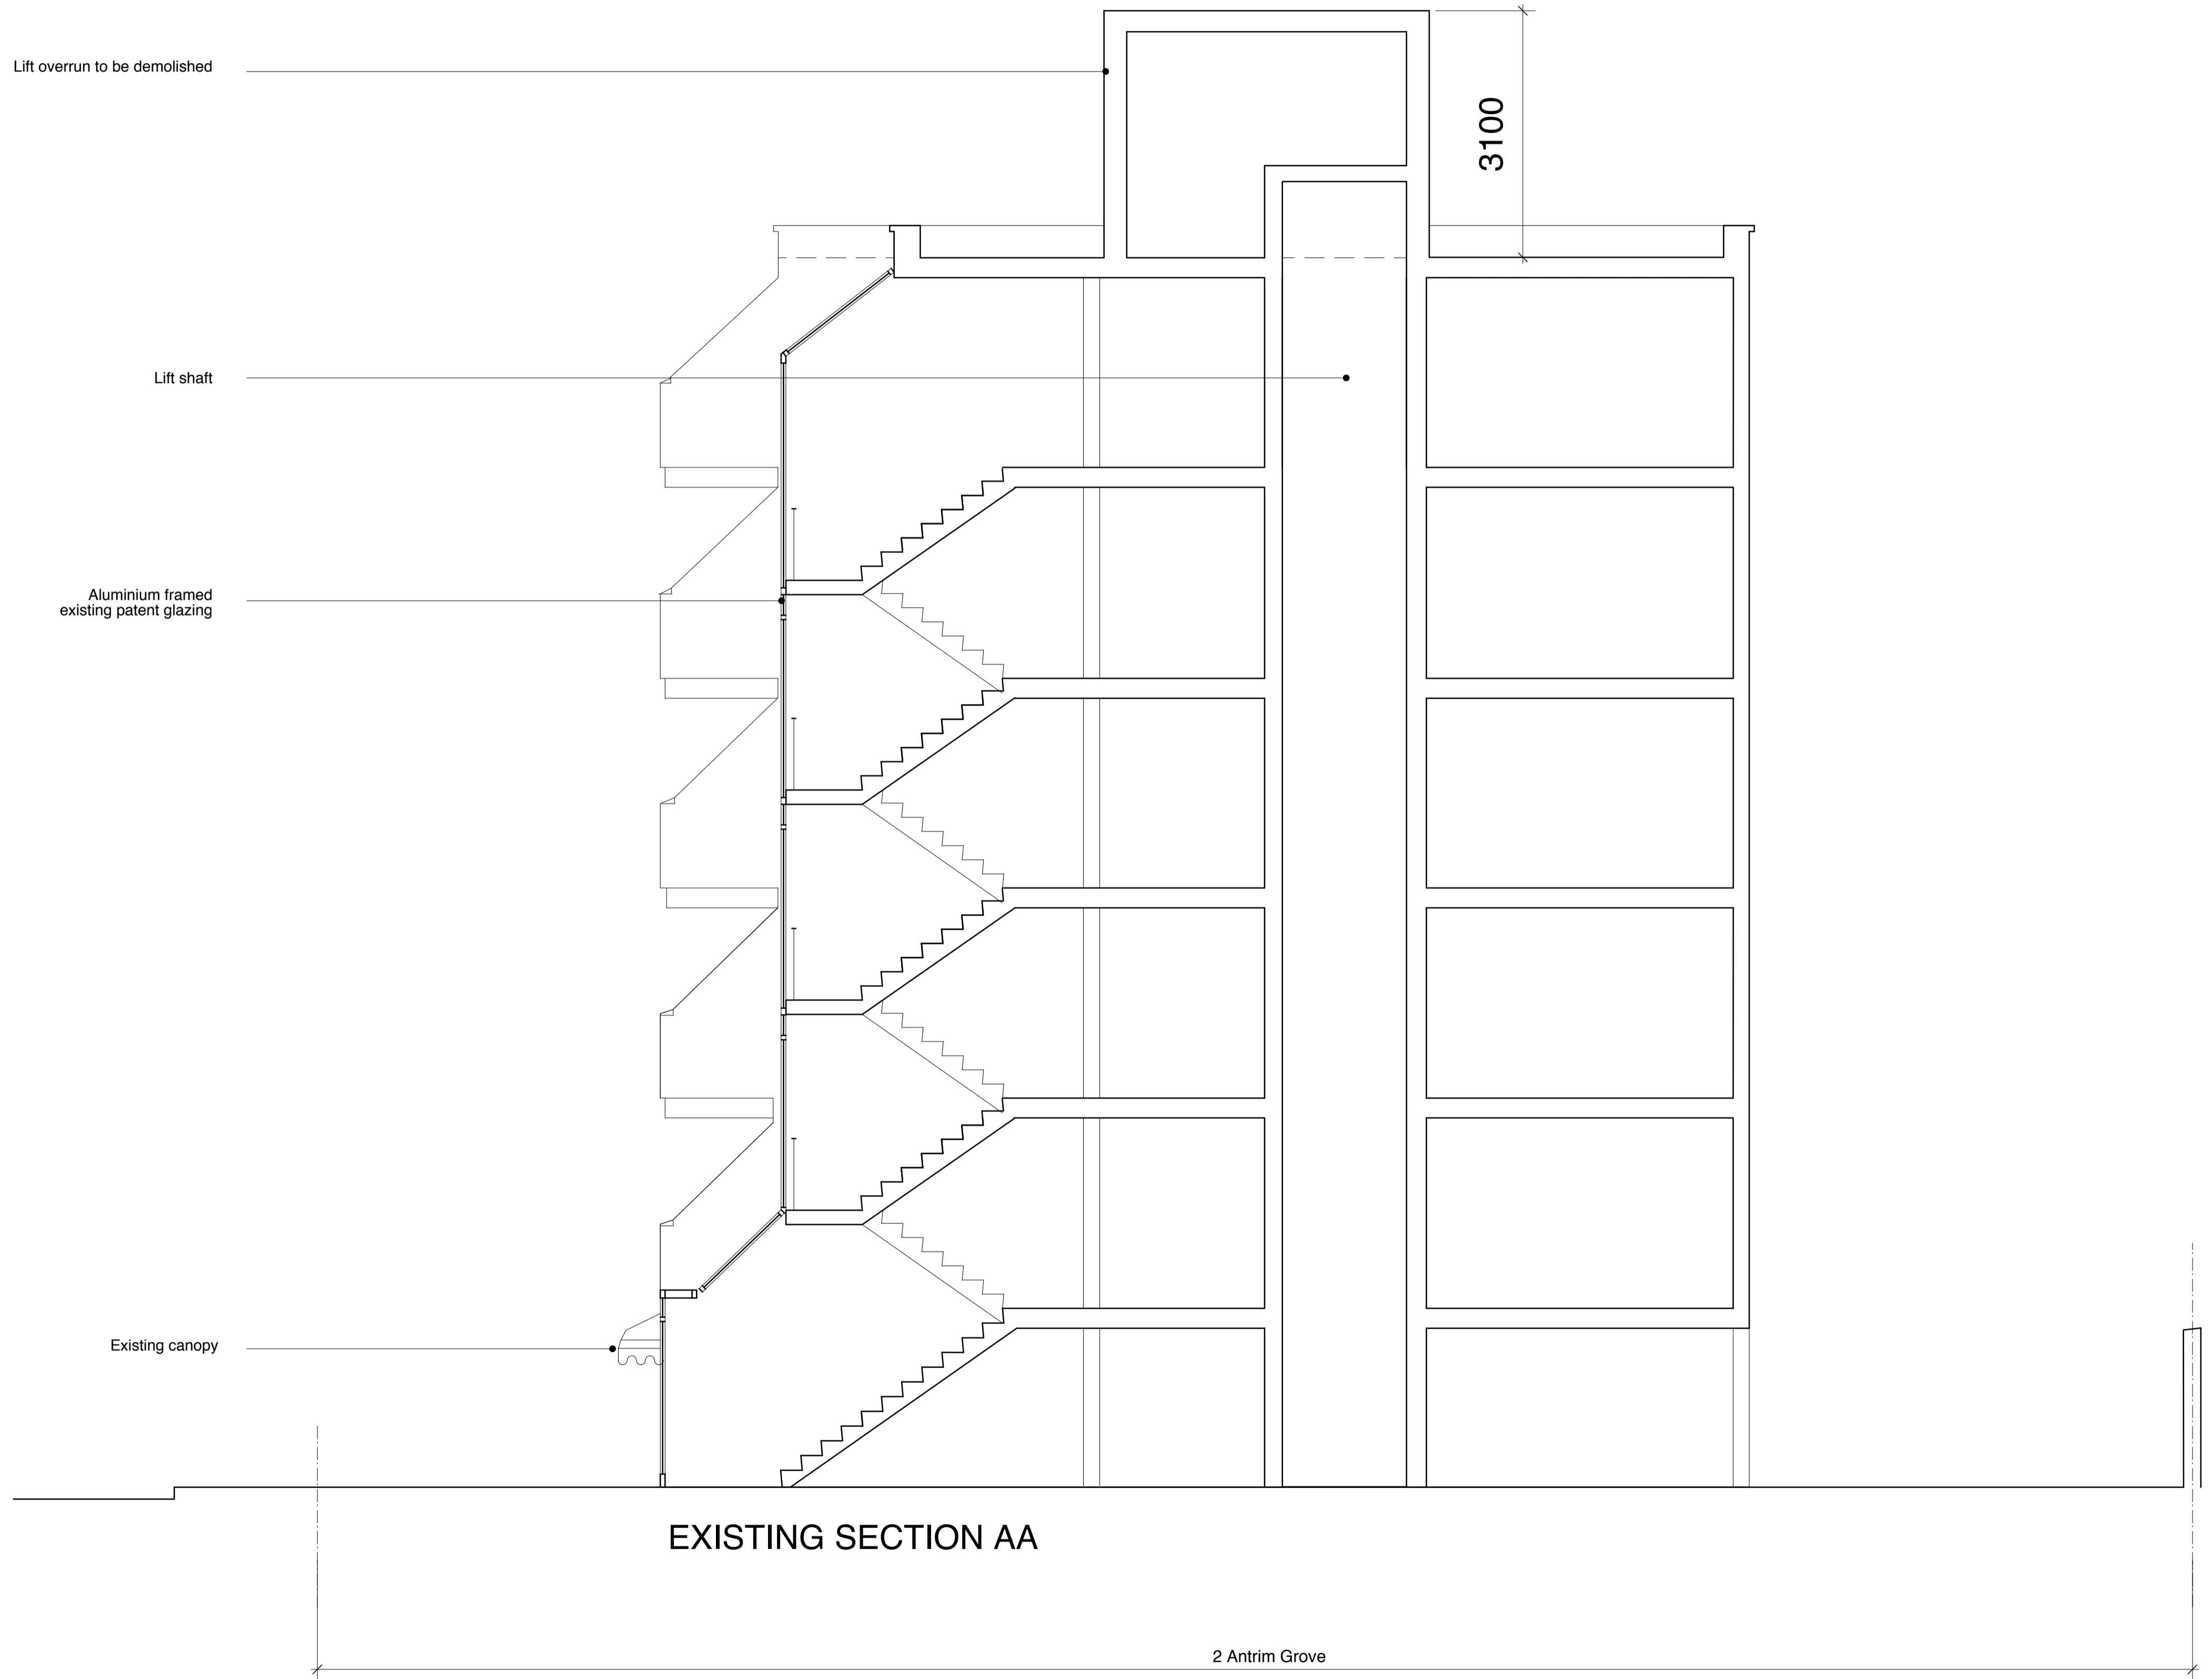
EXISTING SECTION AA

3100

Lift overrun to be demolished

Lift shaft

Aluminium framed
existing patent glazing

Existing canopy

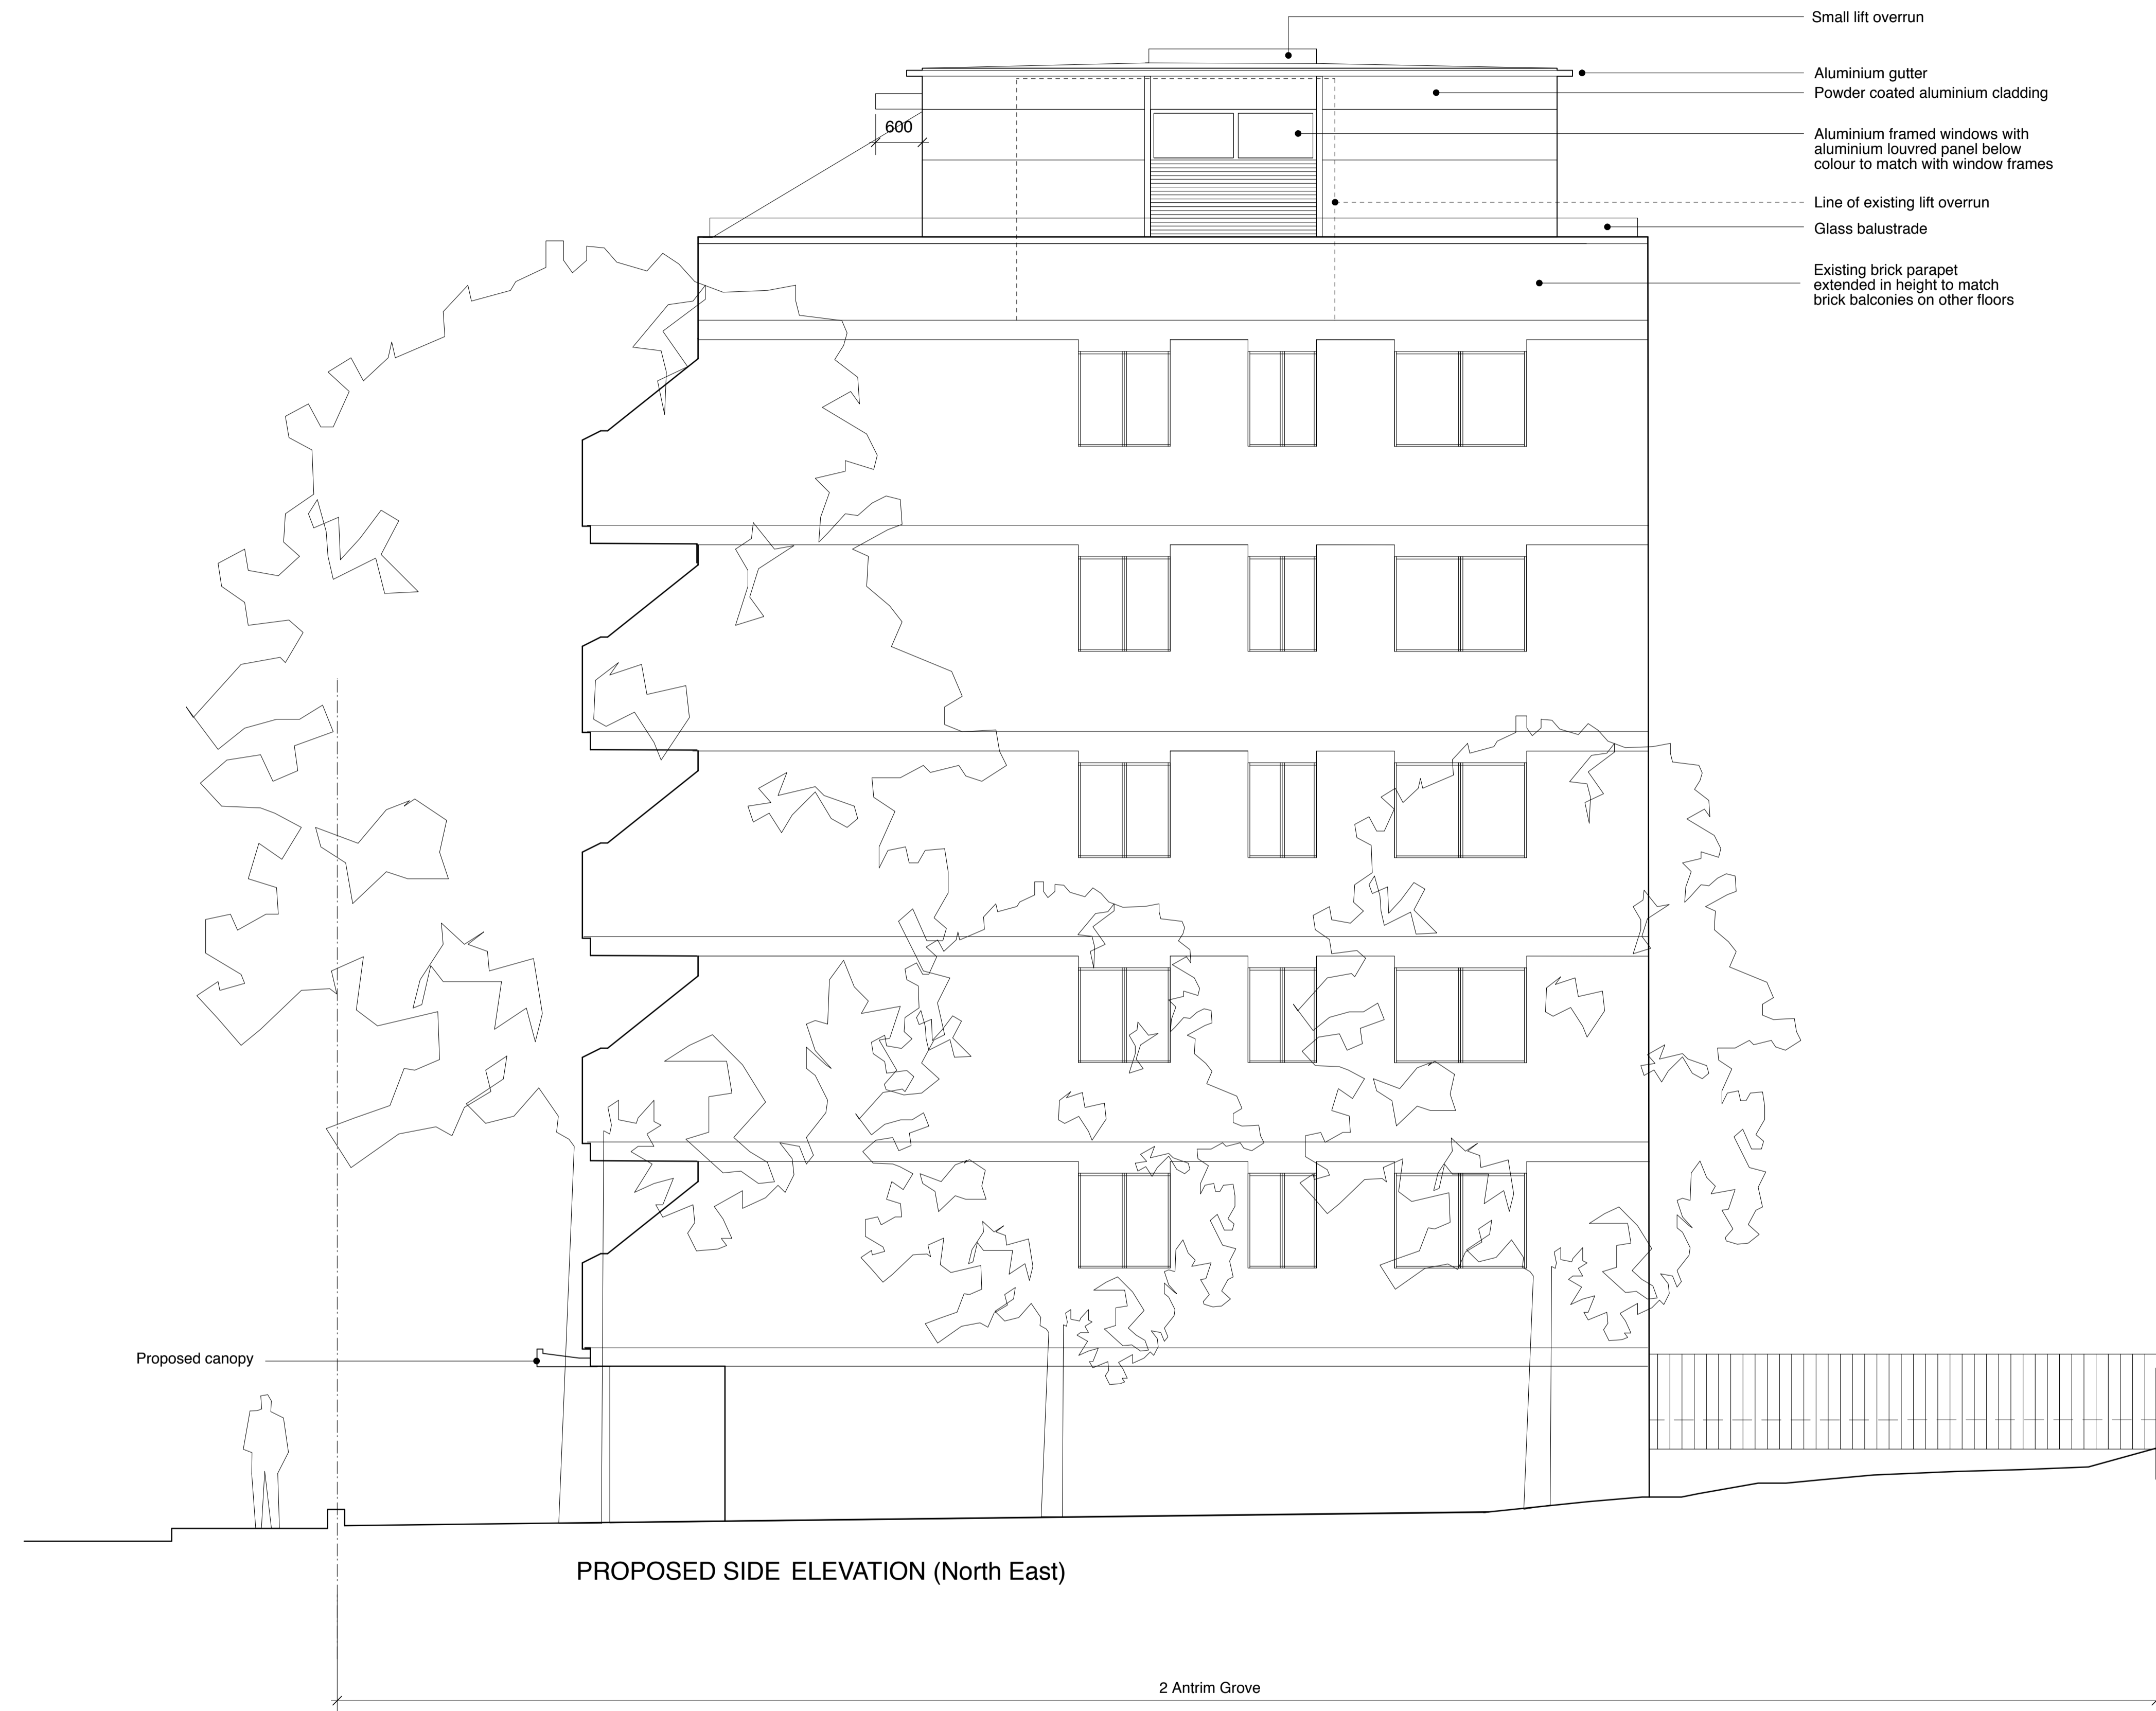
PROPOSED SIDE ELEVATION (North East)

- Small lift overrun
- Aluminium gutter
- Powder coated aluminium cladding
- Aluminium framed windows with aluminium louvred panel below colour to match with window frames
- Line of existing lift overrun
- Glass balustrade
- Existing brick parapet extended in height to match brick balconies on other floors
