Typical window elevations as viewed externally. New windows to replicate extsiting window layout.

Thermally broken, aluminium windows (Comar 5) or similar - designed to emulate 'historic' metal frames ([info@parksidgroup.co.uk](mailto:info@parksidgroup.co.uk))

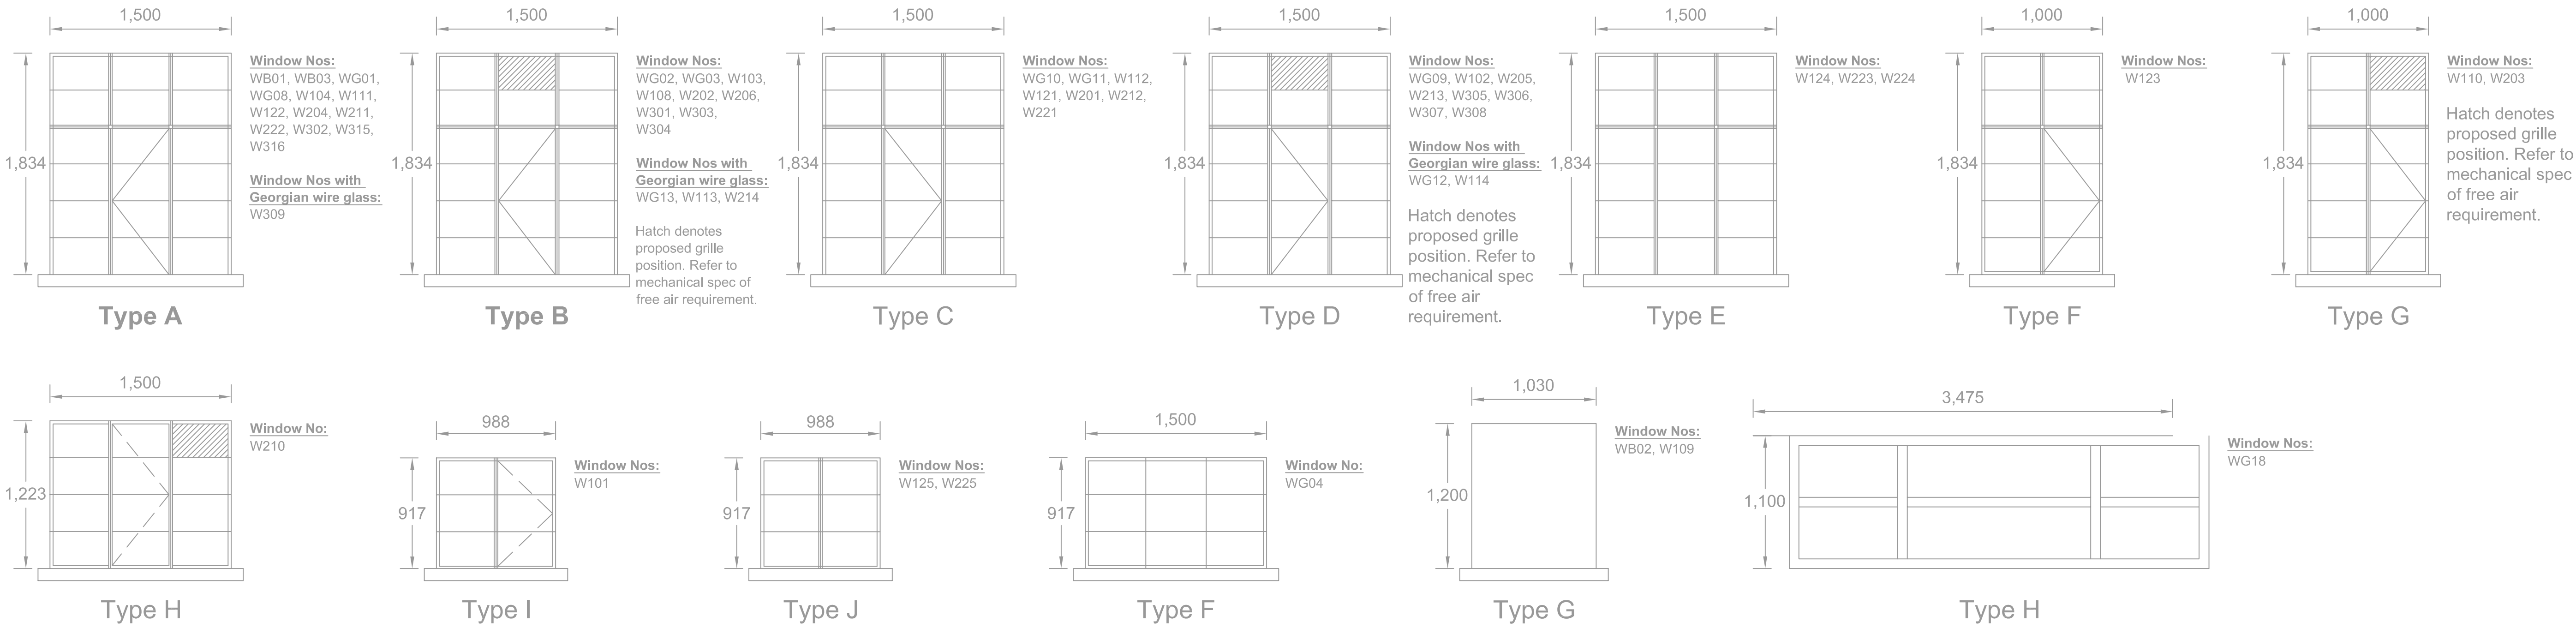
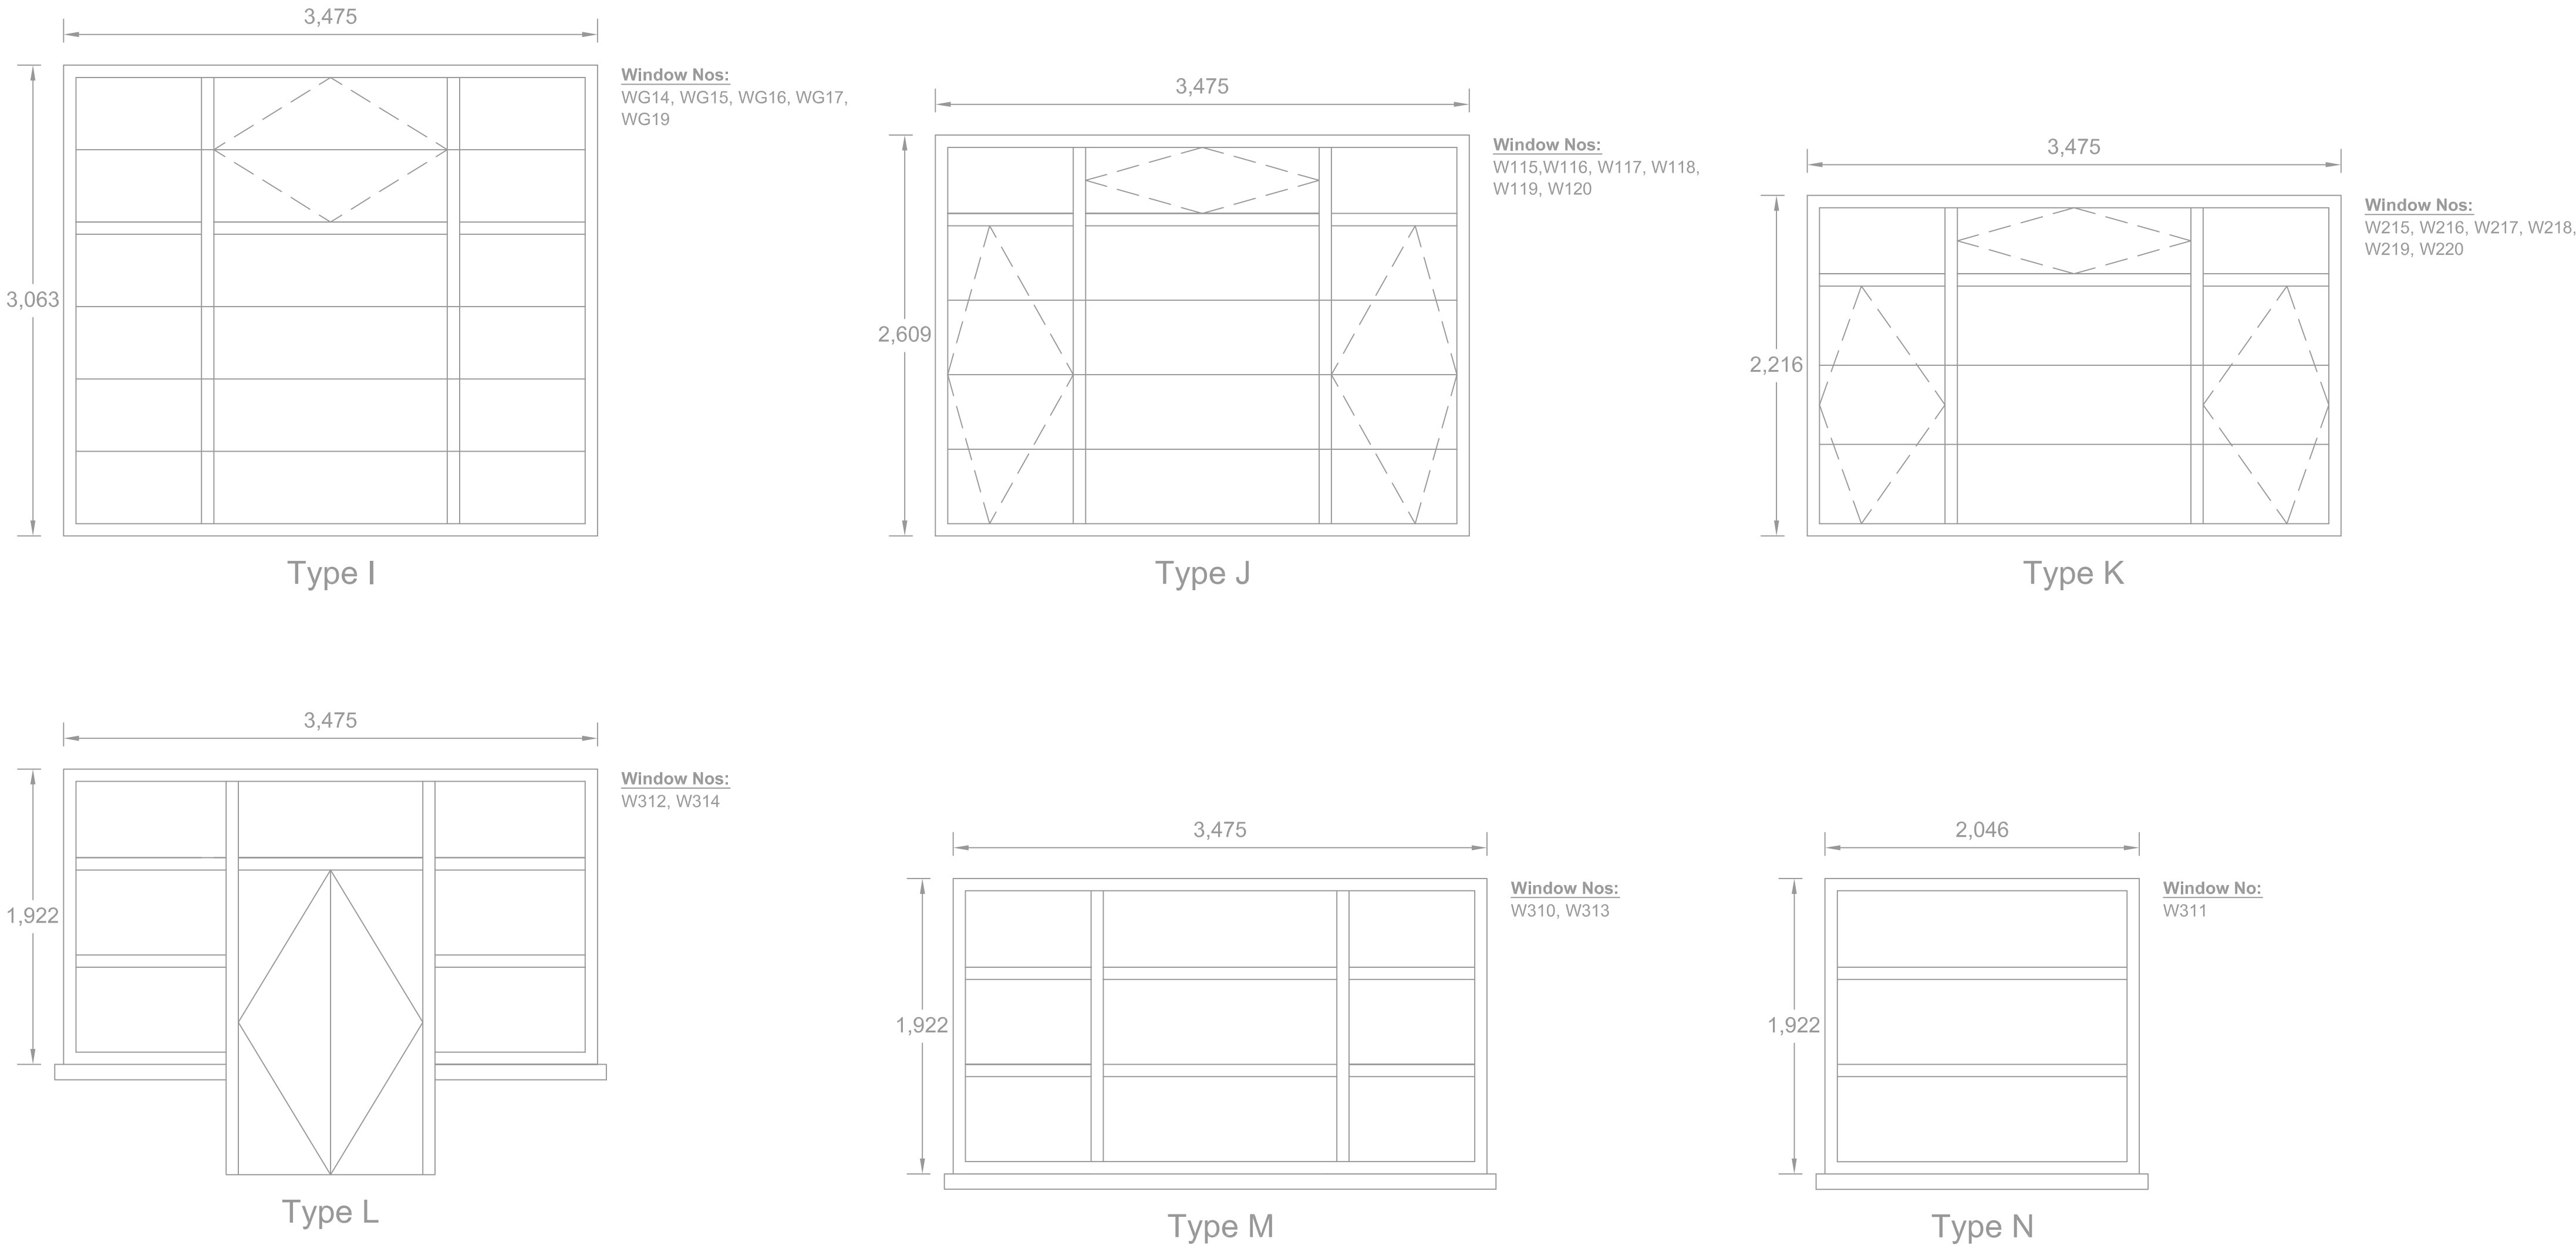
LAYOUT OF WINDOWS W126, W226 AND W317, UNKNOWN. TO BE CHECKED ON SITE.
