THE BRITISH MUSEUM
KEB PARAPET REPAIRS

KING EDWARD VII BUILDING
TYPICAL PARAPET ELEVATIONS
BAY 3 AND SHIELDS 2 AND 3
SHOWN

drawing no.
AB 1/3

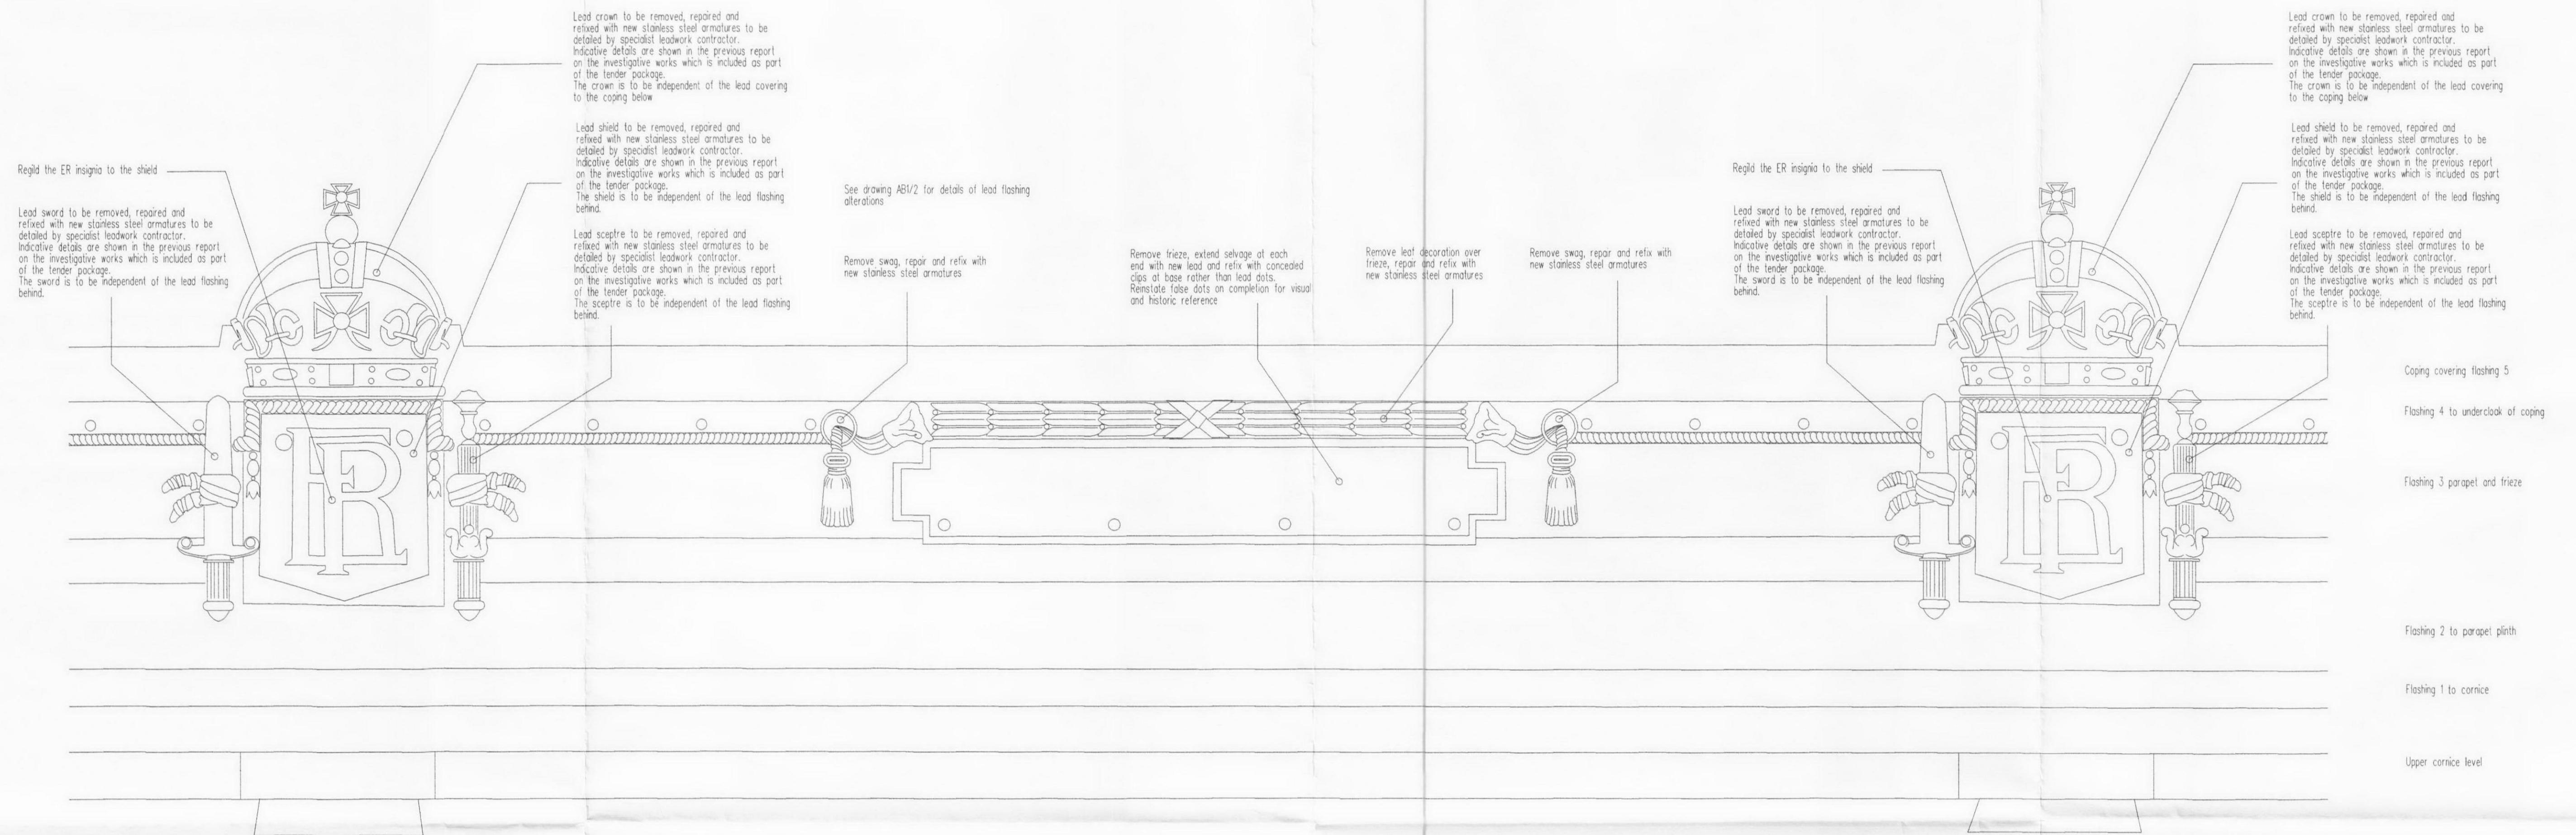
PART ELEVATION (note that the repairs indicated apply to all panels except 1 and 2)

Repairs to leadwork, stonework, brickwork and minor associated elements from the lower gutter level up to the coping level are detailed in the particular specification with preliminary quantities in the Bills of Quantities. The level of defects and final repairs are to be agreed once scaffold access is available, and reviewed against the allowances made.

All armature details are to be prepared by the specialist lead working contractor for review and comment by the design team. The Specialist contractor will be responsible for the design of these components including the preparation of detail drawings and calculations where necessary. The previous reports prepared before and after the sample repairs to Bay 1 and shields / crowns 1 and 2 at the east end indicate typical armature details. No lesser standard will be acceptable.
