Project			
Heath House, NW3 7ET		Charlton Brown Architects	
Title	Demolition and erection of temporary access gates to South Western entrance gateway to forecourt	Number	1017/TempGate/1/01
Date	Oct 2011	Scale	Scales @ A1
This drawing is copyright			Revisions

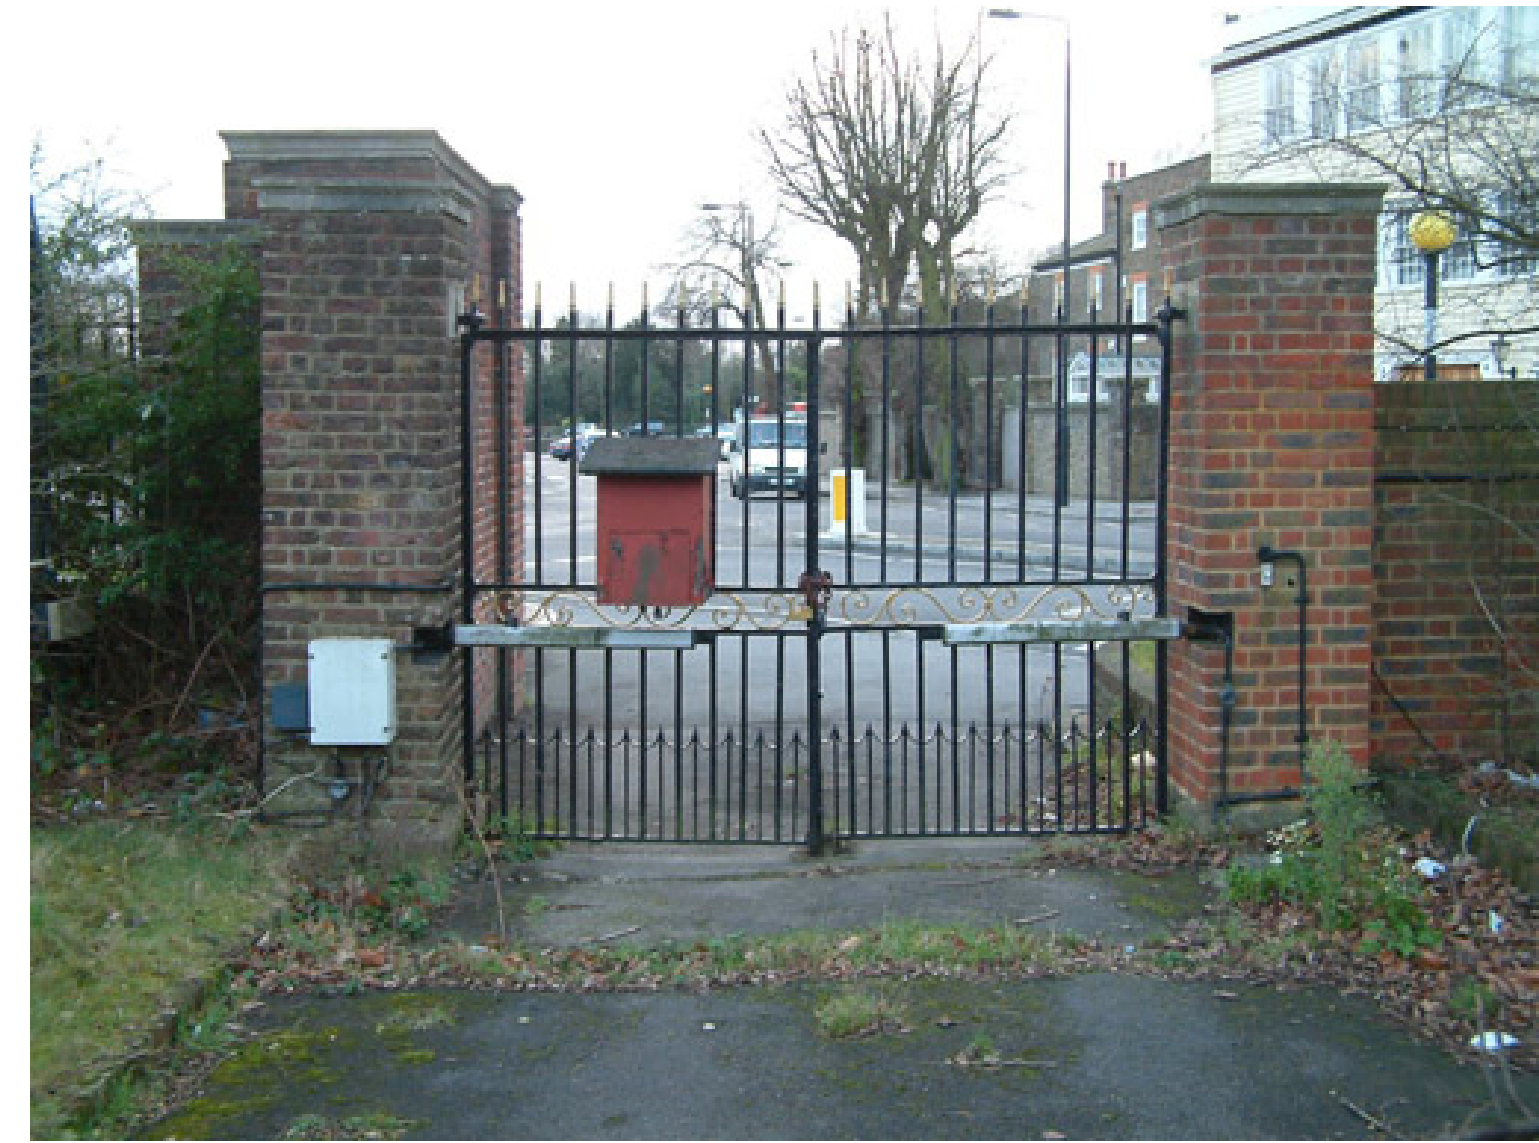
Existing gates shown from the forecourt of Heath House Pier 1 (right hand side of photograph) to be demolished and rebuilt to match Pier 2 (left hand side of photograph) to be retained and protected during the works

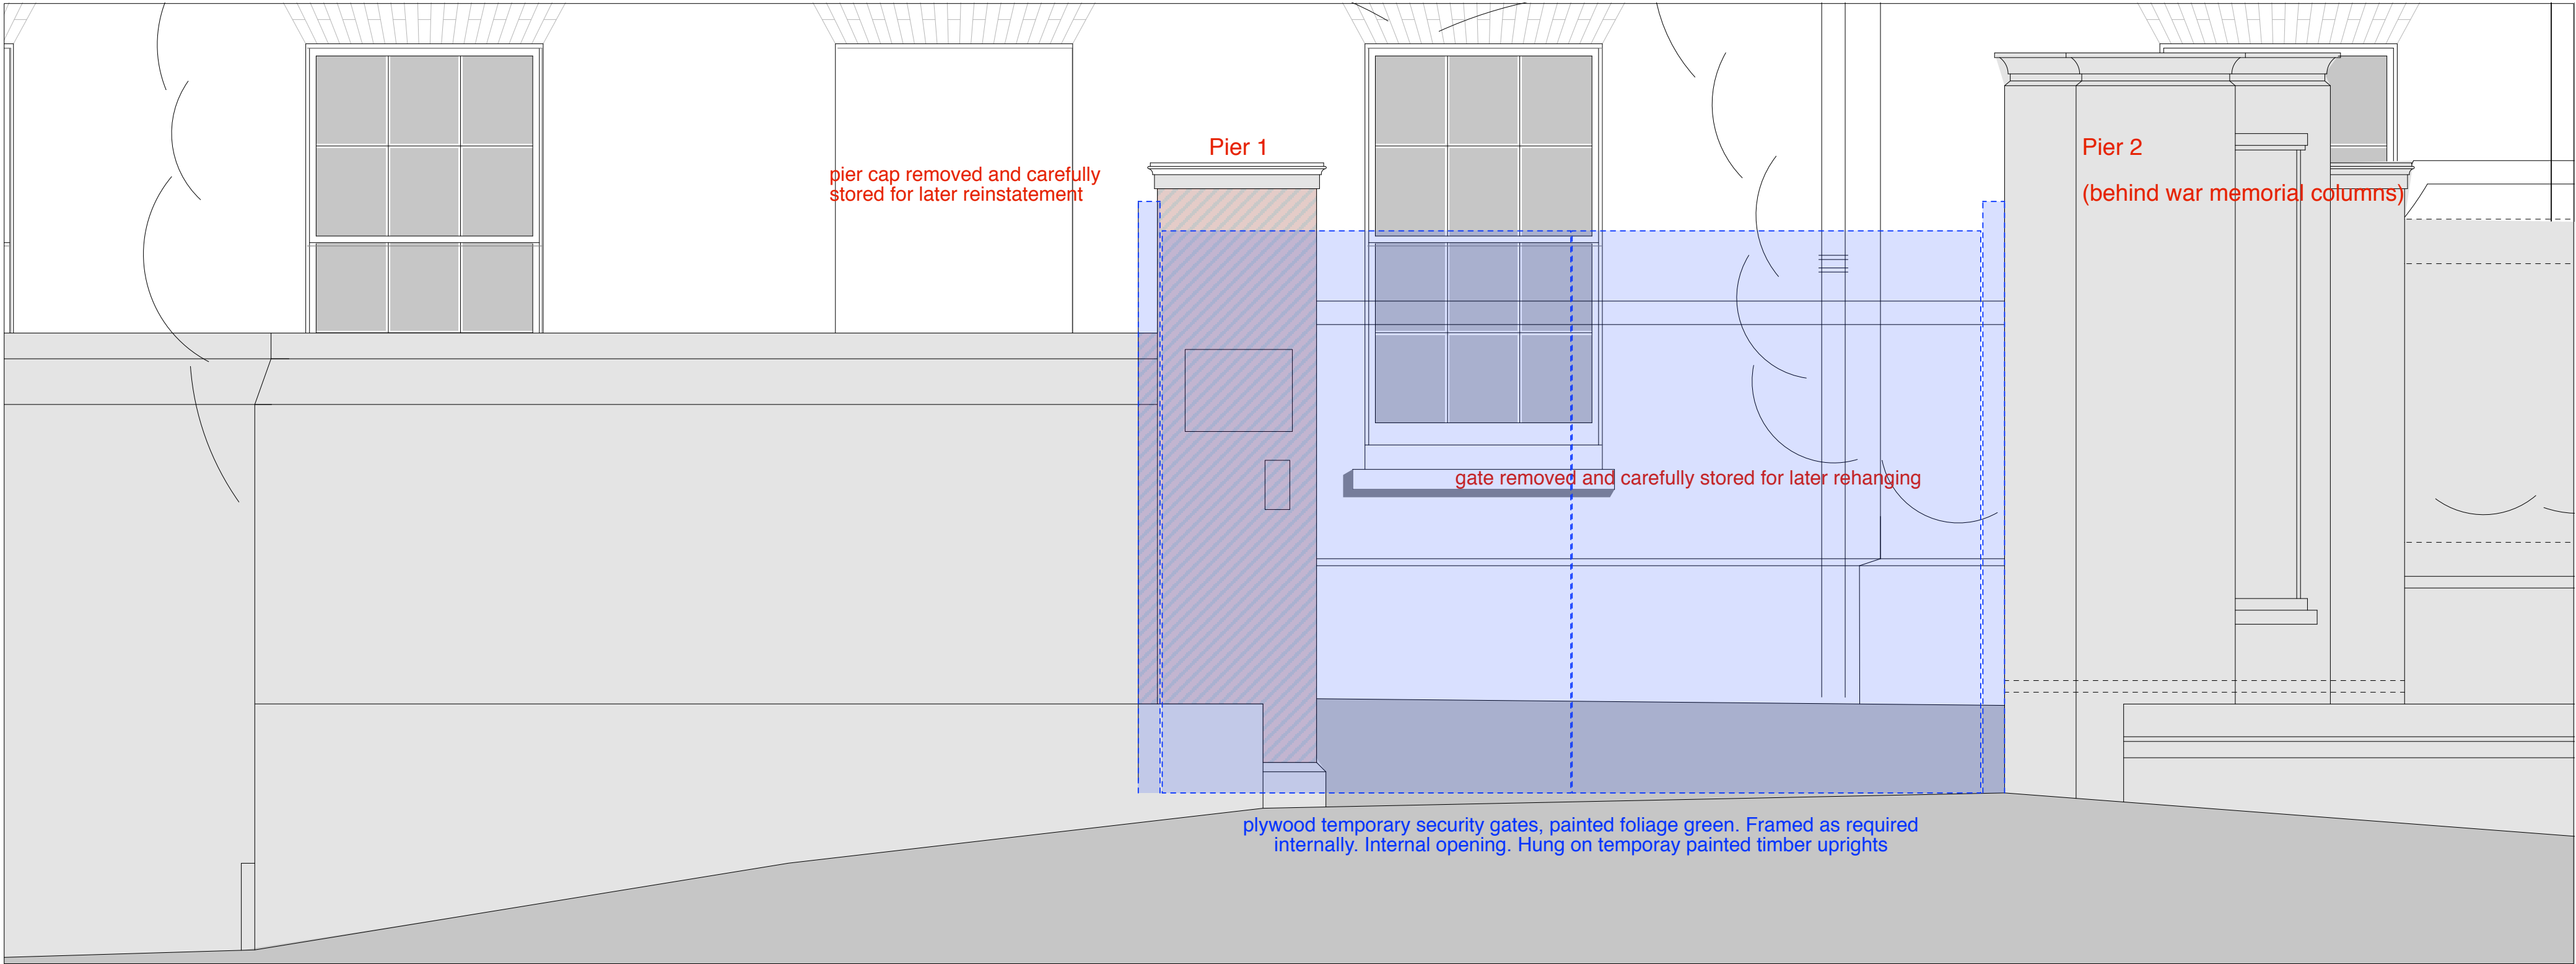
1:20 Elevation of gate and wall from North End Way

Pier 1 to be taken down, pier cap to be carefully set aside for later reuse.

Temporay painted 2.4m high plywood access gates erected on suitable posts to give 3.7m clear opening

At the end of the relevant part of works requiring widened access wall and pier are to be reinstated.

Wall is to be reconstructed from 50/50 Ibstock West Hoathly Handmade 65mm brick and Ibstock West Hoathly Multi bricks in Hawkstone Lime mortar with rubbed and brushed joint coursing and bond to match existing

Pier is to be reconstructed from 50/50 Ibstock West Hoathly Handmade 65mm brick and Ibstock West Hoathly Multi bricks in Hawkstone Lime mortar with rubbed and brushed joint, coursing to match Pier 2. Existing pier cap reinstated on new pier.

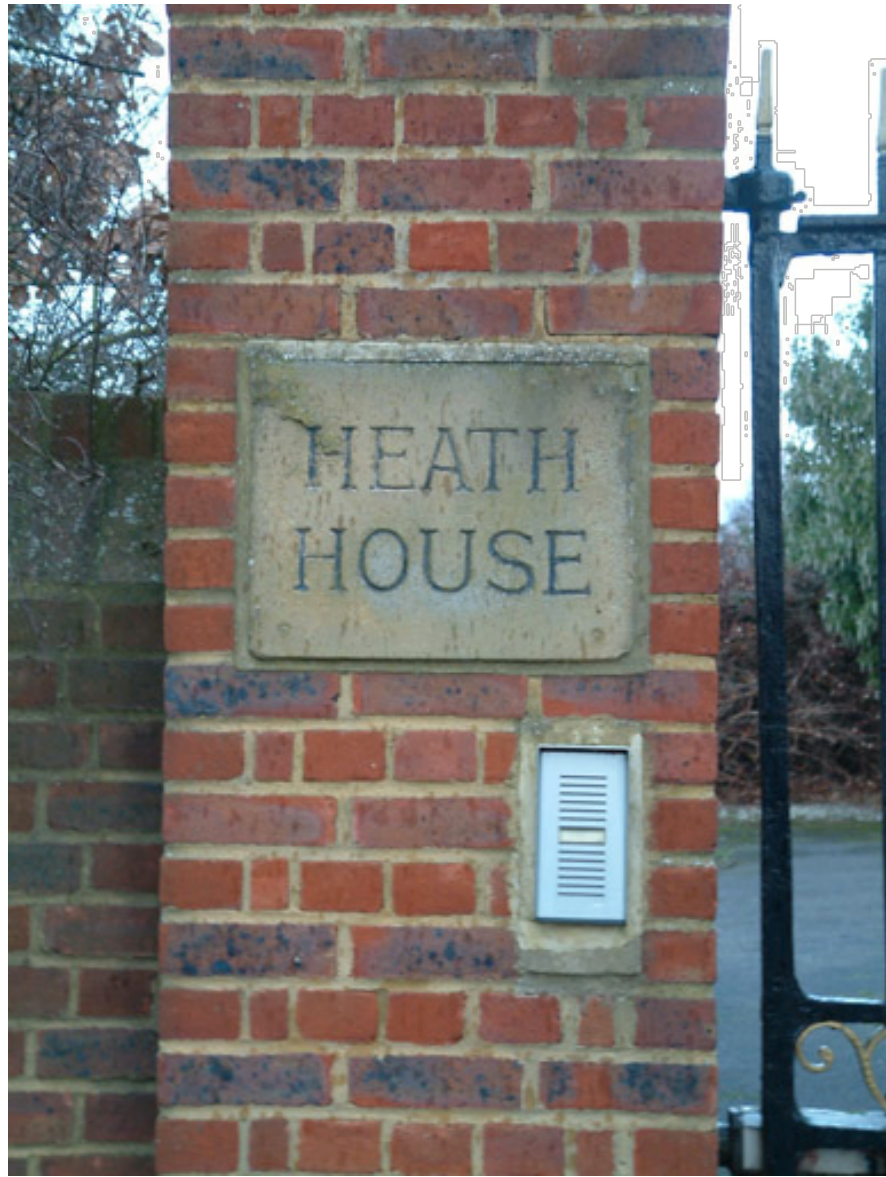
Detail of existing Pier 1 to be demolished and rebuilt to match Pier 2, existing gates removed and carefully stored for later rehanging
