Charlton Brown Architects	
Heath House, NW3 7ET				
Title	Number			
Demolition and erection of temporary access gates to South Eastern entrance gateway to forecourt		1017/TempGate/2/01		
Date	Oct 2011	Scale	Scales @ A1	
This drawing is copyright			Revisions

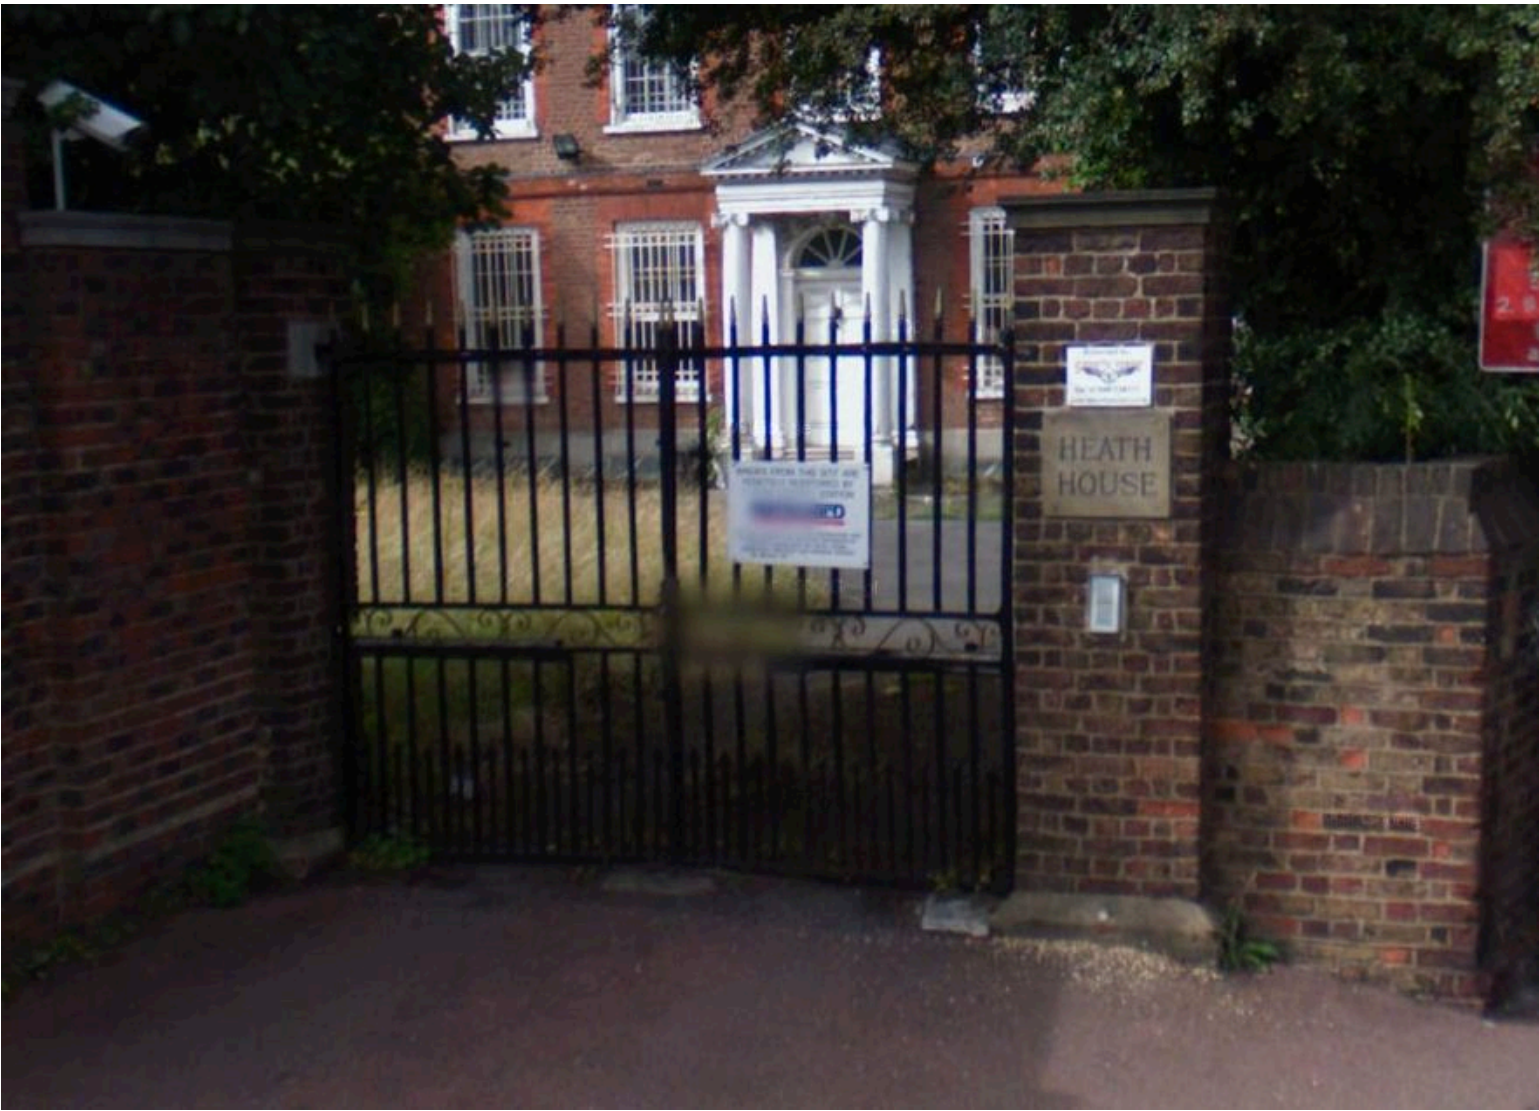
Existing Gates (Gate 2) shown from Spaniards Way. Pier 2 (right hand side of photograph) to be demolished and rebuilt to match existing. Existing gates removed and protected during the works

Detail of existing Pier 2 to be demolished and rebuilt to match existing. Existing gates removed and carefully stored for later rehanging

Pier 2 to be taken down, pier cap to be carefully set aside for later reuse.

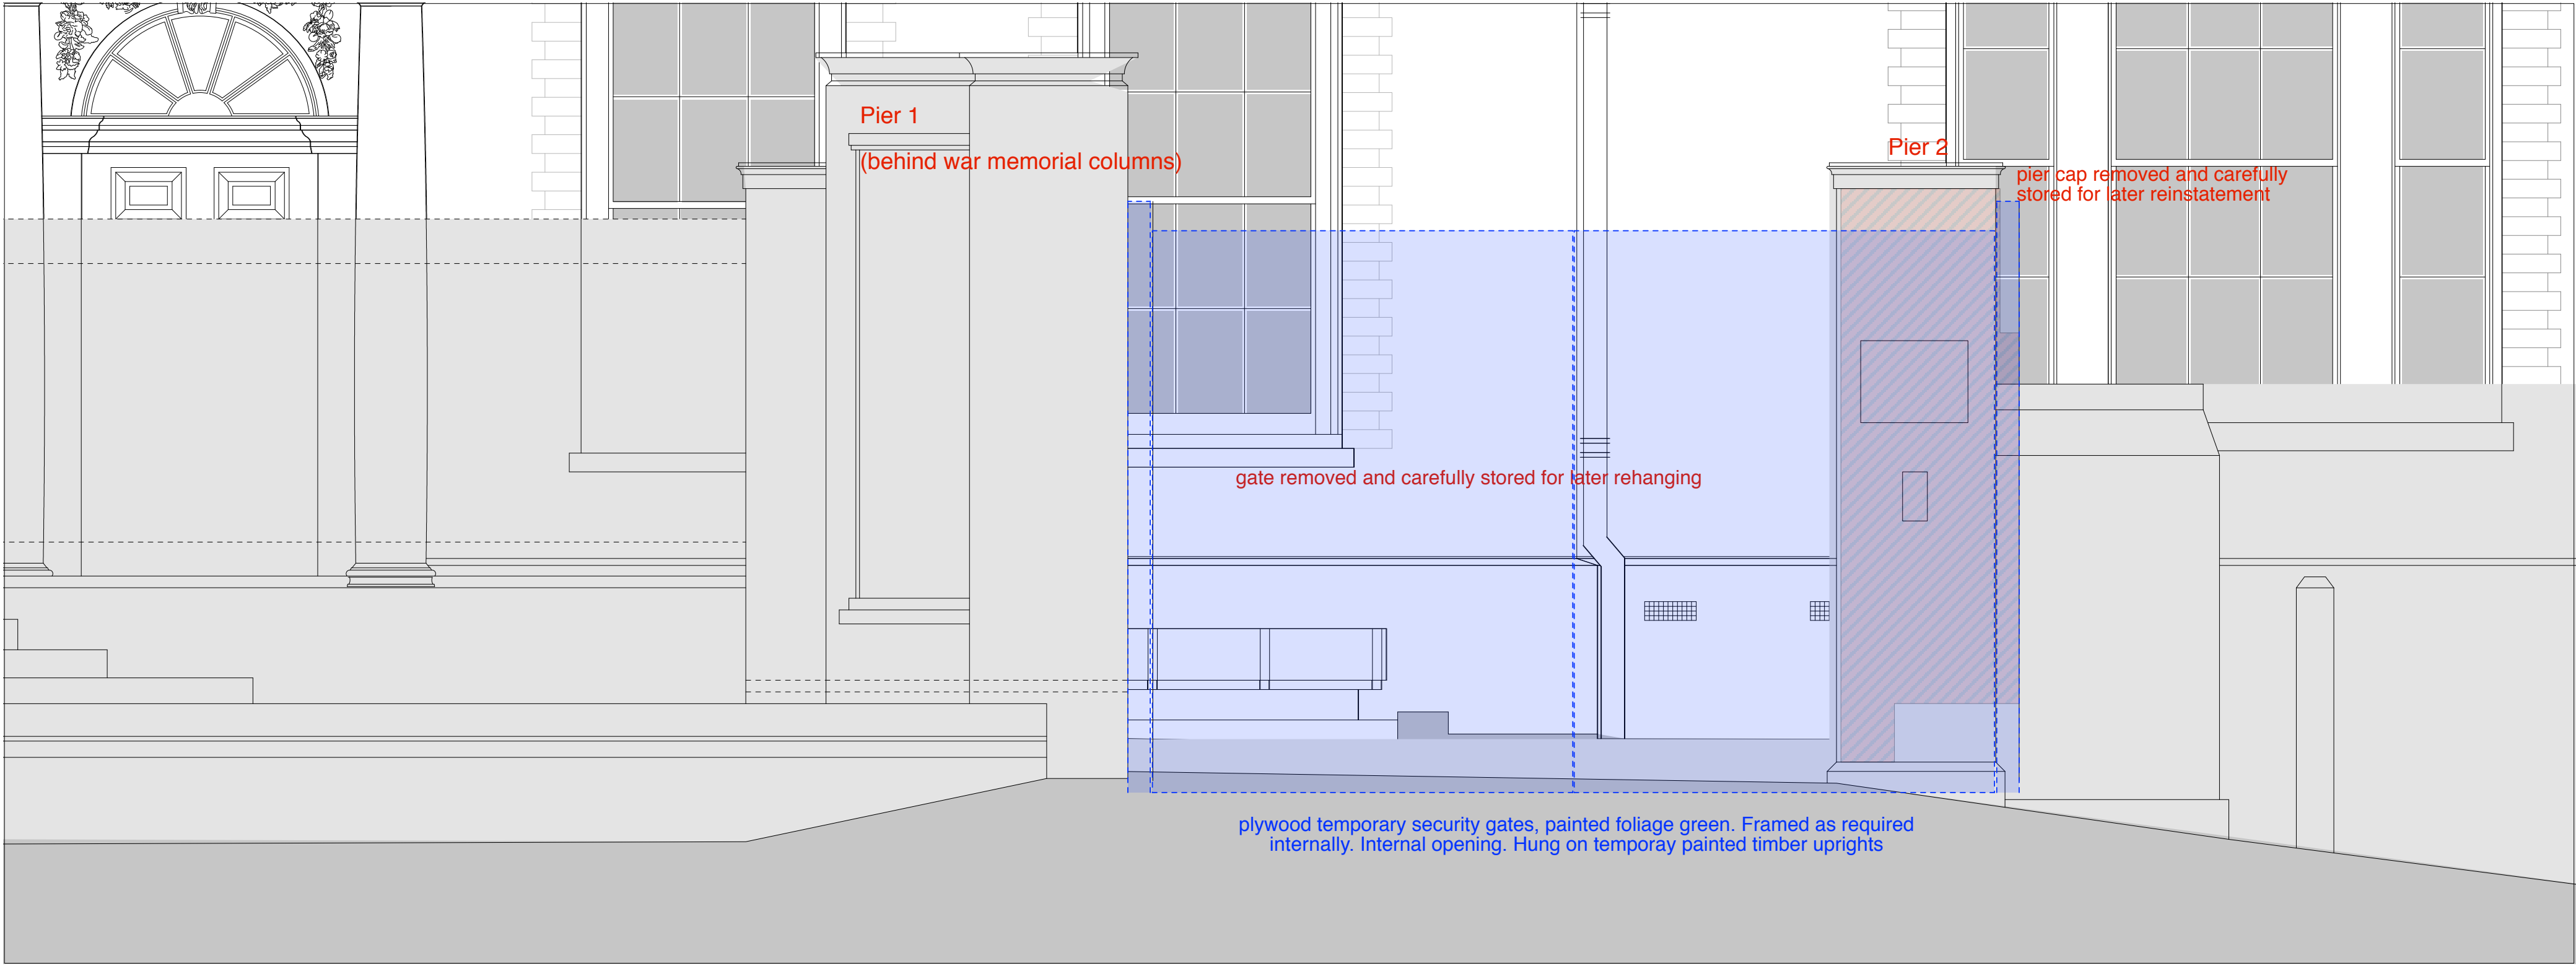
1:20 Elevation of gate and wall from North End Way

Temporay painted 2.4m high plywood access gates erected on suitable posts to give 3.7m clear opening

At the end of the relevant part of works requiring widened access wall and pier are to be reinstated.

Wall is to be reconstructed from 50/50 Ibstock West Hoathly Handmade 65mm brick and Ibstock West Hoathly Multi bricks in Hawkstone Lime mortar with rubbed and brushed joint coursing and bond to match existing

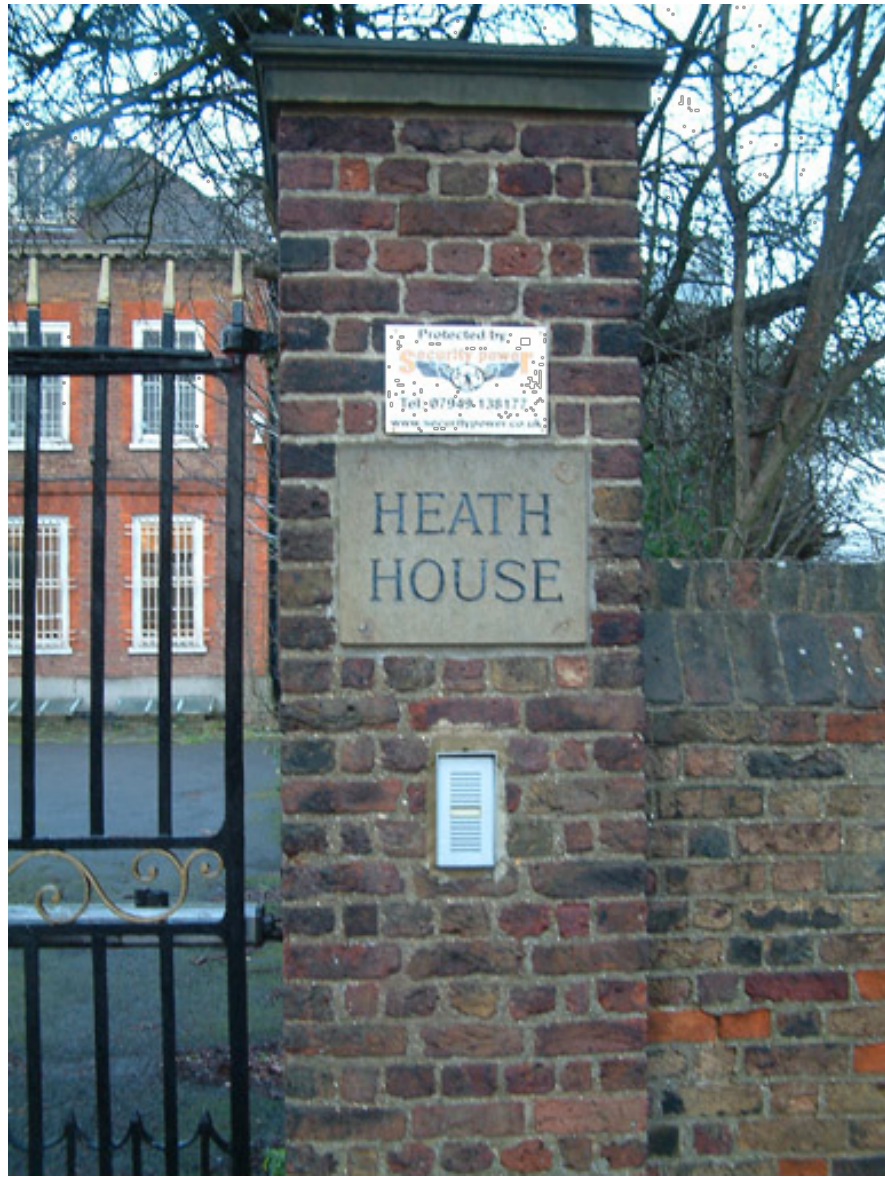
Pier is to be reconstructed from 50/50 Ibstock West Hoathly Handmade 65mm brick and Ibstock West Hoathly Multi bricks in Hawkstone Lime mortar with rubbed and brushed joint, coursing to match Pier 2. Existing pier cap reinstated on new pier.
