side elevation

rear elevation

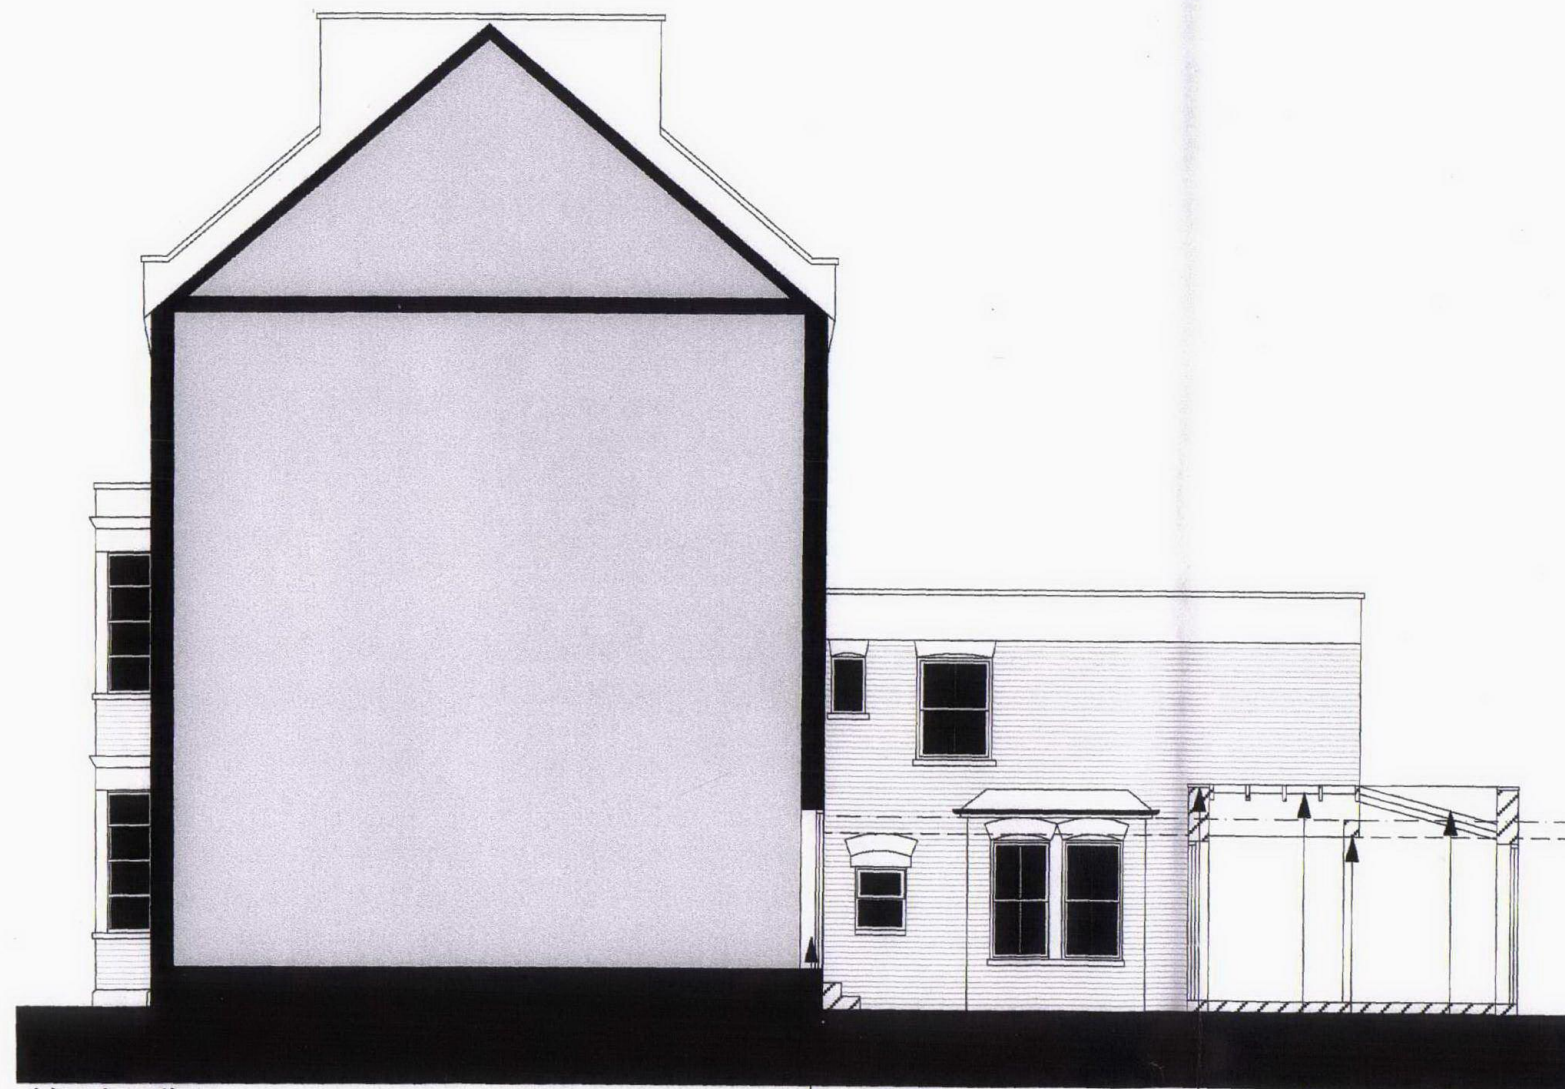
reconstituted
stone capping

steel support

new glazed roof

brick headers

london stock brick
to match existing

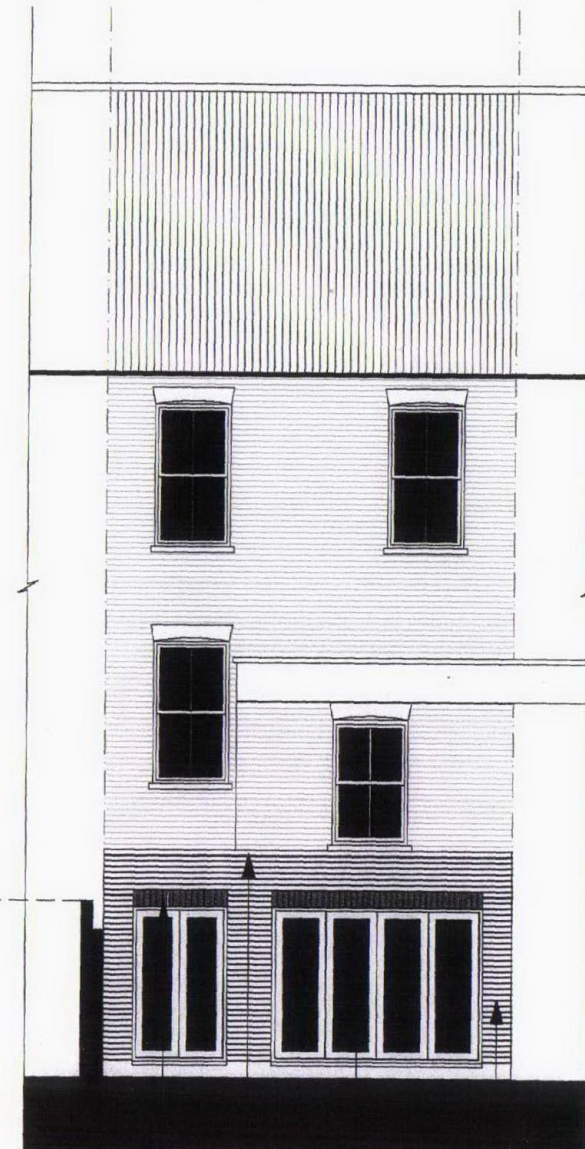
existing window opened up
to ground to form doorway

new glazed roof

double glazed white
timber doors
