Ref: TF/DR/752revA Prepared by: Alan Richardson Issued: 26/09/11

# APPENDIX 1 Tree Survey Schedule

### CAMDEN LOCK VILLAGE (HAWLEY WHARF), CAMDEN

#### ARBORICULTURAL DEVELOPMENT REPORT

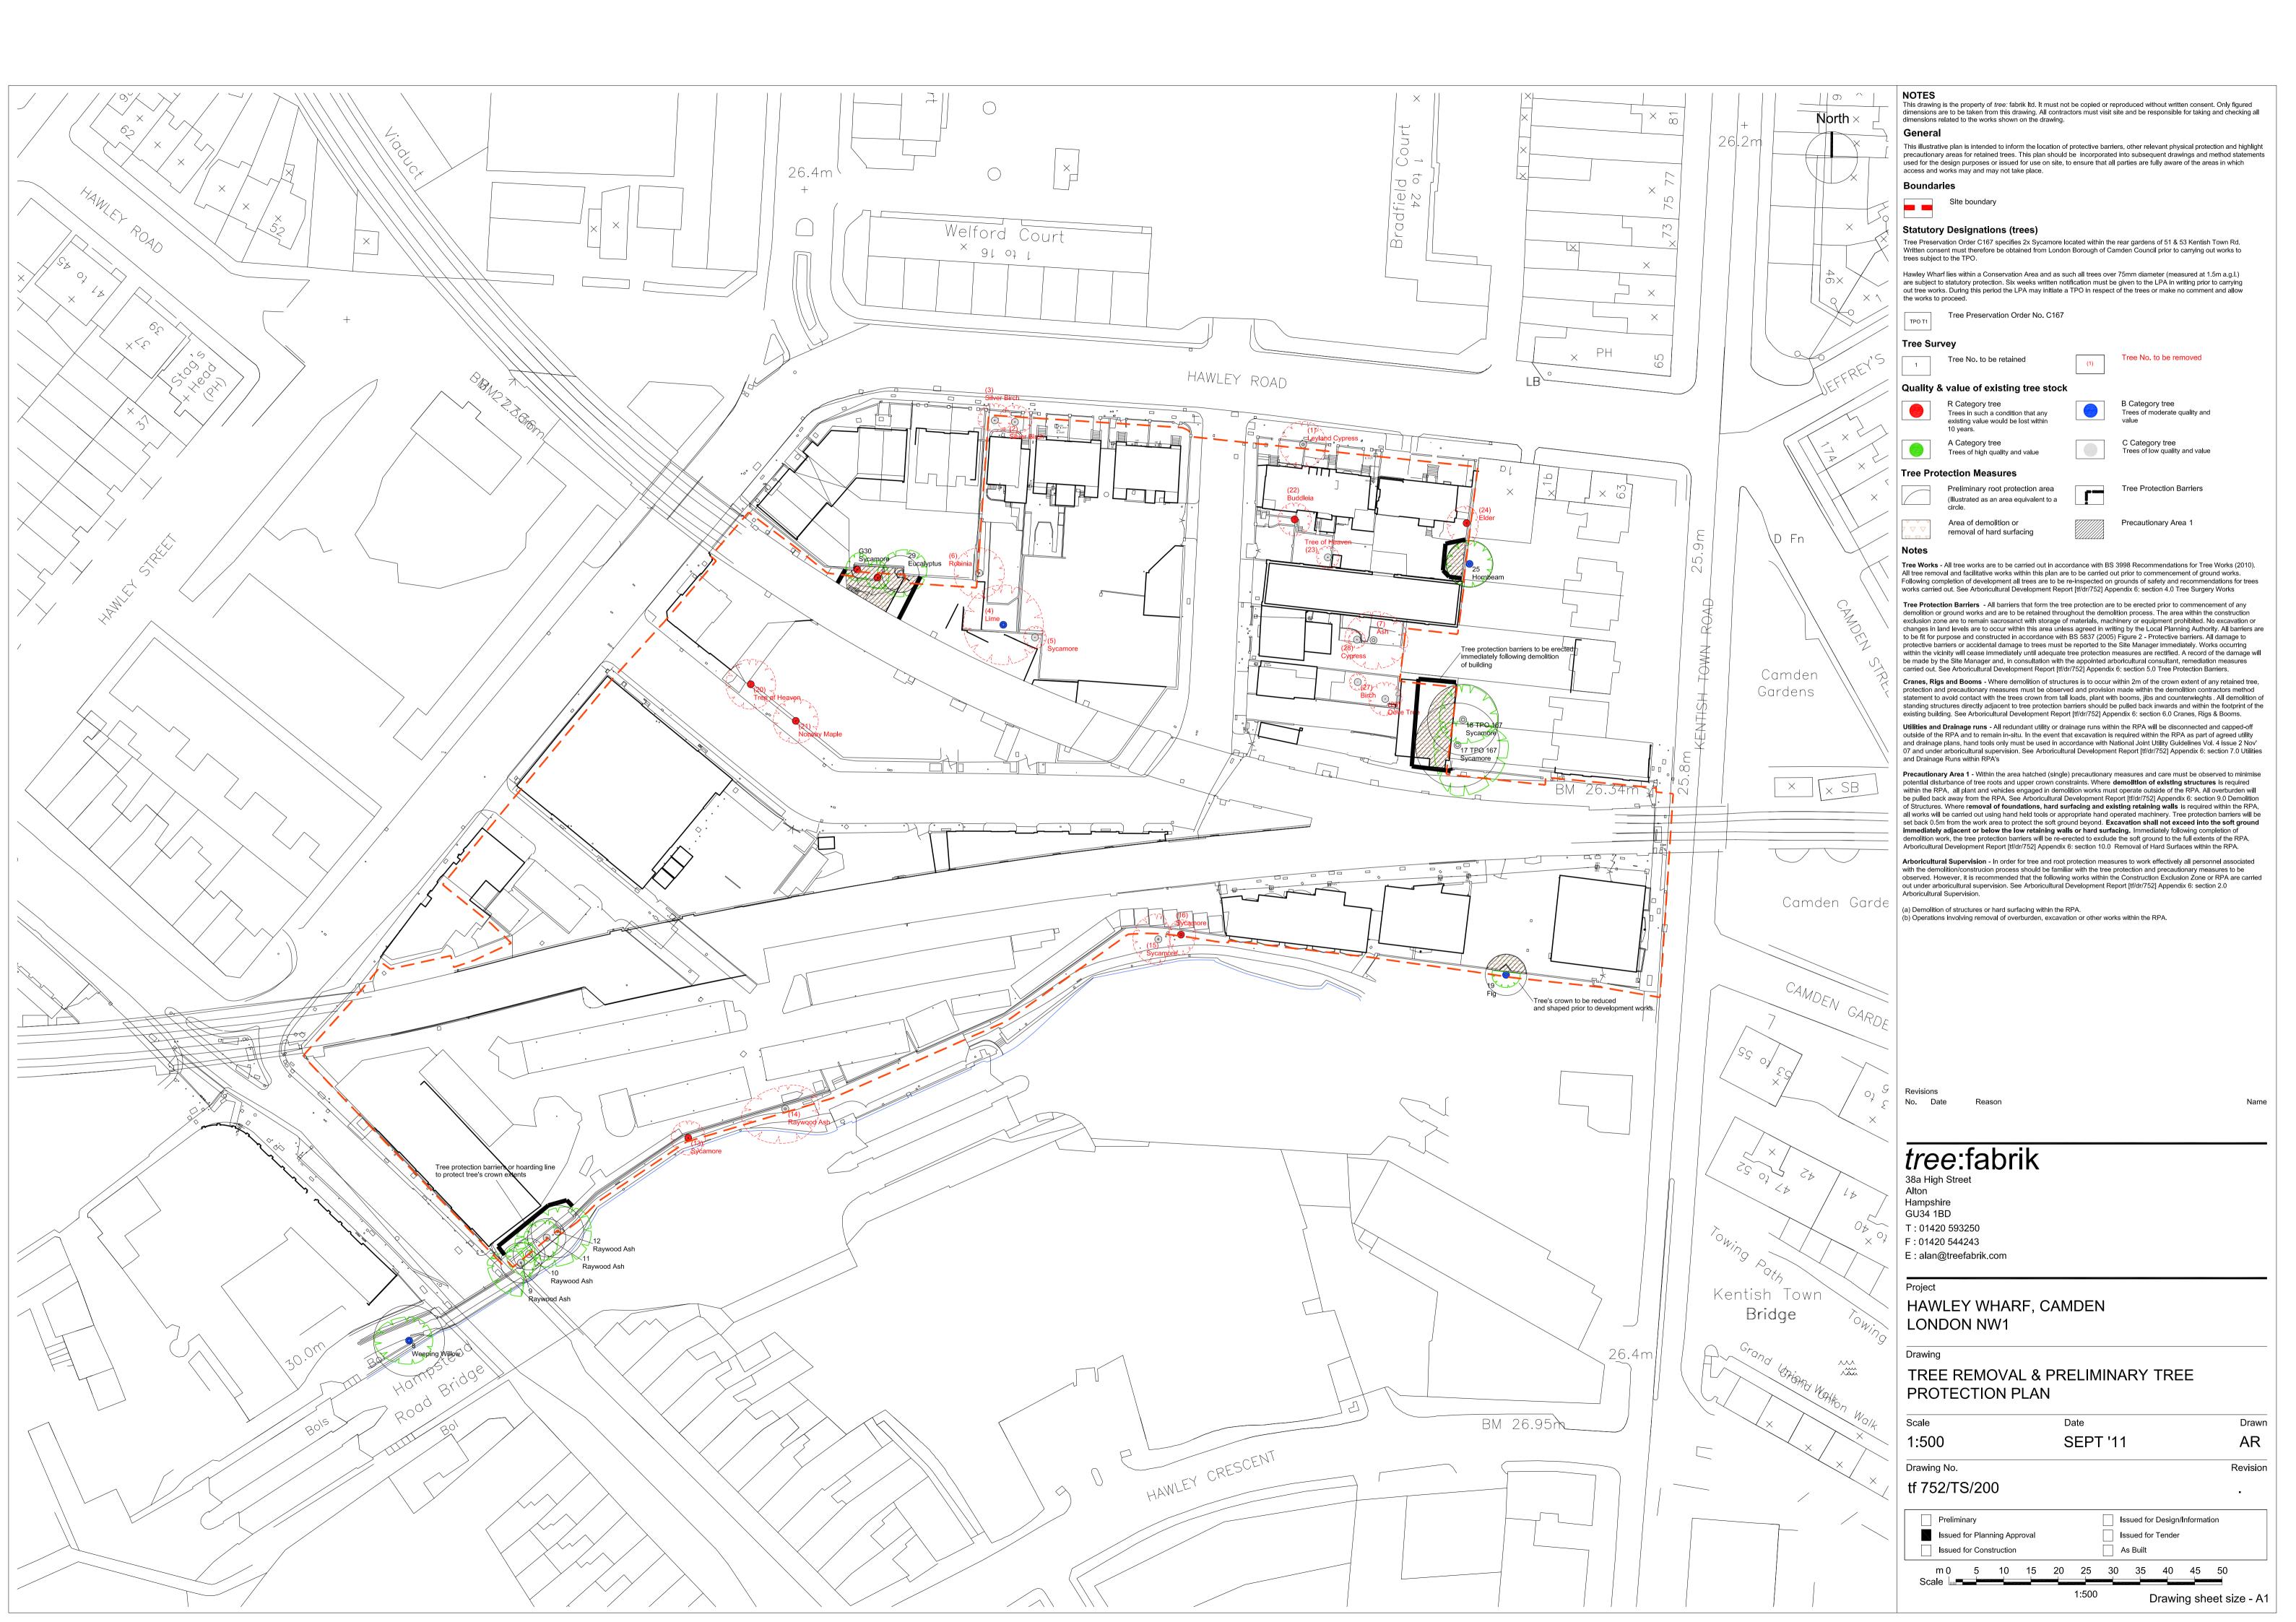
APPENDIX 6
Tree Removal & Preliminary
Protection Plan

A summary of the potential impact on each tree can be found below within Table 1 below and is illustrated within the accompanying Tree Removal & Preliminary Protection Plan [tf752/TPP/200] Appendix 6. A preliminary Method Statement forms Appendix 7 which outlines the practical tree protection and precautionary measures to be observed during the proposed demolition and construction process.

- 4.1 All tree works to facilitate access and development must be agreed with the Local Planning Authority and written consent obtained.
- 4.2 All tree works are to be carried out in accordance with BS 3998 Recommendations for tree work 2010 and current good arboricultural practice by a qualified and experienced tree contractor.
- 4.3 Trees identified for removal are located throughout the site. The position of the trees to be removed are shown on *tree*:fabrik drawing Tree Removal & Protection Plan tf 752/TPP/200 (Appendix 5).

5.1 Following the completion of facilitative tree works and removal, the tree protection barriers will be erected. The position for barriers is shown on *tree*:fabrik drawing Tree Removal & Protection Plan tf 752/TPP/200 (Appendix 5) and the root protection areas forms appendix 2. The area excluded from activity by the barriers forms the **Construction Exclusion Zone**.

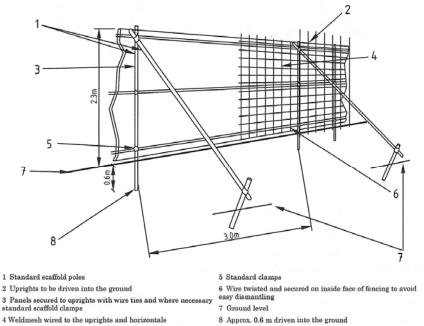
Figure 2 — Protective barrier

- 5.2 The position of the barriers is to be marked out on site and agreed at each stage with appropriate representatives from the Contractor and appointed arboricultural consultant. The barriers will be erected **PRIOR** to any works in the vicinity of the trees or the delivery of machinery, materials, plant or equipment to the site or any adjacent land thereto.
- 5.3 Barriers must be fit for purpose and should consist of a scaffold framework comprising of a vertical and horizontal framework, well braced to resist impacts, with vertical tubes spaced at a maximum of 3m. Onto this, weldmesh panels should be securely fixed with wire or scaffold clamps unless similar fencing is agreed with the Local Planning Authority see Detail of Tree Protection Barriers (extract of Fig.2 BS5837 2005) below.

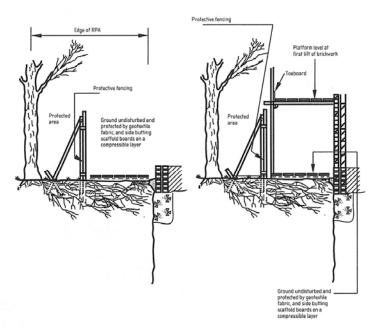
Figure 3 - Scaffolding within the RPA

5.4 Ground protection for pedestrian movements and scaffolding within the RPA will be constructed in the form of a single thickness of scaffold boards on top of a compressible layer laid onto a geotextile see Detail of Scaffold within RPA (extract of Fig.3 BS5837 2005) below.
