Flat 4, 11 Oval Road, London NW1 7EA

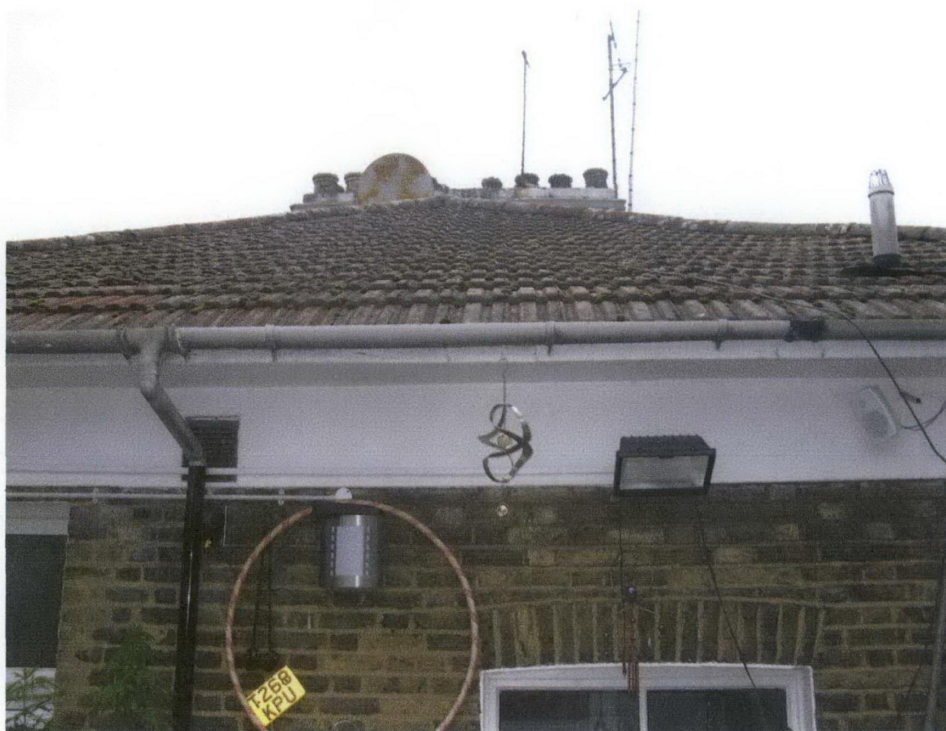
Condition of existing roof. Side elevation of roof hip.

The roof structure has deflected with the weight of the concrete tiles.

There is substantial ingress of water.

The proposal is to replace the concrete tiles with natural slate tiles.
