**OUTLINE REMEDIAL STRATEGY
CHARLTON STREET, CAMDEN, LONDON, NW1 1JD**

Bleriot Construction Ltd is proposing to conduct the required remedial works at the residential property at 31 Chalton Street, London as part of their requirements under the planning process. This document is intended to summarise the investigation works that have previously been undertaken and to make recommendations on the appropriate remedial criteria to be adopted and the best remedial solution to achieve them.

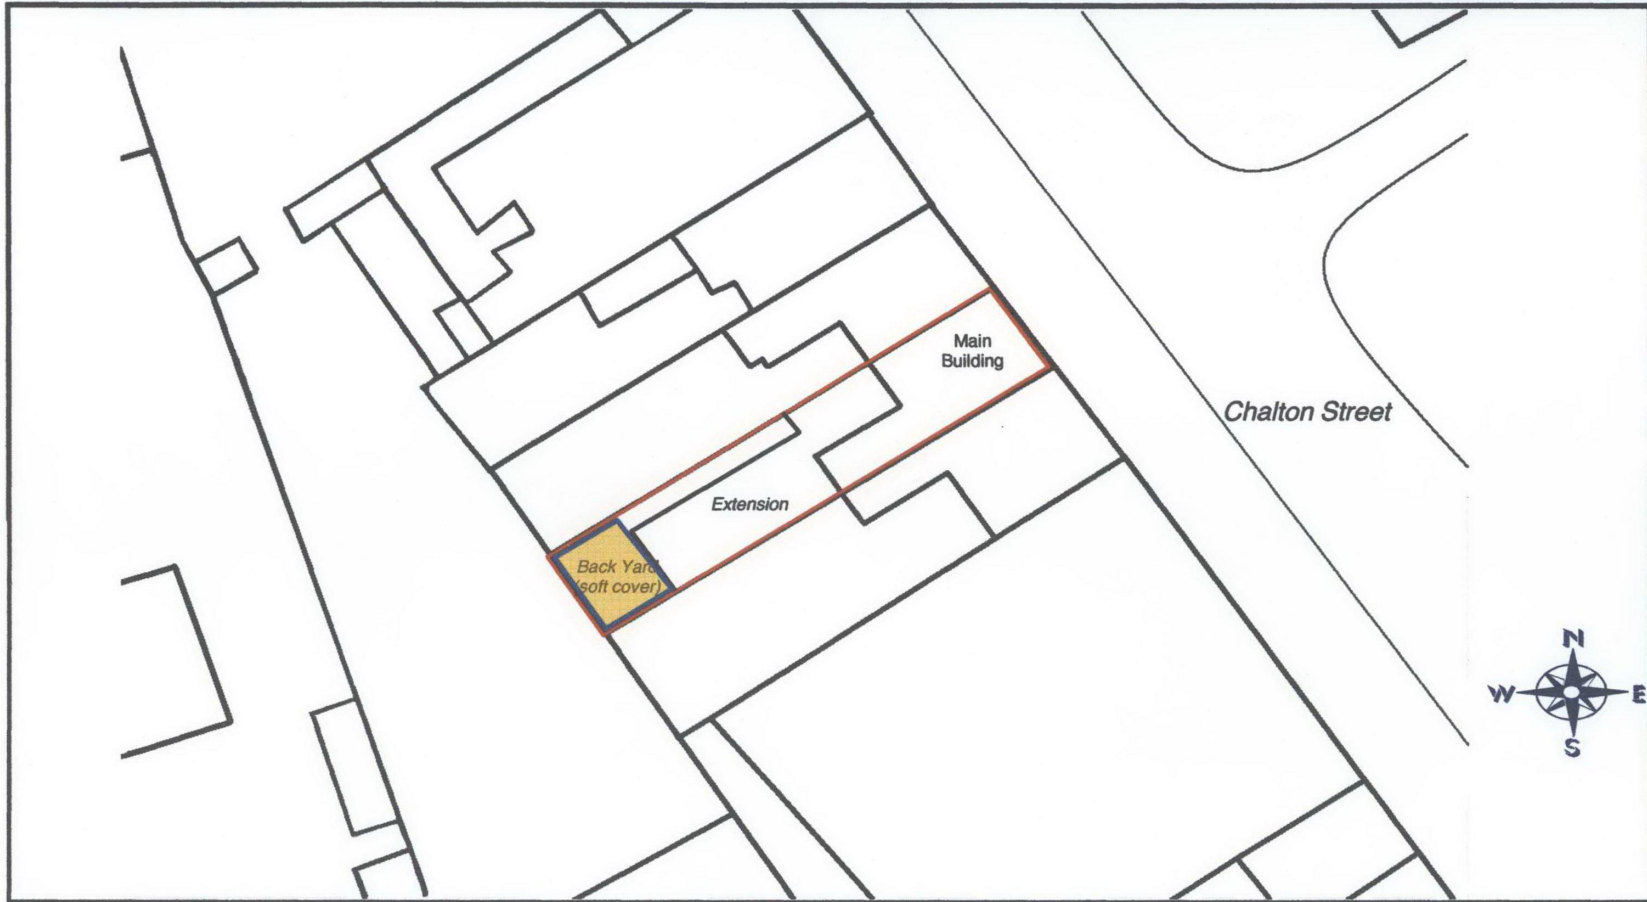
Plan Showing Areas Requiring Remediation

Remedial Area

Laboratory testing was conducted on soils that included a general suite for heavy metals and hydrocarbons. Elevated hydrocarbon and heavy metal concentrations, including lead, arsenic, benzo(a)pyrene, naphthalene and dibenzo(ah)anthracene, were identified in soft standing ground at the rear of site highlighted on Figure 1. These identified elevated concentrations in the upper 0.60m of the rear garden that would require remedial action.

At the time it is noted in the Planning Officer comments (Rachel Stopard) that Camden Borough Council⁽²⁾ considered the scope of the investigation to be appropriate for the site. Camden confirmed that there is one area on site that would require remedial action between 0.30m to 0.60m. Certificates and onsite validation of imported material would be required along with waste receipts of the excavated material.

1. Source removal of soft standing material at the rear of site to depth of 0.60m
2. On site screening and laboratory testing of in-situ soils at the base of the excavation
3. Onsite validation of imported surface cover and soil sampling for laboratory analysis
