BS5837:2005 Tree Survey Report,
incorporating
Arboricultural Implications Assessment
and Method Statement

In support of an application
for a docking station on the
carriageway and footway adjacent to:

**O'Donnell Court, Brunswick Square
Camden**

Site Ref: 02/610211
Status: FINAL
Date: 24 June 2009

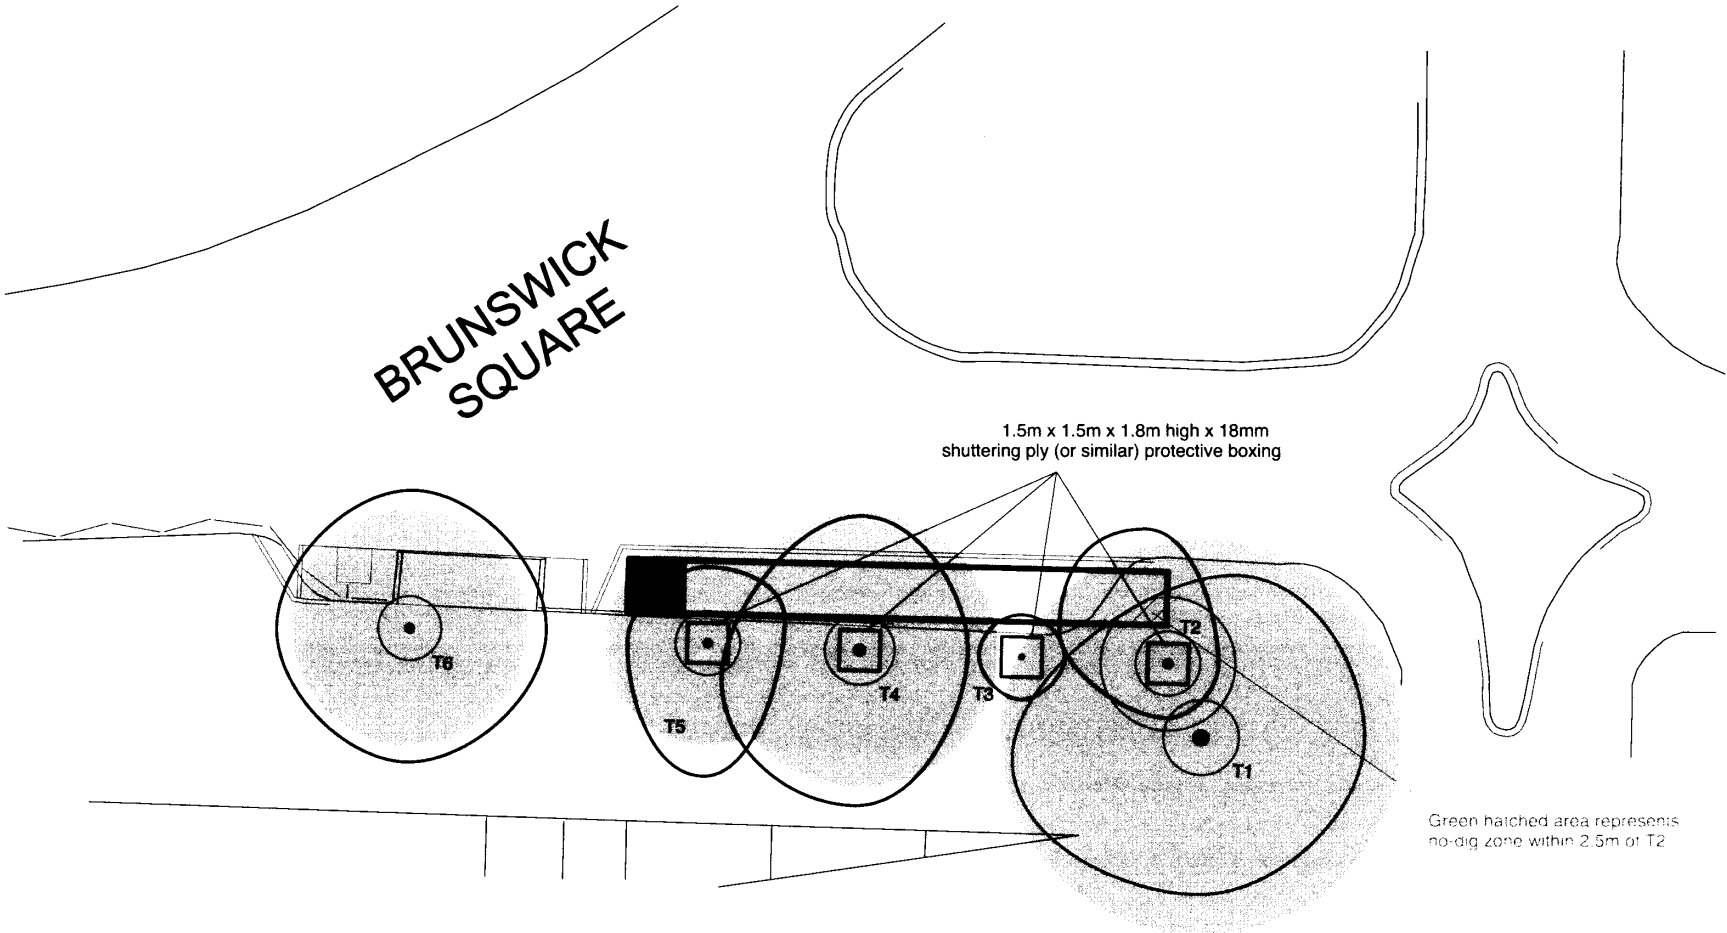
Appendix 4: Tree Constraints Plan

The proposed docking station (hereafter referred to as 'the Site') is located within the Root Protection Areas (RPAs) of a four trees (T1, T2, T4 and T5), located within the adjacent footway. Full details of these trees are included in the Tree Data Schedule (Appendix 3).

The Tree Constraints Plan (Appendix 4) shows the location of T1-T6 in relation to the proposed development. The plan indicates that the proposed docking station is located within the RPAs of T1, T2, T4 and T5. Between the footway and the majority of the Site (i.e. that part of the Site located on the existing carriageway) are a row of kerbstones. The hostile conditions immediately beneath the carriageway, coupled with the depth of the kerbs indicate that significant roots are not likely to be encountered within this portion of the Site at the required excavation depths. The impacts of trenching operations in this portion of the Site are therefore considered to be minor.

In order to minimise the impacts of excavation within the footway, the docking station is to be installed without excavation within 2.5m of T2. This shall be done by incorporating a no-dig design over the relevant area.

The stems of T2, T3, T4 and T5 shall require additional protection, as specified in Section 6, to prevent damage by construction machinery.
