72 & 74 South Hill Park, NW3

Proposed Development:

Design and Access Statement

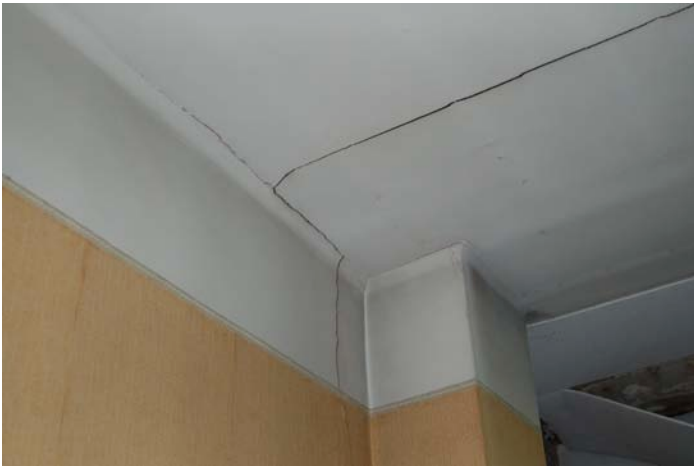
1. cracking caused by subsidence to rear ground floor

- 1.3.5** No 72 South Hill Park is suffering from subsidence. There is visible cracking to the party wall with no 74 and elsewhere. Floors to all levels have bowed significantly. The rear terrace is badly cracked. **(ill nos. 1 to 5)**

- 1.3.6** Trial pits have been made and the structural engineer (Greig Ling Consulting Engineers) is of the opinion that the subsidence has been caused by the 1950s construction pulling away from the Victorian fabric. Greig Ling have recommended that no. 72 and the party wall with no 74 be underpinned and that existing floor joists through out the building are removed, relaid and braced to the exterior walls.

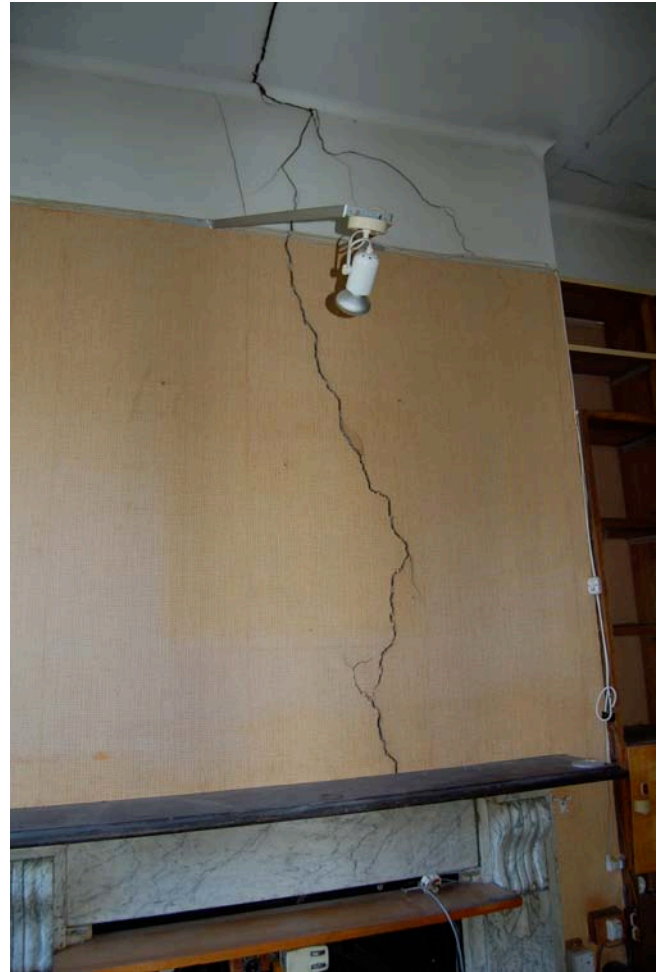
2. cracking caused by subsidence to rear ground floor

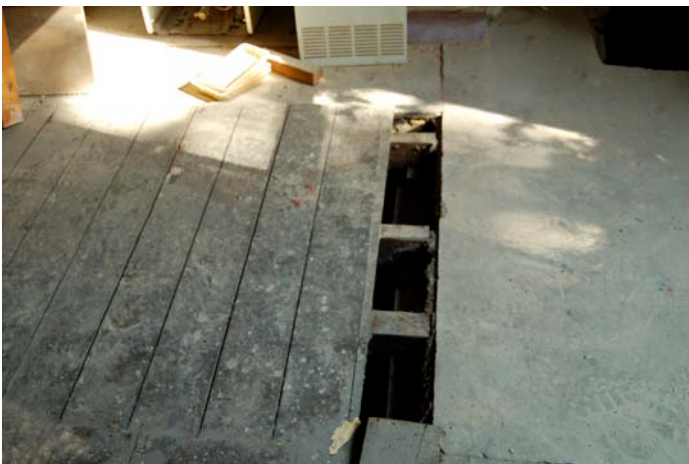
3. heave caused by subsidence to front basement

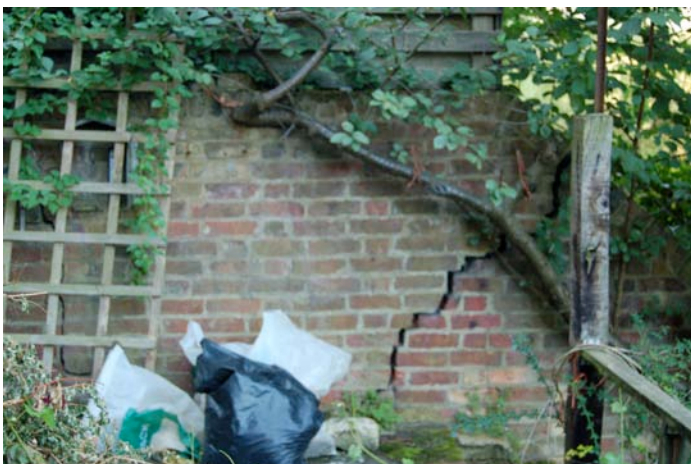
4. cracking caused by subsidence to garden terrace

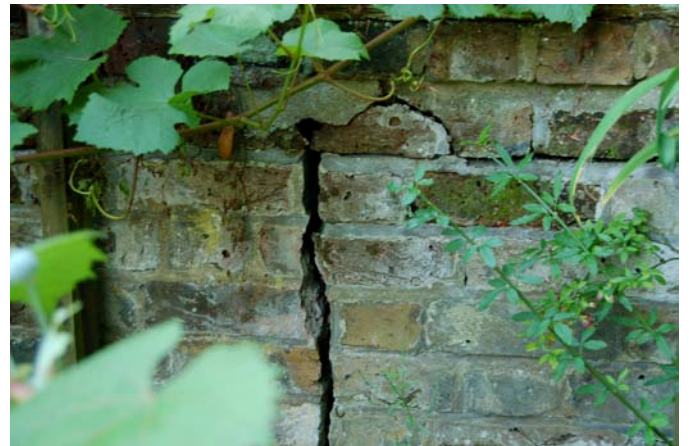
5. cracking caused by subsidence to garden terrace

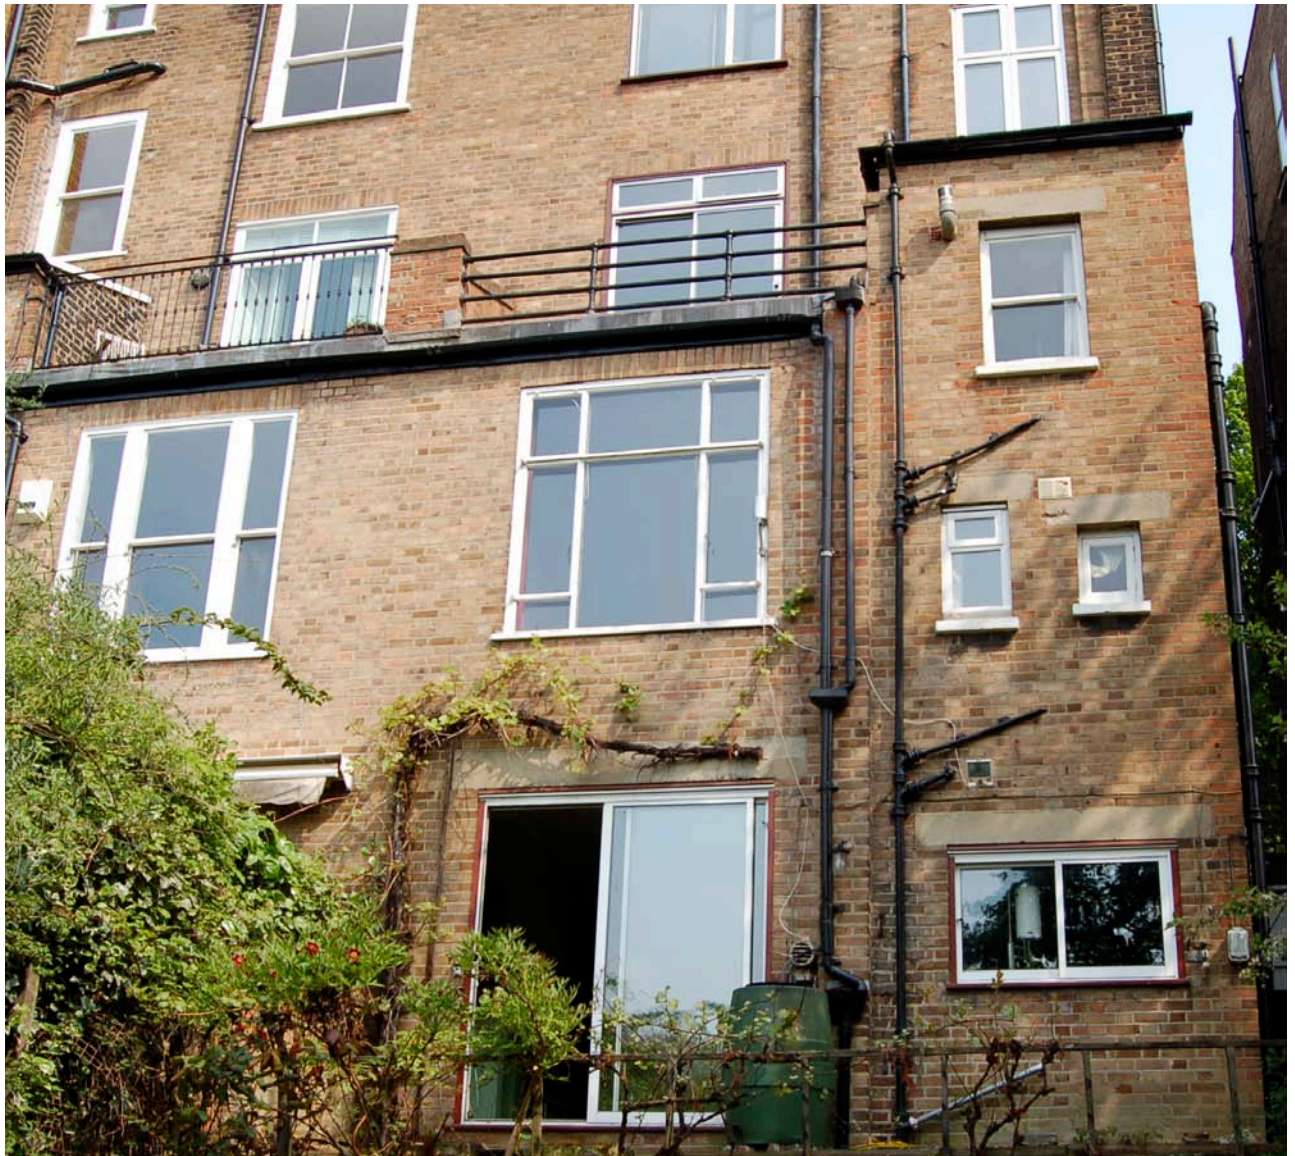
6. detail of rear elevation windows, no 72

The entire front elevation was rebuilt in fletton brickwork on an exposed concrete ring beam above the second floor windows. **(ill nos 6 & 9)**

- 1.3.2** The rear windows to both properties are not original and are virtually flush with the facing brickwork. Existing windows to no 72 are a mixture of steel frame, plastic coated aluminium, UPVC and timber. **(ill nos 6 & 7)**

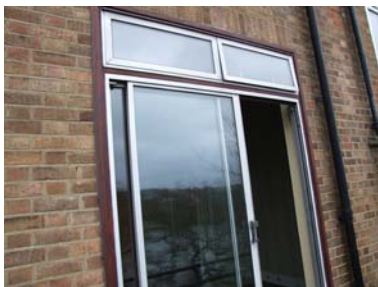
7. detail of rear rear elevation junction of nos 72 & 74

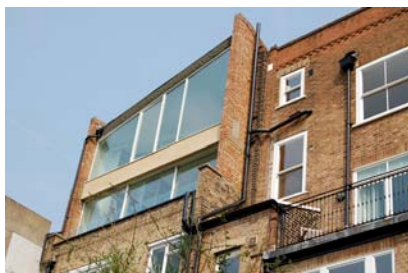
8. detail of rear rear elevation junction of nos 72 & 74

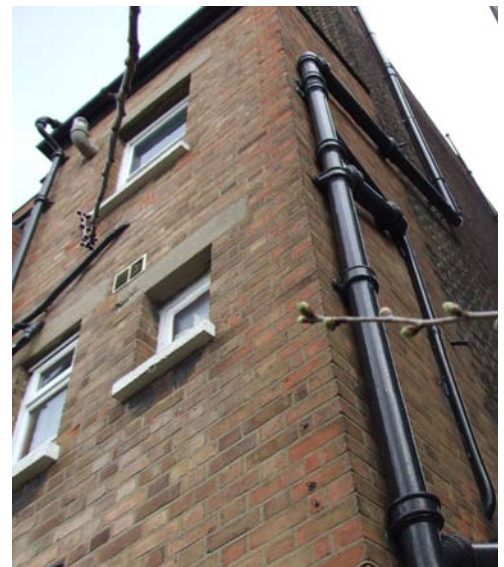
9. detail of rear elevation windows, no 72
