EUSTON CIRCUS

PROPOSED RETENTION OF DIGITAL LED ILLUMINATED ADVERTISING PANELS AT EUSTON ROAD UNDERPASS

PUBLIC SAFETY REPORT

GDB/4498/PSR.2 July 2014

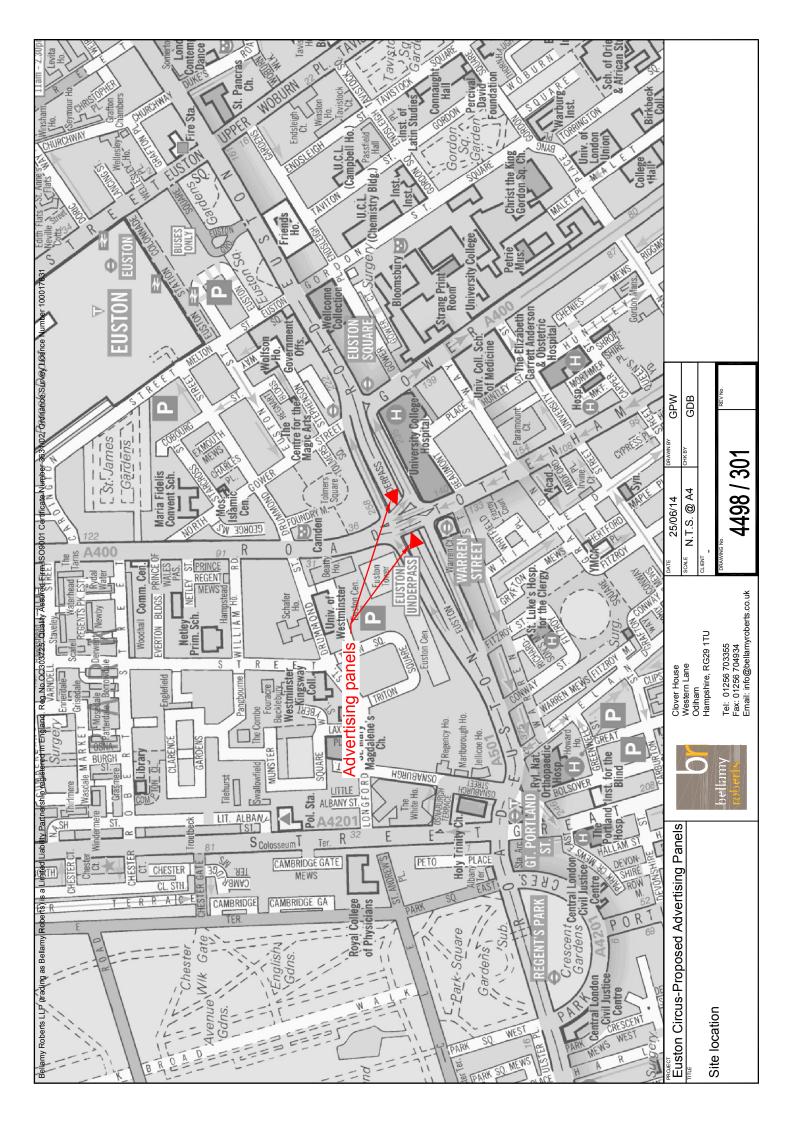
APPENDIX 1

Appendix 1 Site Location Plan

- As described above, the proposal is to retain the existing LED digital advertising panels on the fascias and parapet fences facing east and west on the bridge carrying the ground level road network over the A501 Euston Road underpass at Euston Circus. These advertising panels face east and west respectively towards drivers travelling through the underpass on the Euston Road main line. The location is shown on the plan at **Appendix 1.**

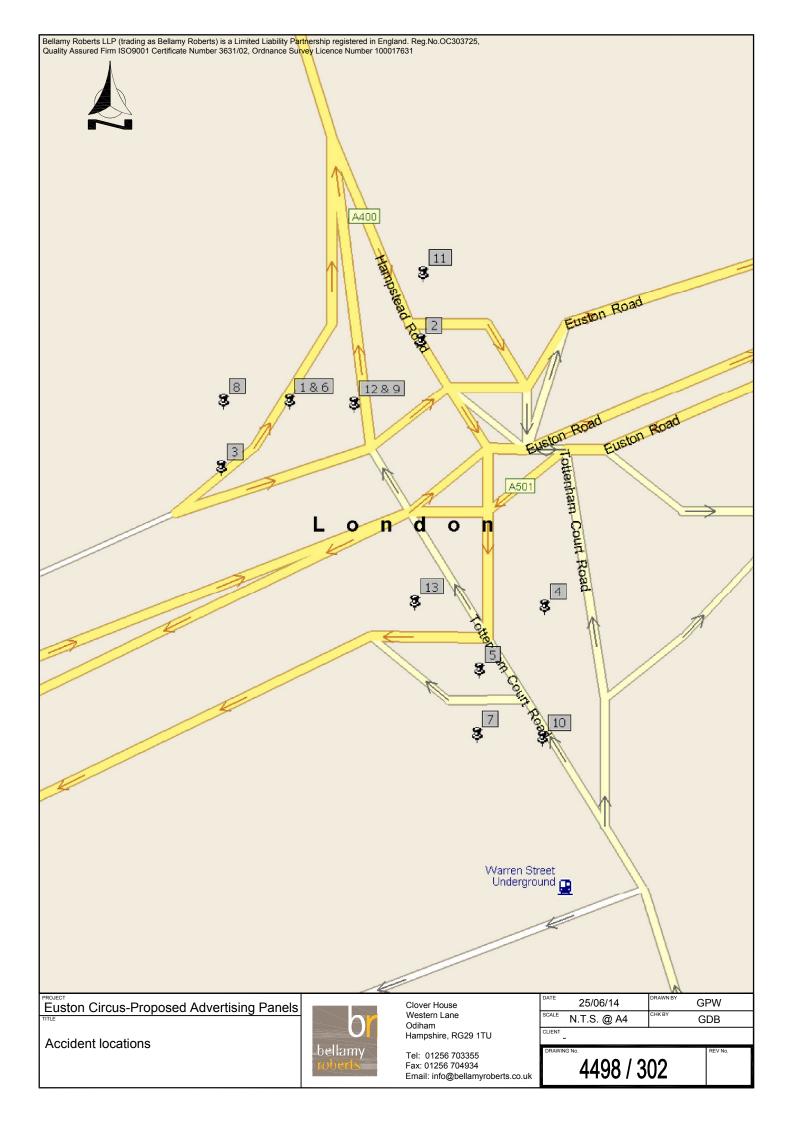
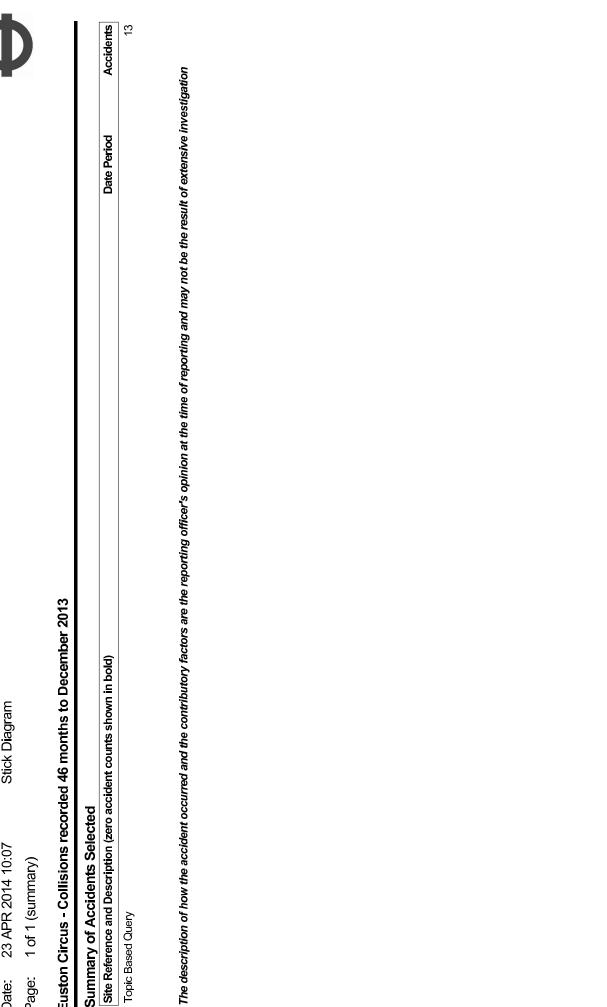
APPENDIX 3

Appendix 3 TfL Accident Data for Euston Circus

Euston Circus - Collisions recorded 46 months to December 2013

- 3.6 TfL have provided personal injury accident data for the Euston Circus area, extending over a 46 month period ending December 2013. A plot of the recorded accidents and the related data is included at **Appendix 3**.

- 3.9 The accident location plan at **Appendix 3** shows that 3 of the 11 accidents since the existing displays were commissioned, have occurred on the left turn movement from the eastbound slip road (accidents 3, 6 and 8). However, these accidents are all at a point where the driver is physically turning left and therefore looking left away from the display panels on the west-facing fascia of the underpass. Combined with the absence of any accidents involving vehicles proceeding straight ahead from the slip road at that point, it is very
