1 EASTERN EXTERNAL STAIRCASE
SCOPE OF REFURBISHMENT - ELEVATION 1:25

Project: Centre Point
Client: Almacantar
Drawing title: EASTERN EXTERNAL STAIRCASE
SCOPE OF REFURBISHMENT
Scale 1: 25@A1 Date: DEC 2013 Drawn by: NT
Project number: 2332 Drawing No: (24)212 Rev: A
Status: STAGE E Checked by: AS

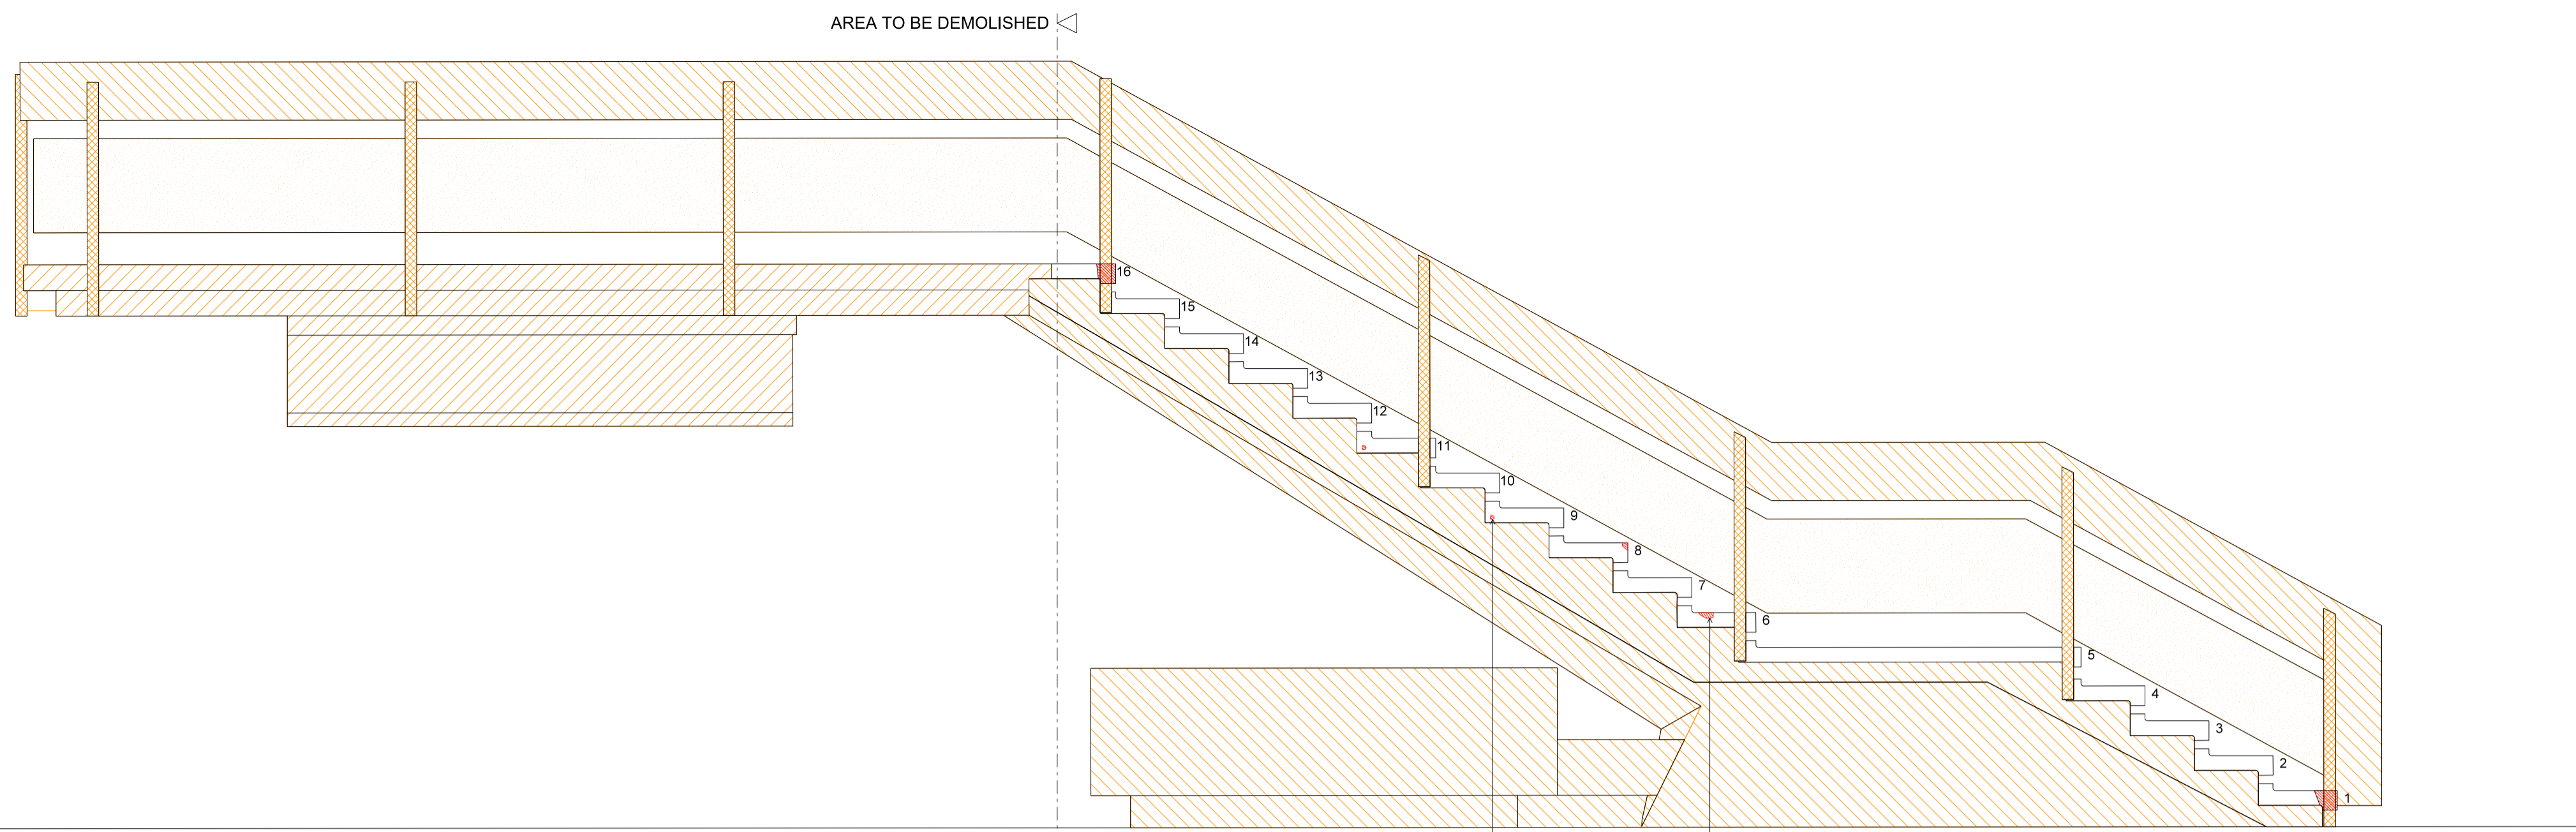
Rust staining to treads to be made good.
Minor repairs to be made good.

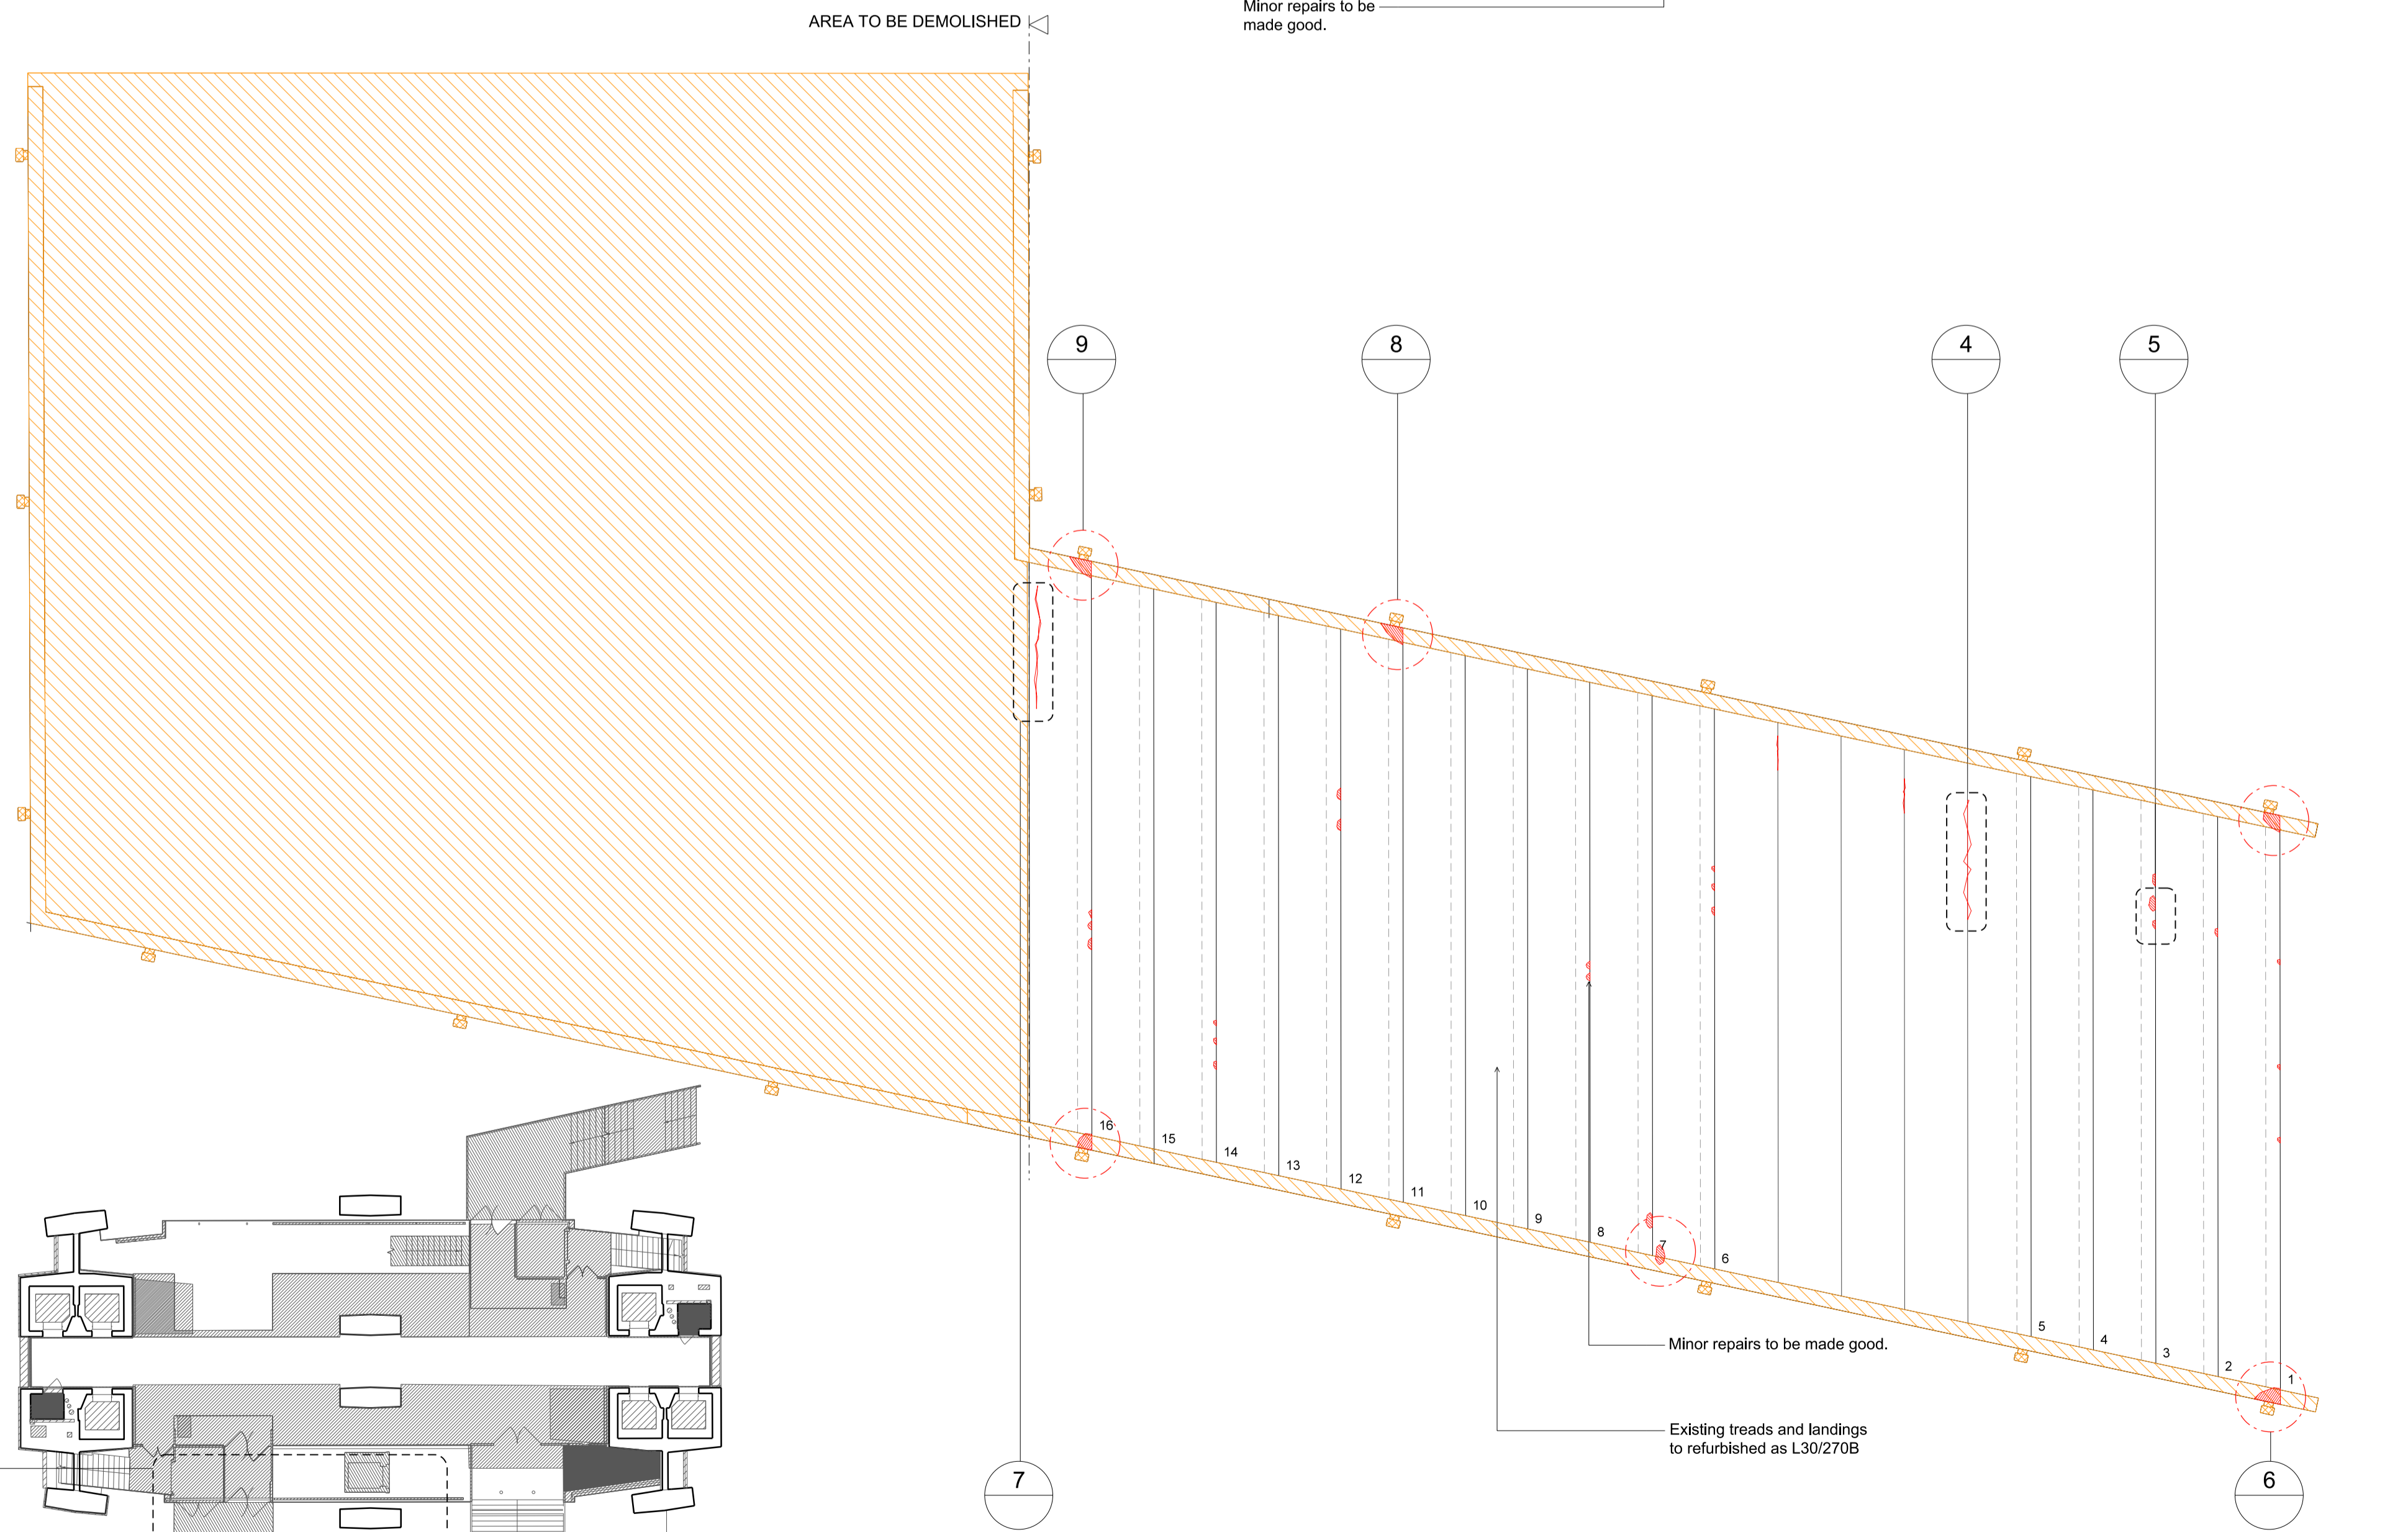
3 EASTERN EXTERNAL STAIRCASE
SCOPE OF REFURBISHMENT - PLAN 1:25

Minor repairs to be made good.
Existing treads and landings to refurbished as L30/270B

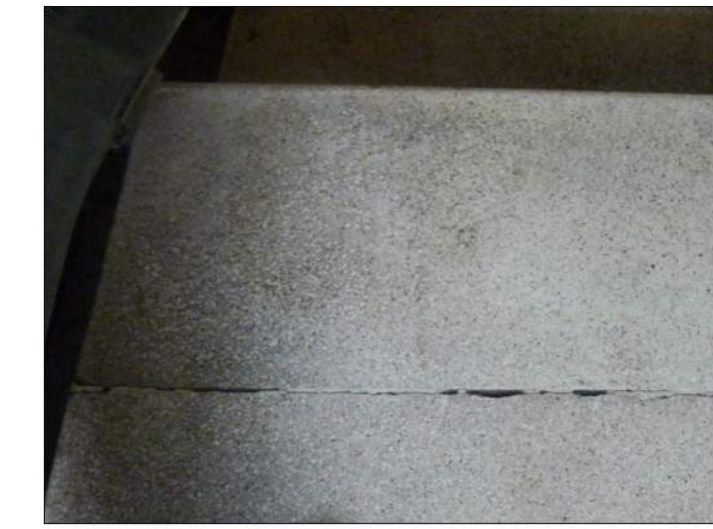
4 EASTERN EXTERNAL STAIRCASE
NOSING STRIP

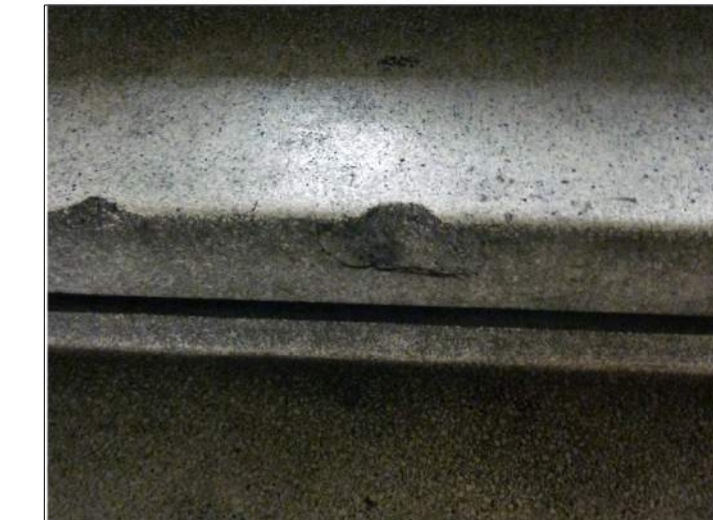
5 EASTERN EXTERNAL STAIRCASE
RUST STAINING

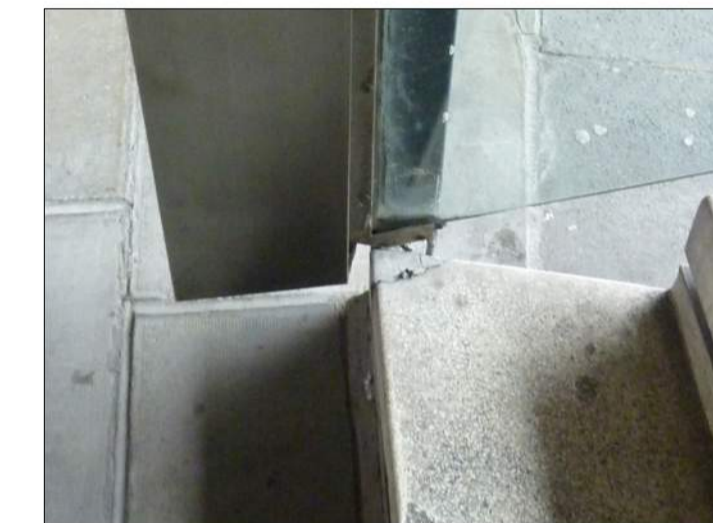
6 EASTERN EXTERNAL STAIRCASE
EXISTING REPAIRS

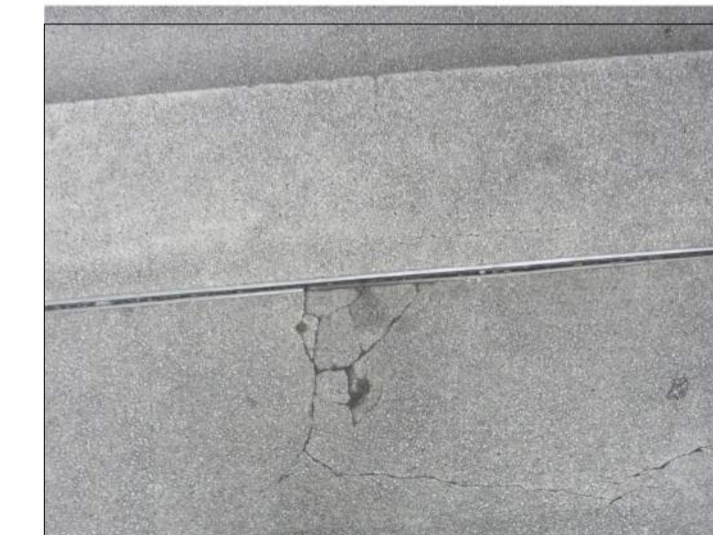
7 EASTERN EXTERNAL STAIRCASE
DAMAGED TREAD EDGES

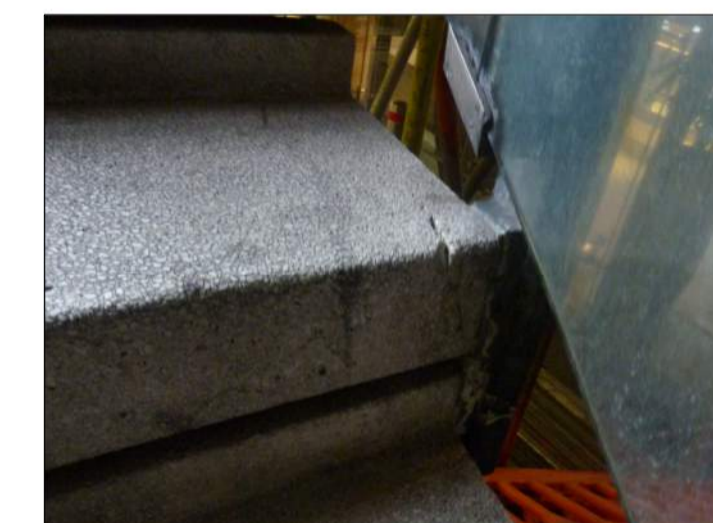
8 EASTERN EXTERNAL STAIRCASE
DAMAGED TREAD CORNERS

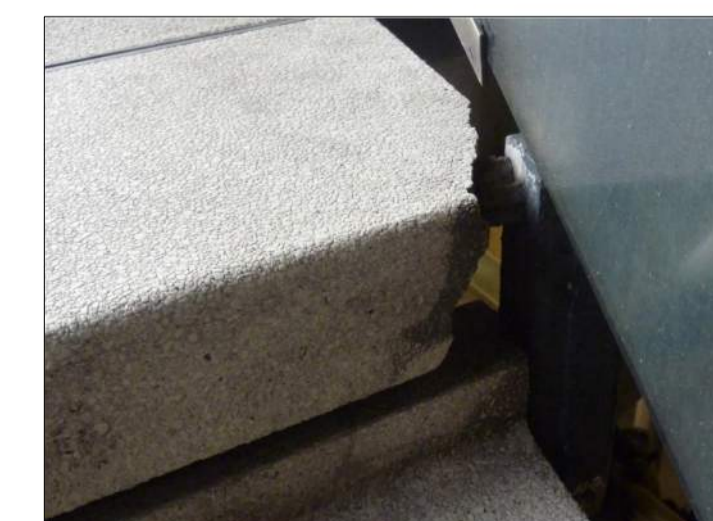
9 EASTERN EXTERNAL STAIRCASE
HANDRAIL POST FIXING
