1 WESTERN EXTERNAL STAIRCASE  
SCOPE OF REFURBISHMENT 1:25

Project: Centre Point  
Client: Almacantar  
Drawing title: WESTERN EXTERNAL STAIRCASE  
SCOPE OF REFURBISHMENT  
Scale 1: 25@A1 Date: DEC 2013 Drawn by: NT  
Project number: 2332 Drawing No: (24)210 Rev: -  
Status: STAGE E Checked by: AS

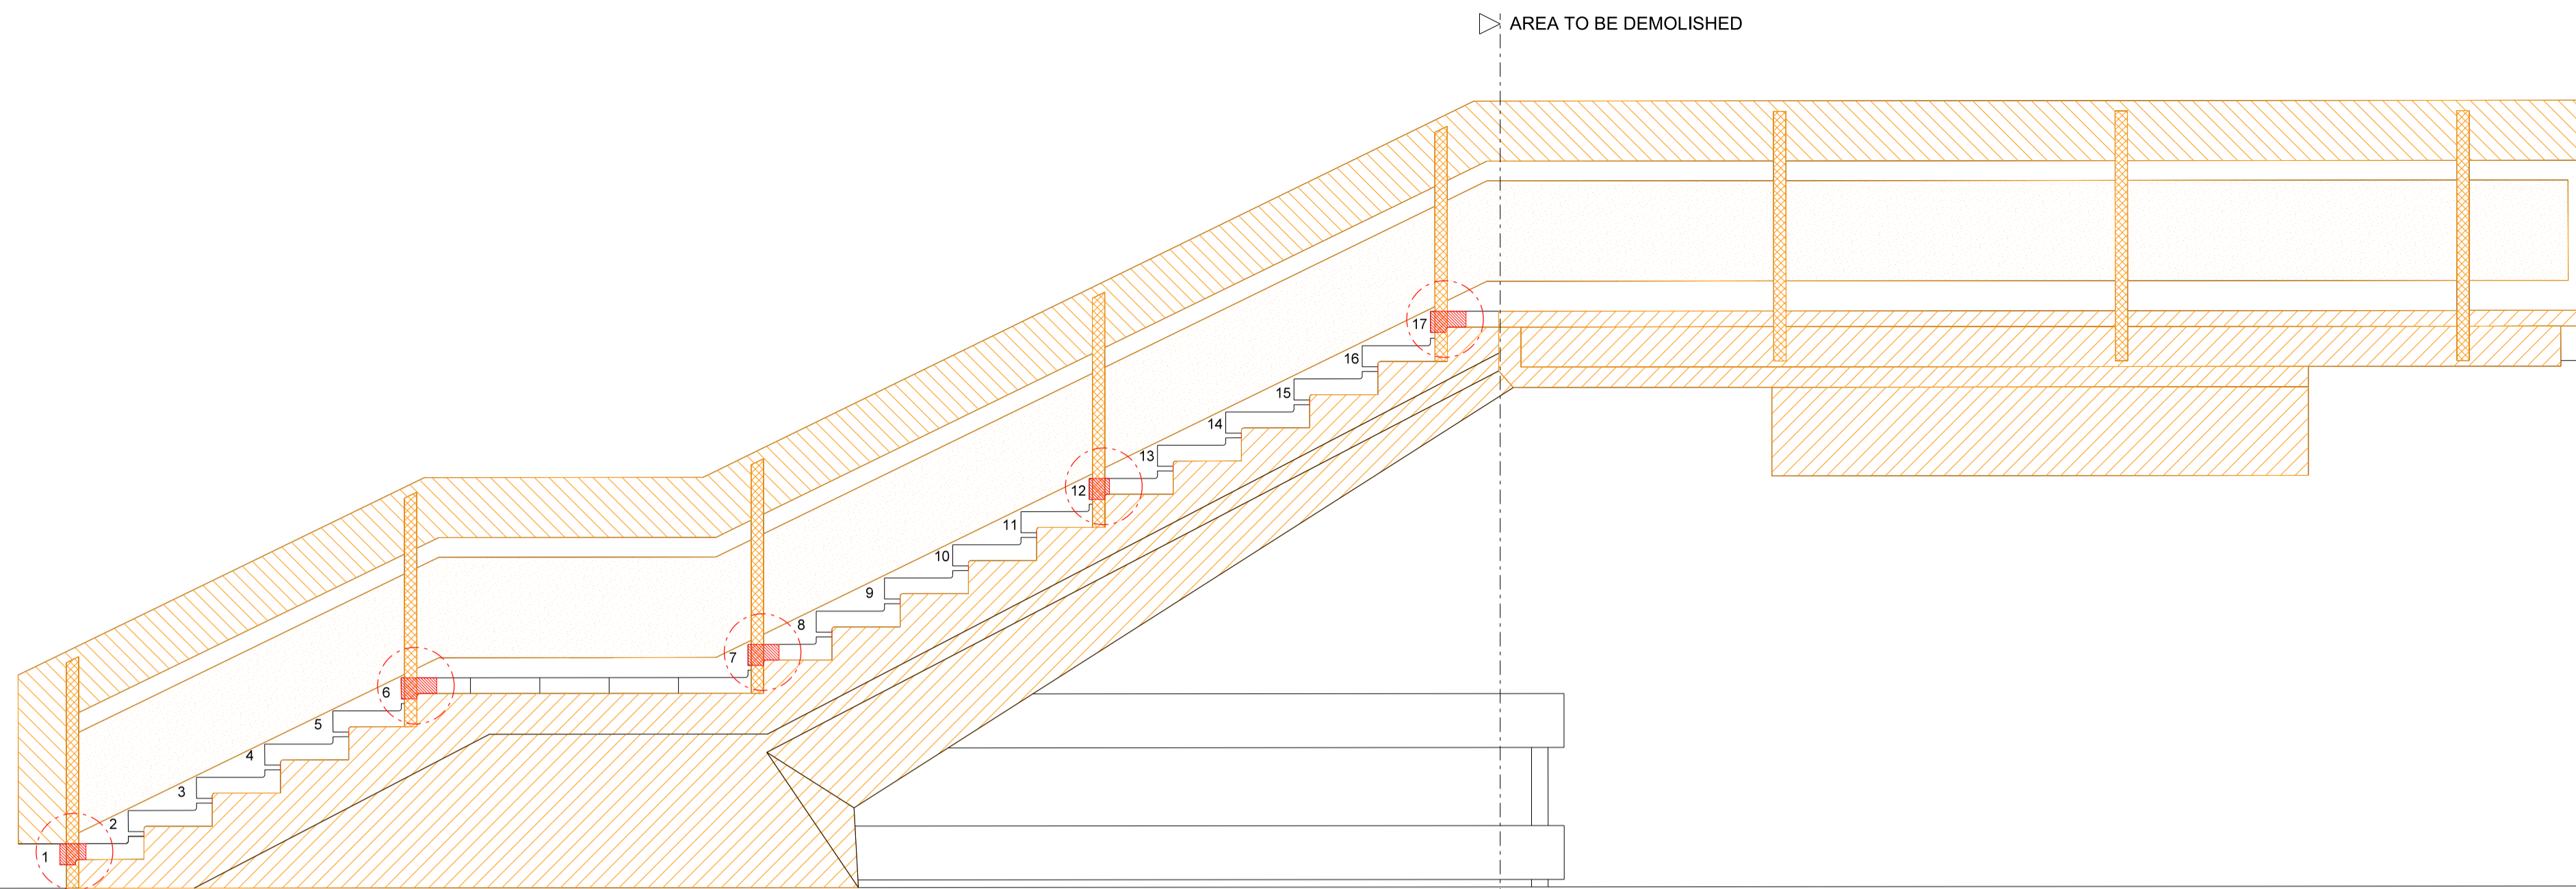
1 WESTERN EXTERNAL STAIRCASE  
SCOPE OF REFURBISHMENT 1:25

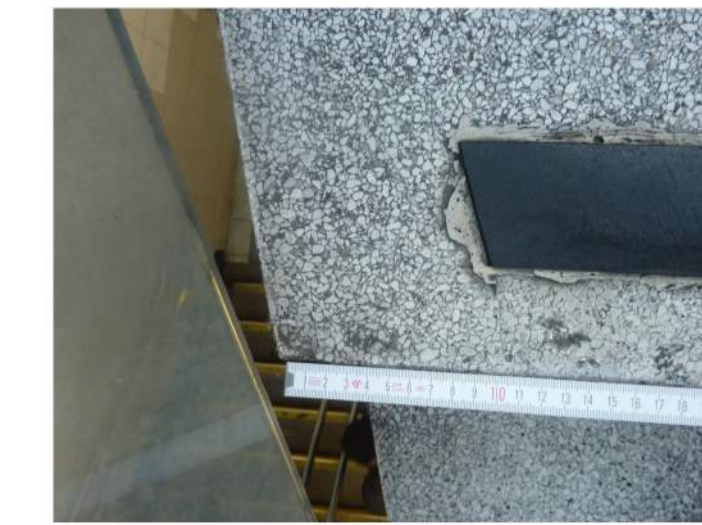
4 WESTERN EXTERNAL STAIRCASE  
NOSING STRIP

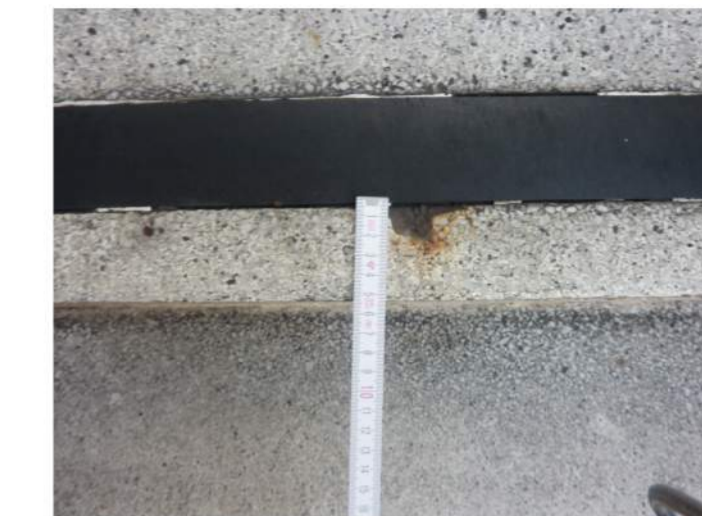
5 WESTERN EXTERNAL STAIRCASE  
RUST STAINING

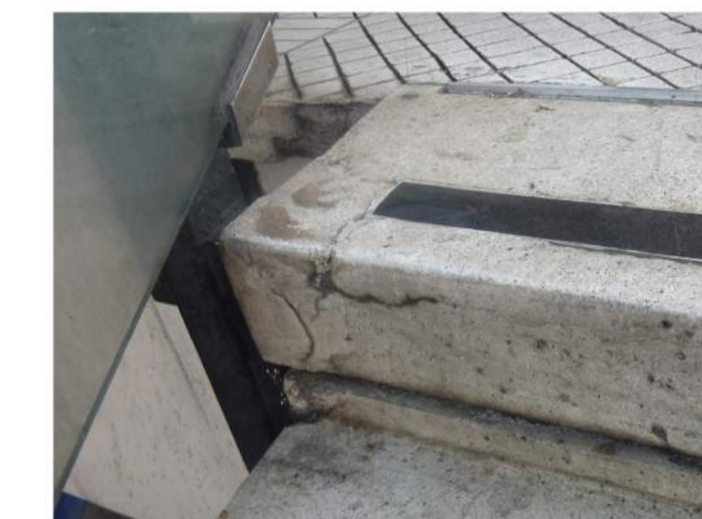
6 WESTERN EXTERNAL STAIRCASE  
EXISTING REPAIRS

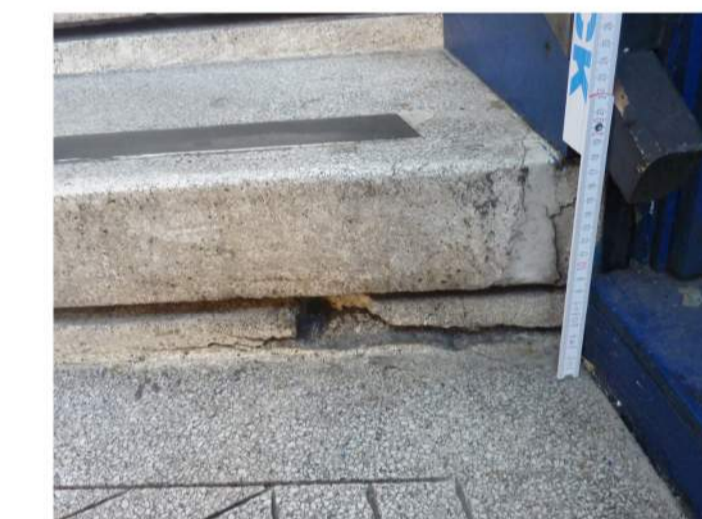
7 WESTERN EXTERNAL STAIRCASE  
DAMAGED TREAD EDGES

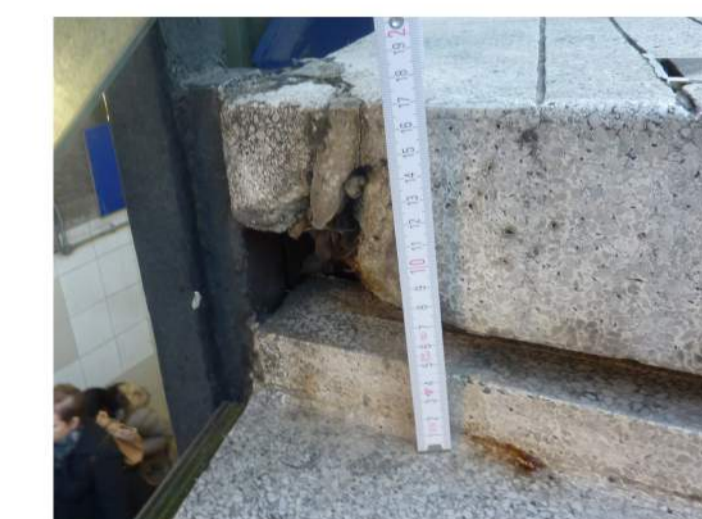
8 WESTERN EXTERNAL STAIRCASE  
DAMAGED TREAD CORNERS

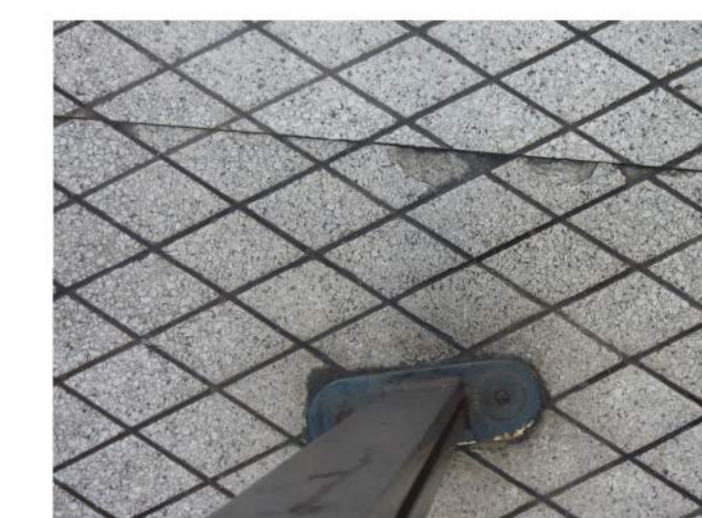
9 WESTERN EXTERNAL STAIRCASE  
HANDRAIL POST FIXING
