**120, Flat, Fortune Green Road, LONDON, NW6 1DN**

**Report Reference: SAS\_57148871\_1\_1**

**Report Date: 10-JUN-2014**

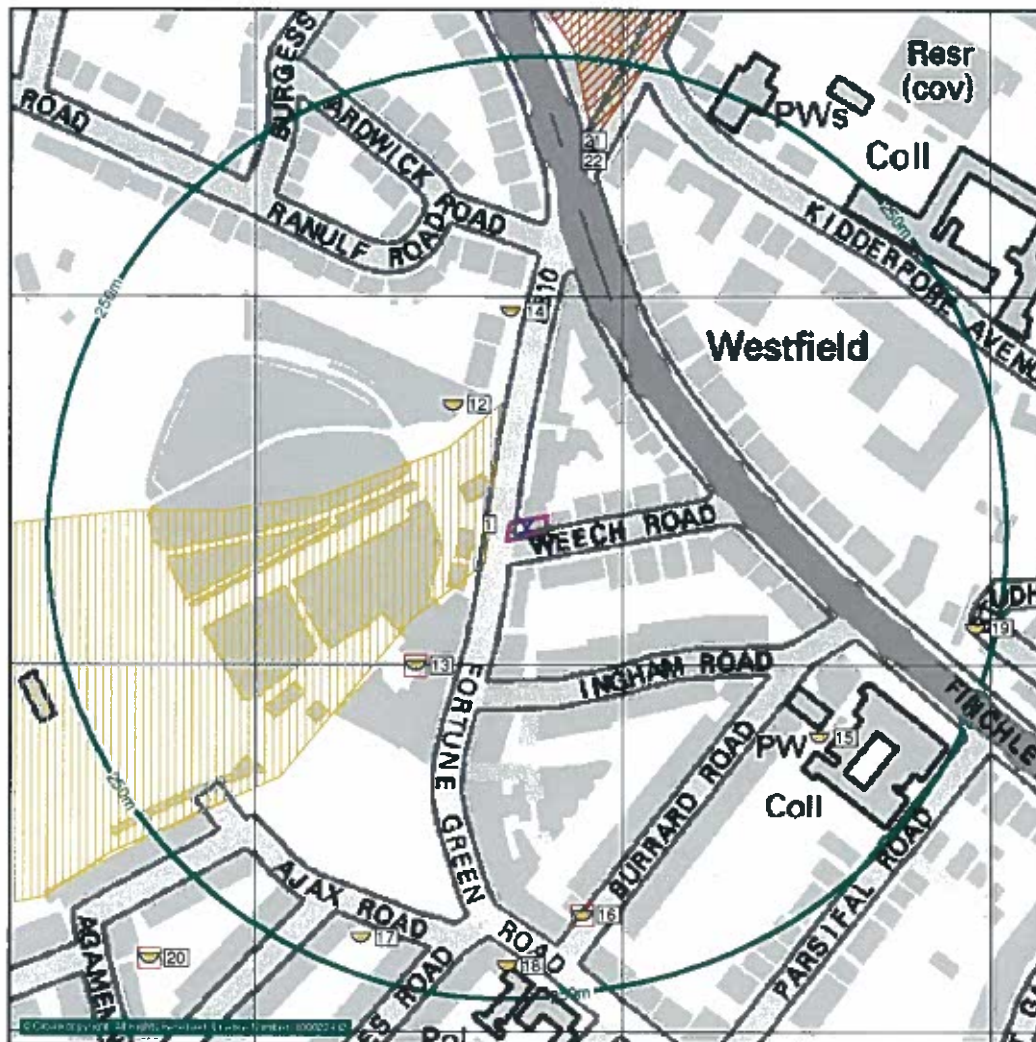
| Report Sections and Details | Page |
|---|---|
| This section contains a map, which shows historical land use features. The following pages detail these features and identify the Reference Number and direction. A table listing all the maps used to source this information is included. | |
