| INFORMATION | | | |
|---|---|---|---|
| drawing no. | 4142 | SERV | SKE02 |

| project | Stanley South Building - Building E1 |
| title | STANLEY BUILDING ROOM 2 TYPICAL<br>LAYOUT |

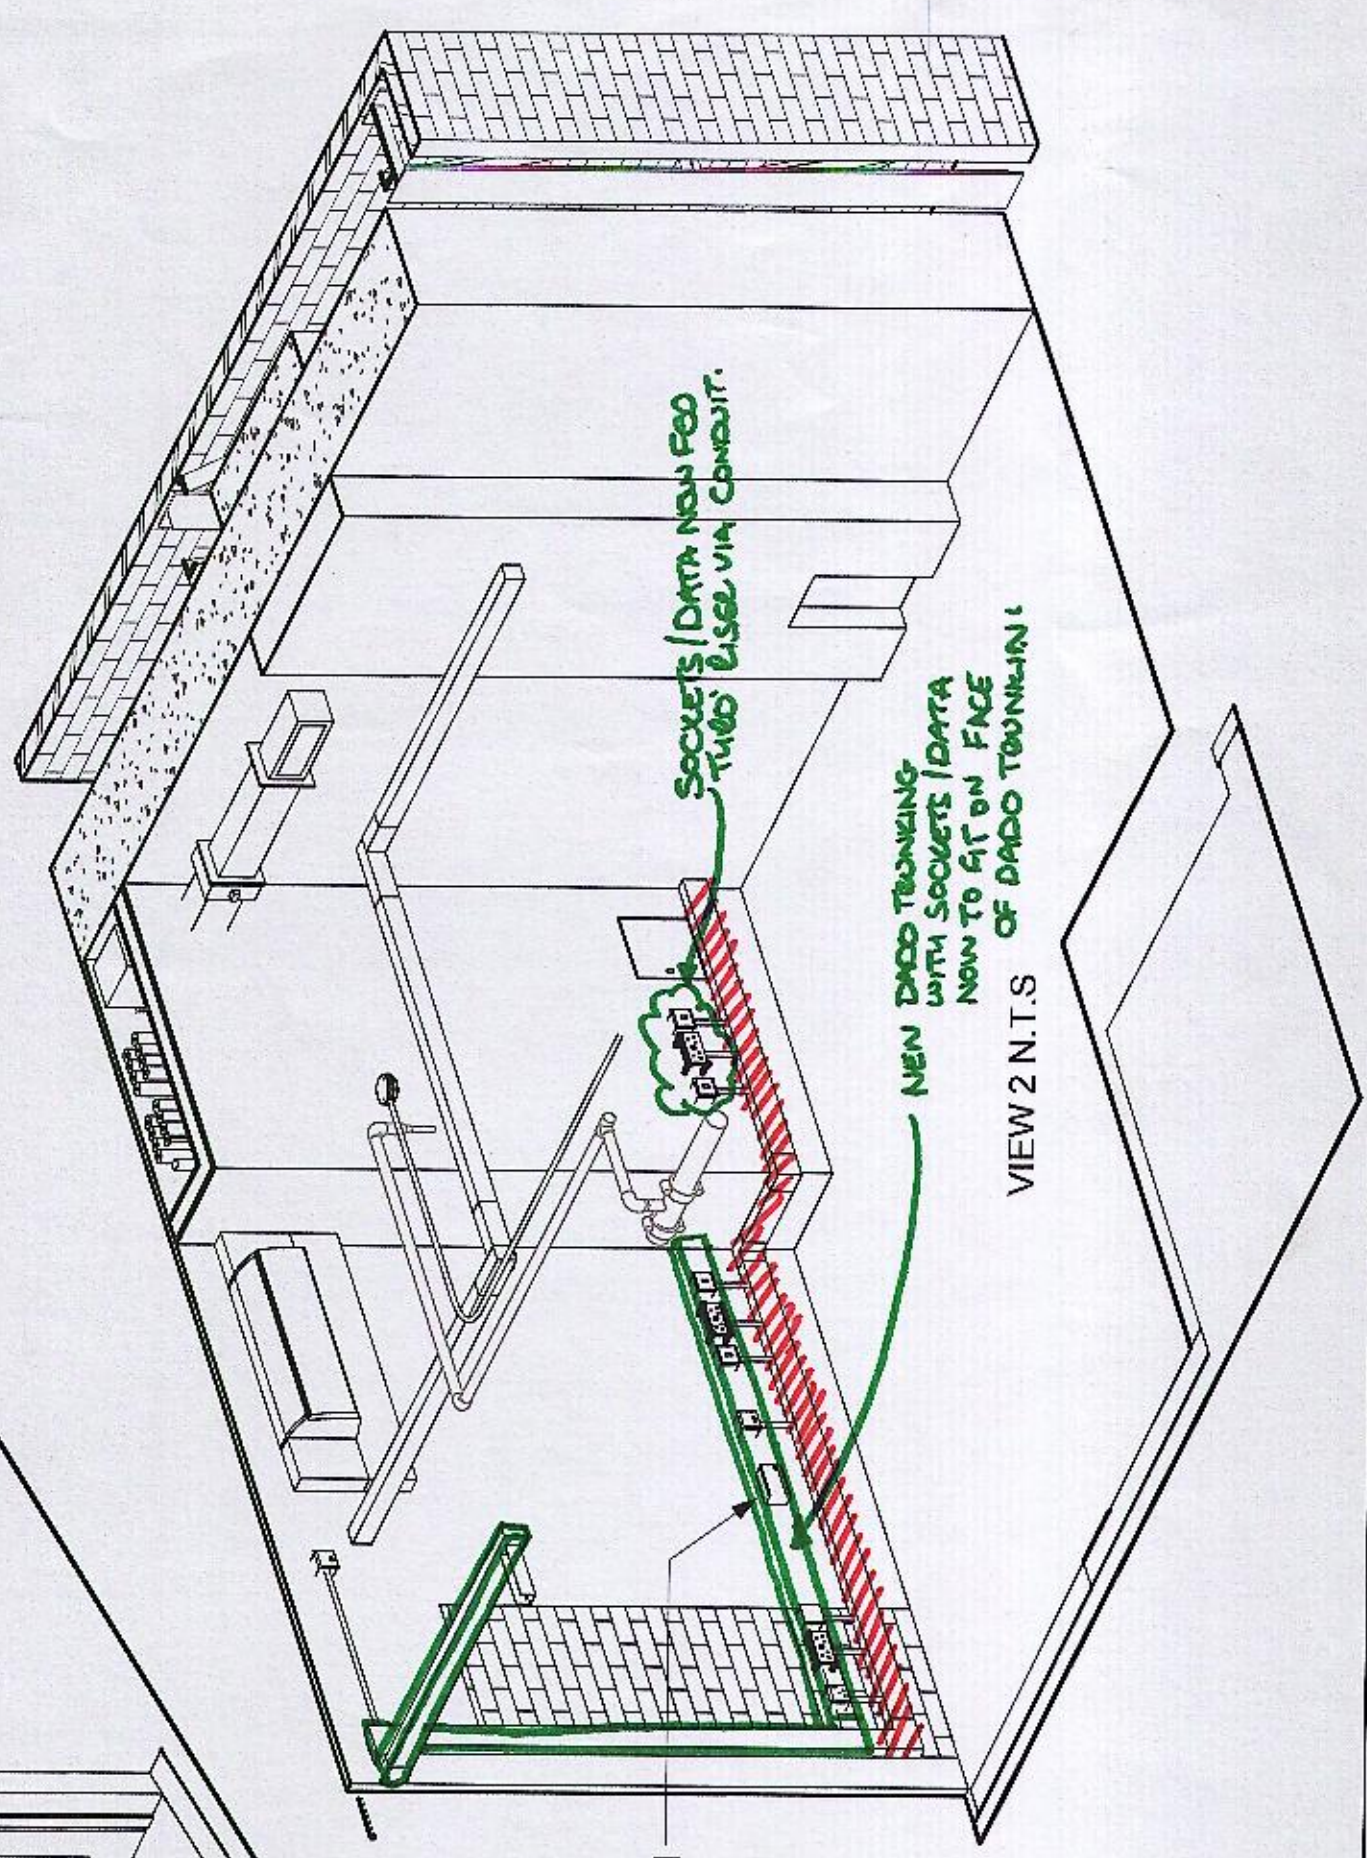
REFRIGERANT LEAK DETECTION  
ROOM 2 PLAN  
SCALE 1:50

PROPOSED REDUCED TRAINING  
EXISTING TRAINING NOW REMOVED.

SOCKETS, NEW FEO VIA CONDUITS,  
BURN IN FLOOR VOID.

TRAINING OMITTED.

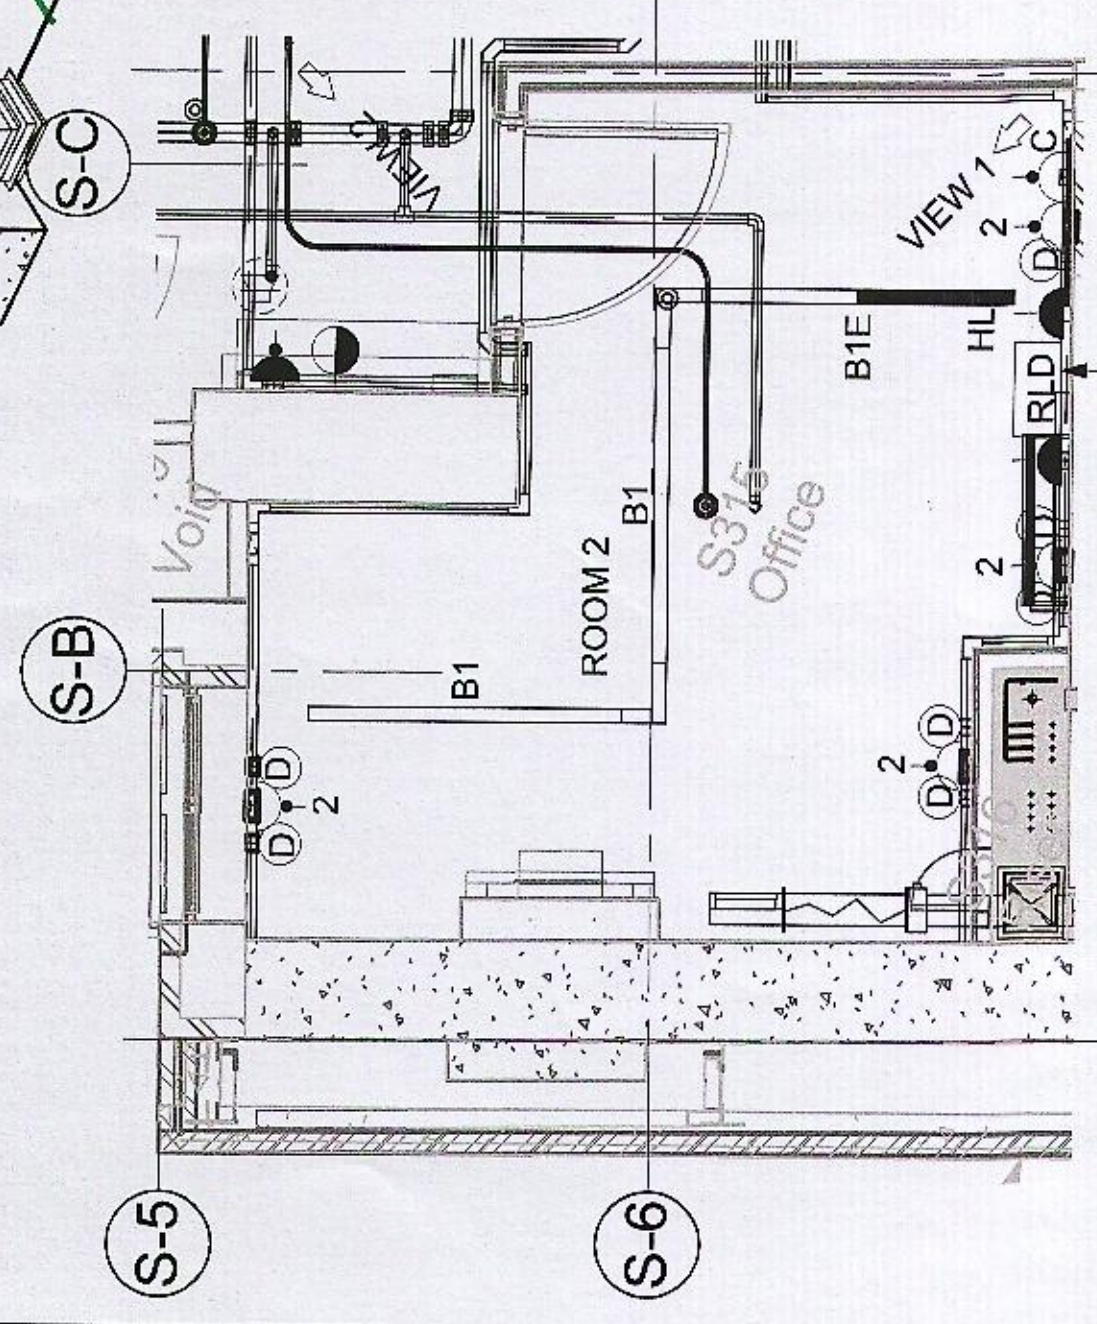
VIEW 1 N.T.S

REFRIGERANT LEAK DETECTION
