DRAWING TITLE Listed Building Repairs First Floor

PROJECT 57 BIRKENHEAD STREET LONDON WC1

SCALE 1:50 @ A3 DATE May 2014 517 14 DWG No

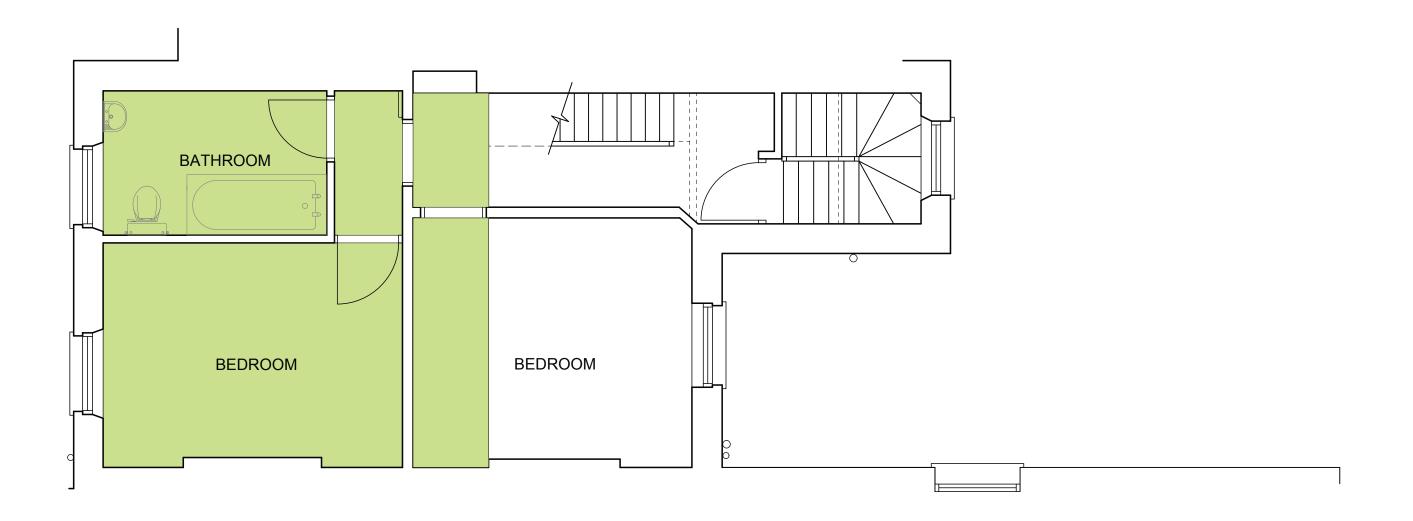
Remove bathroom fittings, cap services and wastes. Remove defective materials and replace.

Extend new services to bath, wash basin and wc. Extend waste services to existing waste pipes.

Replace tiling to floor and walls.

Repairs to fabric
