Repairs to fabric

DRAWING TITLE Listed Building Repairs PROPOSED WORKS Lower Ground Floor	PROJECT 57 BIRKENHEAD STREET LONDON WC1	SCALE DATE DWG No	1 : 50 @ A3 May 2014 517 11
LANYON-HOGG ARCITECTS Ltd. <i>Architecture + Interiors + Furniture</i> Tel 020 8882 1849 post@lanyon-hogg.com www.lanyon-hogg.com PLANNING DRAWING ALL DIMENSIONS TO BE CHECKED ON SITE ERRORS TO BE REPORTED TO THE ARCHITECT

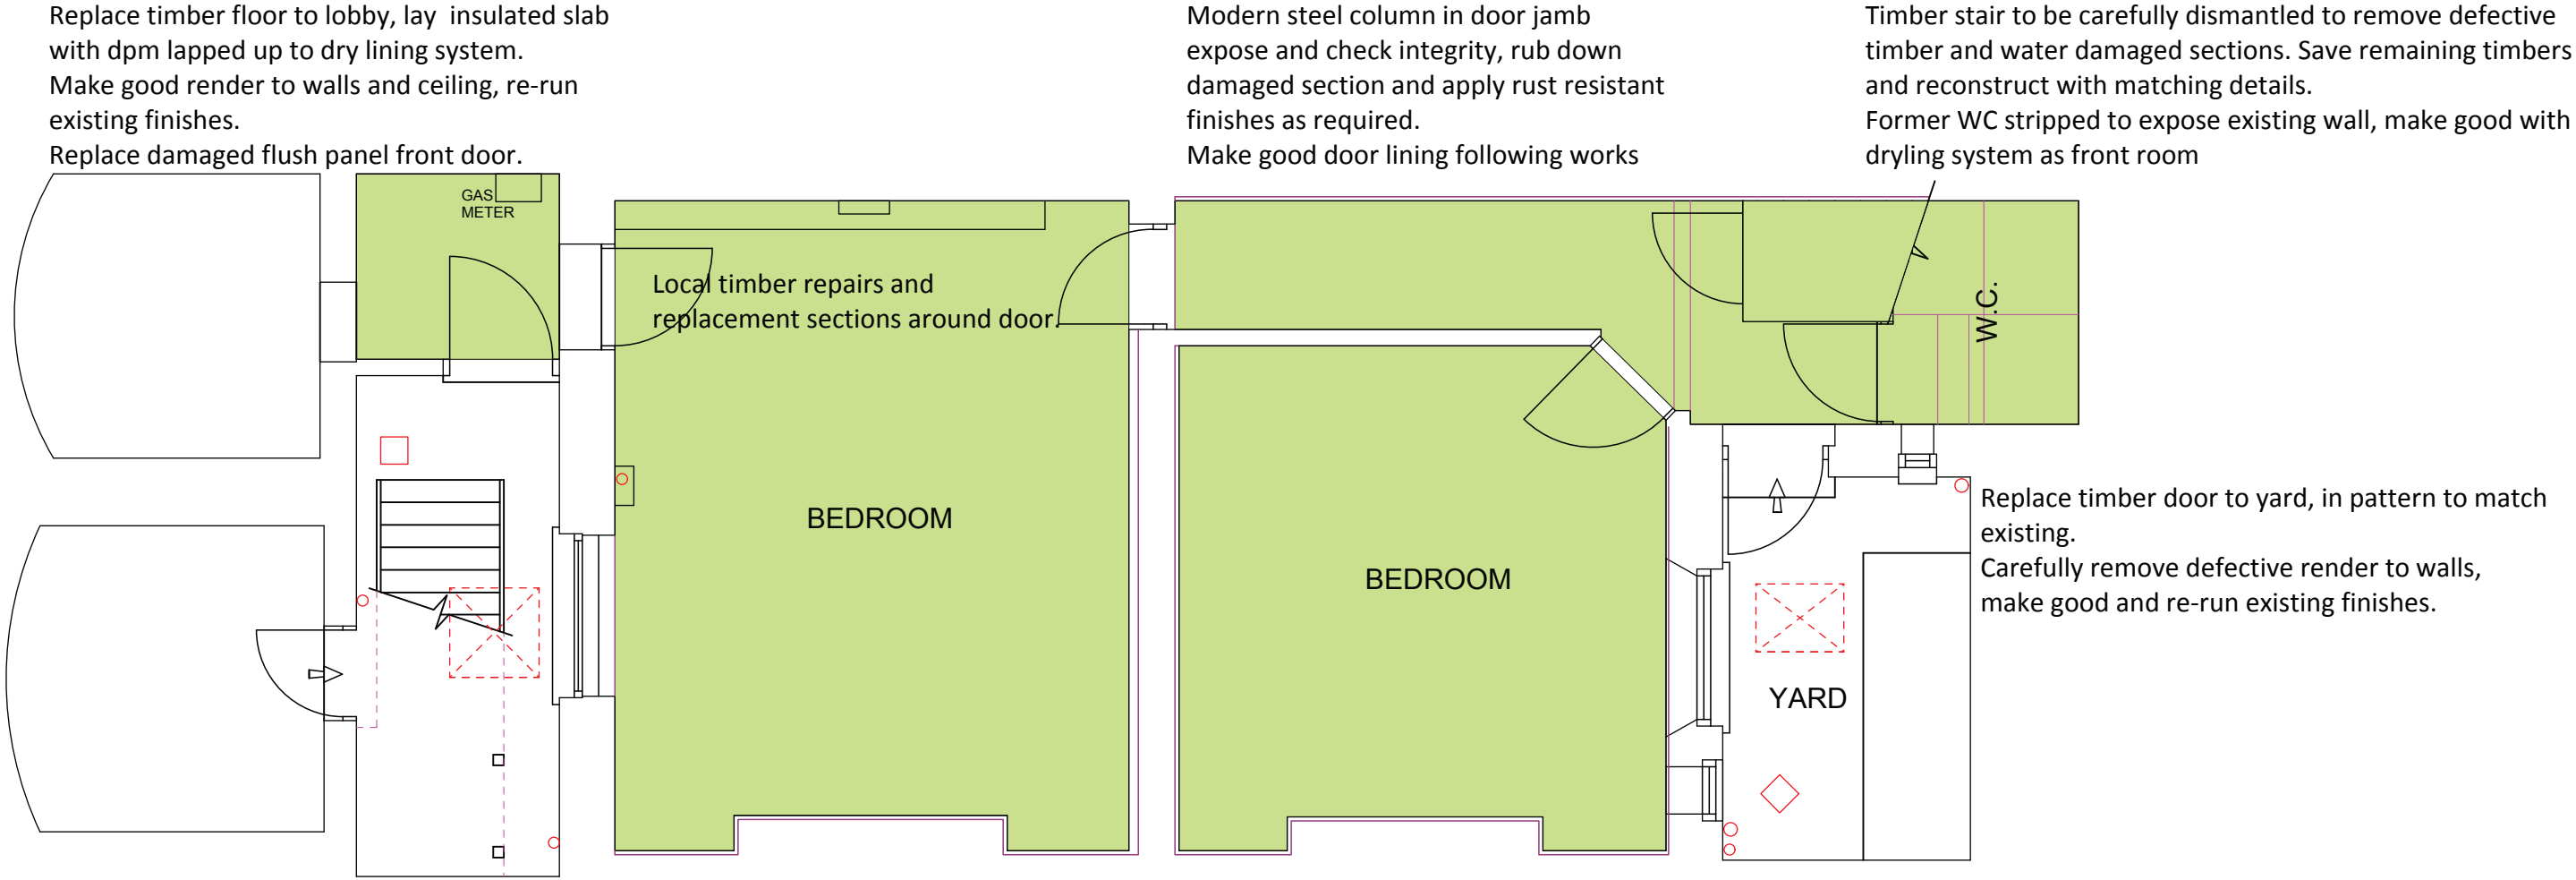
Carefully strip out all electrical, water and gas services. Include timber boxing.
Remove all water damaged lath & plaster + plasterboard ceilings fitted in basement.
Remove damaged MDF & sw joinery.
Replace doors with timber panelled doors as existing pattern.
Replace architrave and skirting boards to existing pattern.

Modern Dry lining system removed.
Carefully remove plugs and voids from walls.
Make good brickwork and prepare for replacement dry lining system.
Lift concrete slab, reduce levels and install integrated floor/wall drain system to dry lining.
