| Luard Conservation<br>67 Salford Avenue<br>London NW10 4EP<br>+44 (0)20 8061 7544<br>+44 (0)7963 741 117<br>info@luard-conservation.com | The Elms, Fitzroy Park | | |
| | EW/G.21 | | |

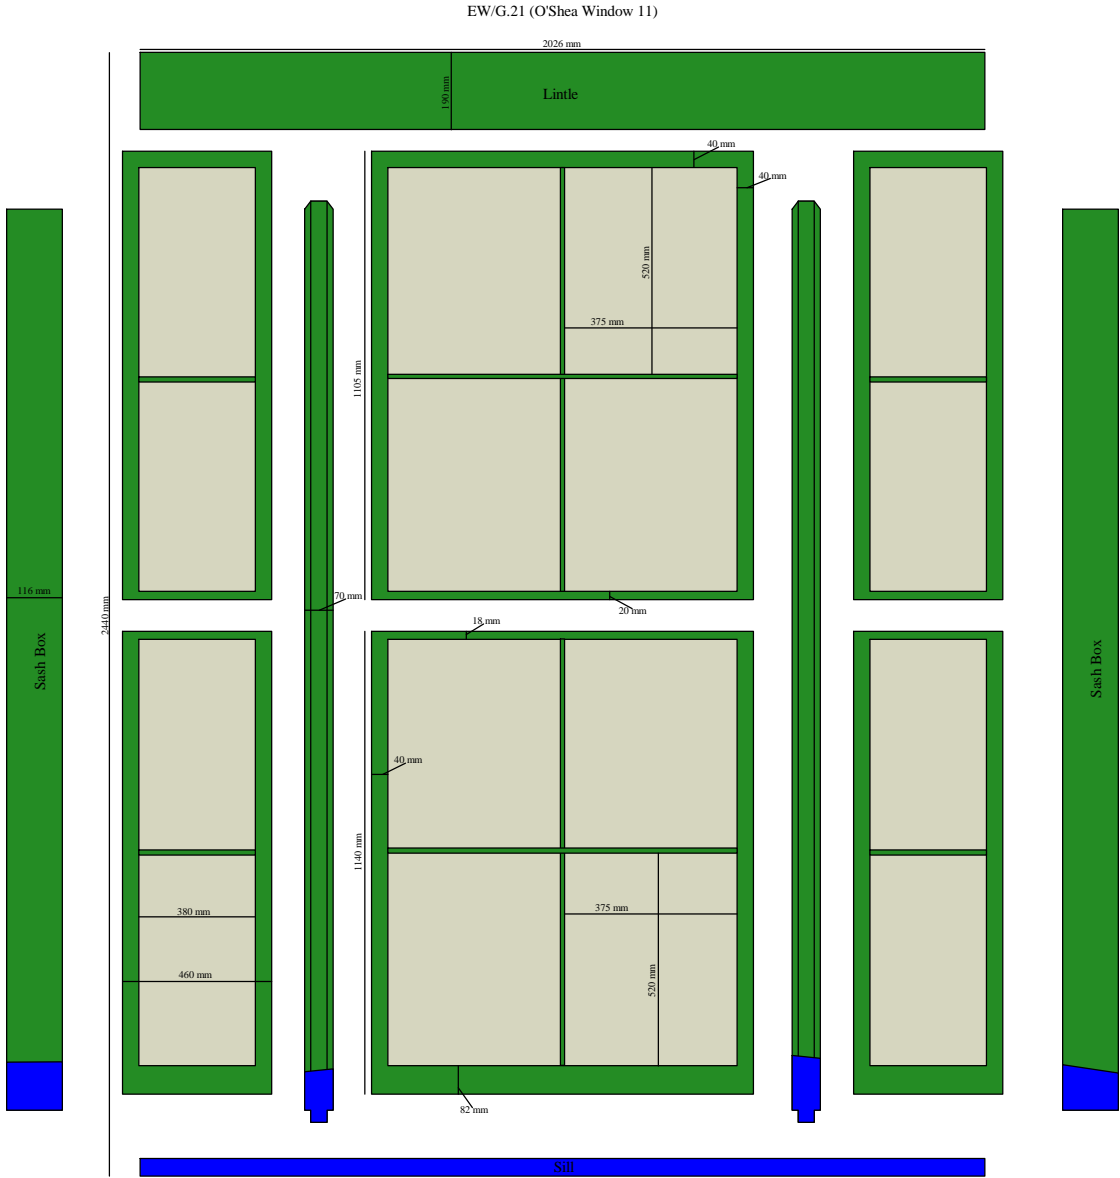
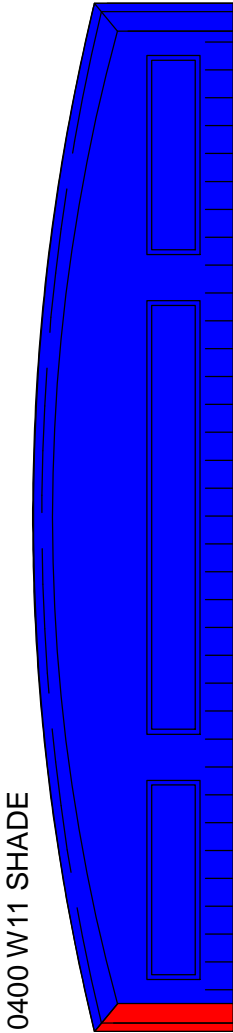
Missing timber

Existing timber requiring refurbishment

Timber recommended to be replaced

The shade to EW/G.21 exists but is in bad condition and will require substantial repair and replacement.
