EW/G.19 (O'Shea Window 13)

Luard Conservation 67 Selloms Avenue London NW10 4HJ +44 (0)20 8961 7544 +44 (0)7963 741 117 info@luardconservation.com	The Elms, Fitzroy Park		
	EW/G.19		
	NOT TO SCALE

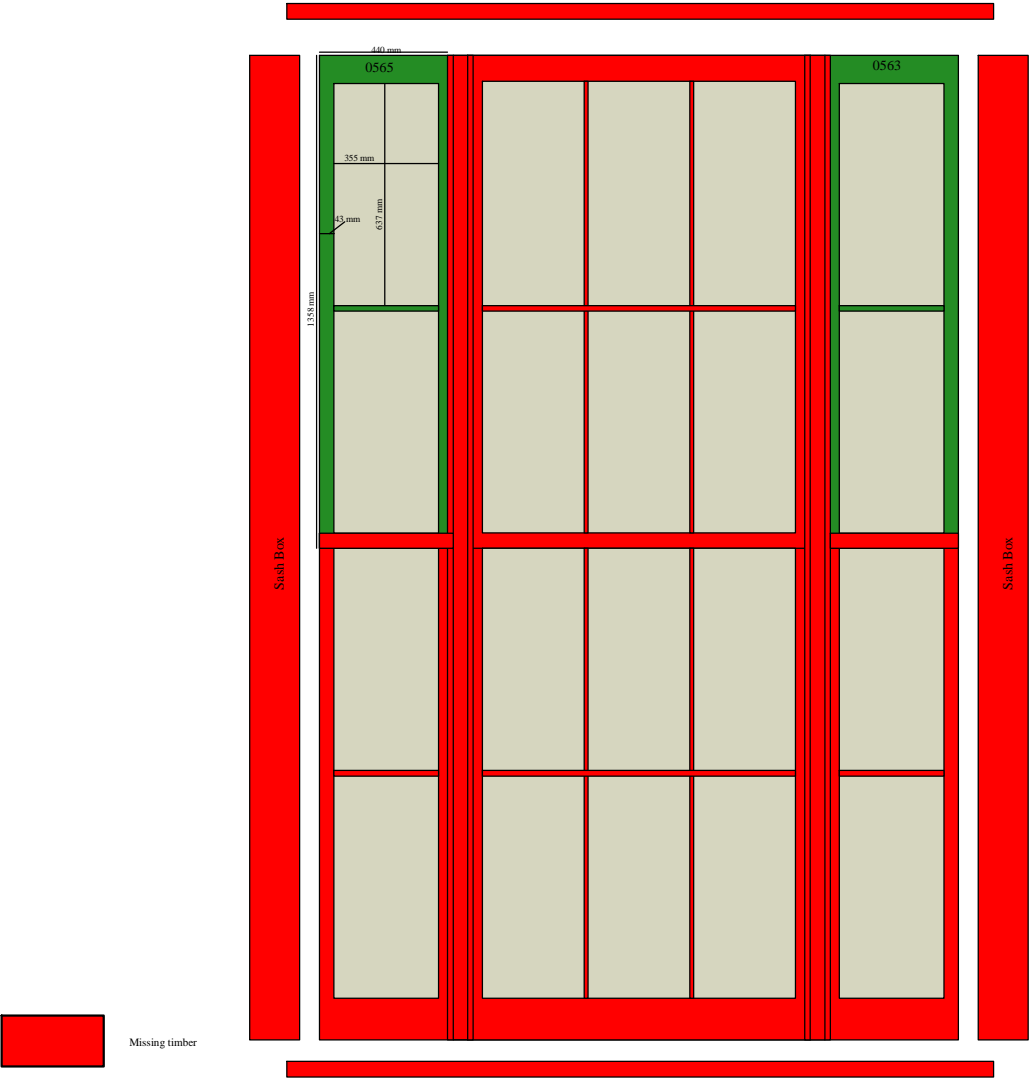
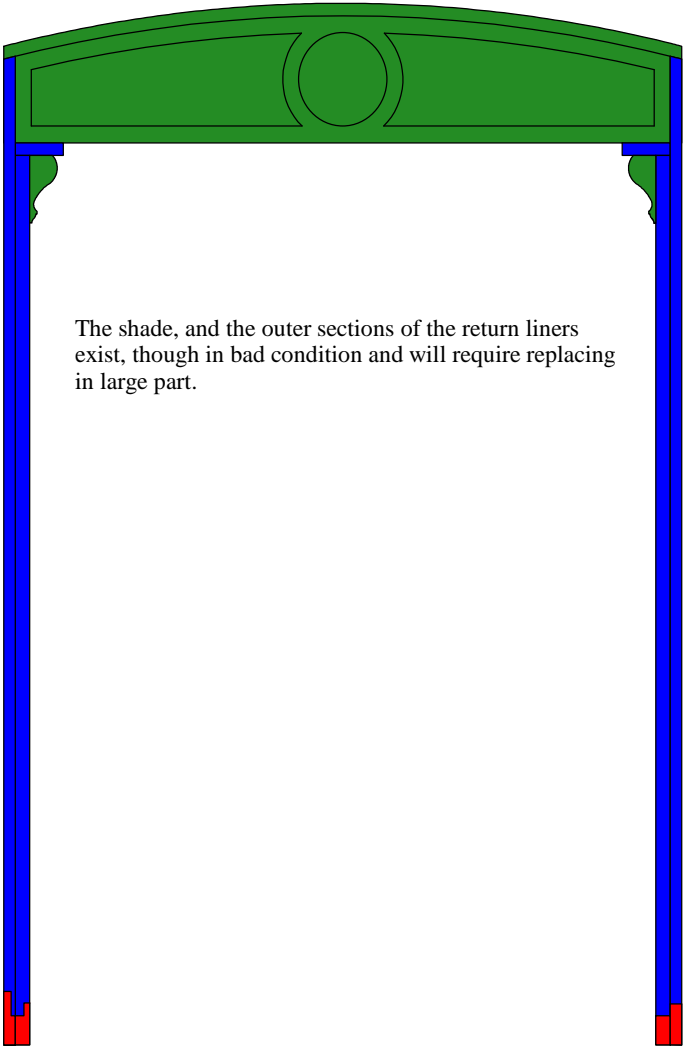
Missing timber

Existing timber requiring refurbishment

Timber recommended to be replaced

The shade, and the outer sections of the return liners exist, though in bad condition and will require replacing in large part.
