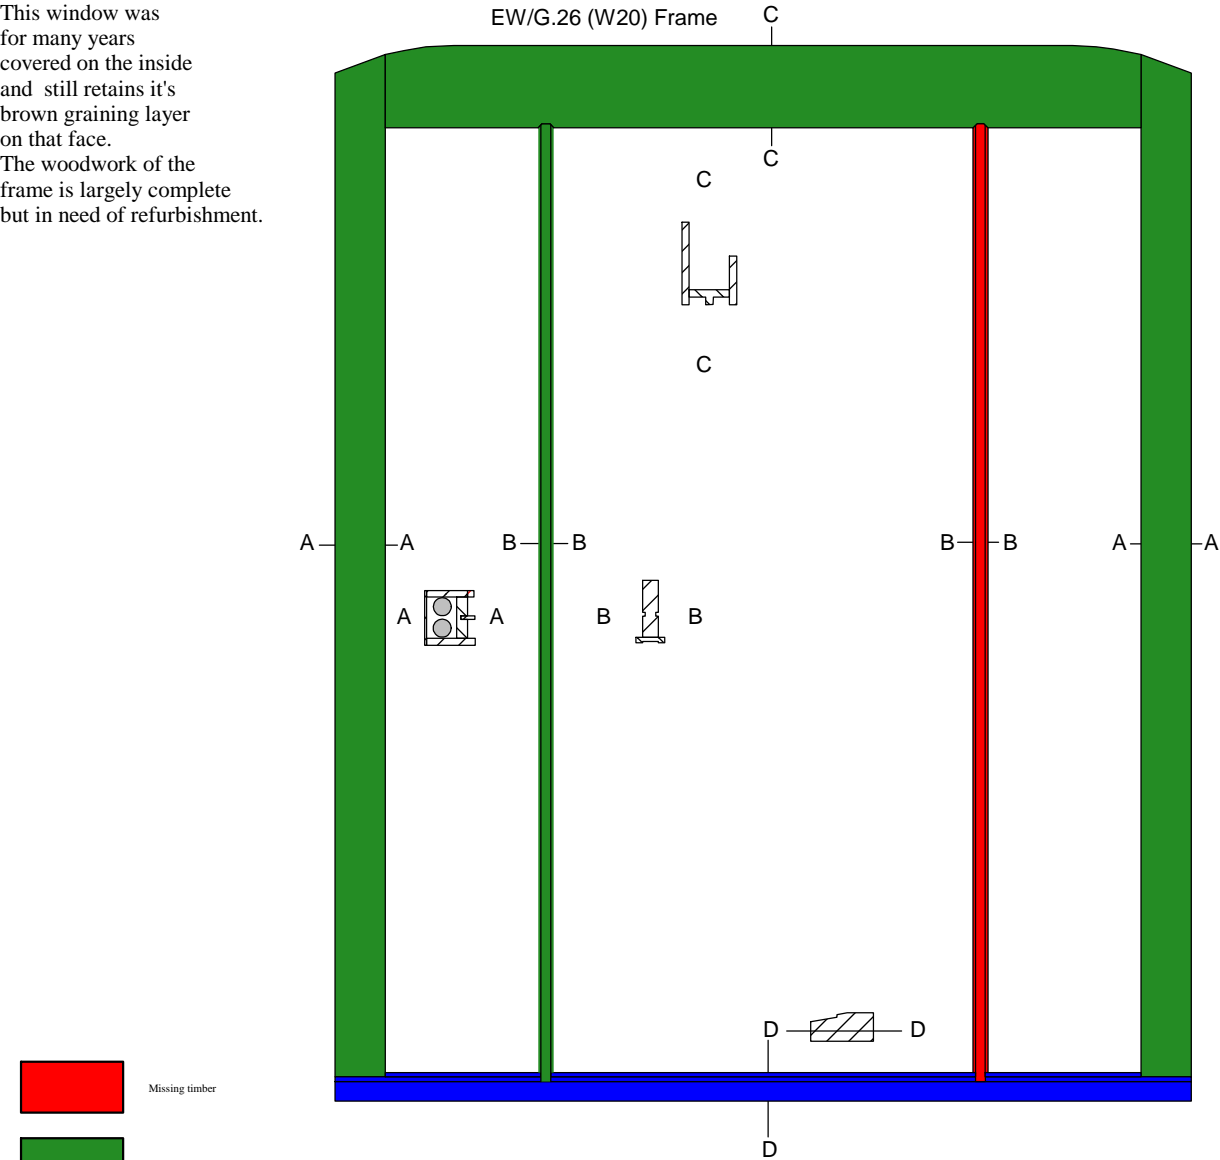
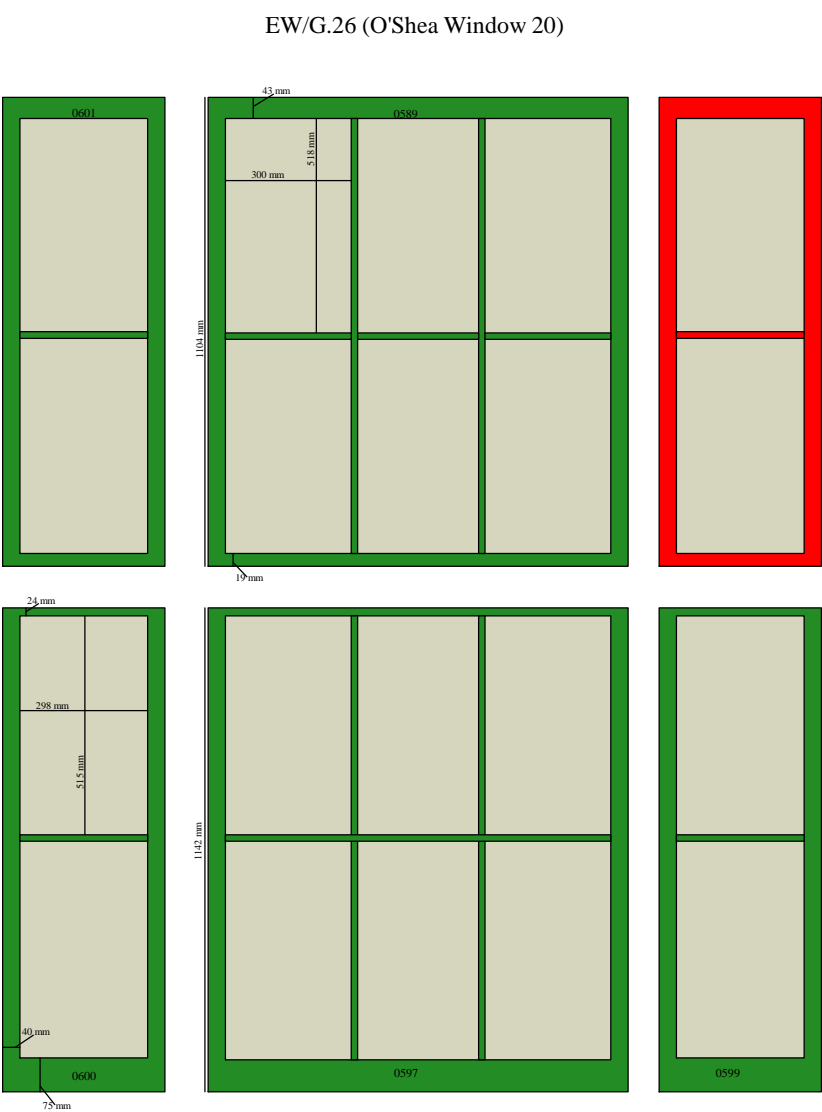
This window was for many years covered on the inside and still retains it's brown graining layer on that face. The woodwork of the frame is largely complete but in need of refurbishment.
