## LINCOLN'S INN GAZETTEER

**Section:** NEW SQUARE

**Location:** 8 NEW SQUARE

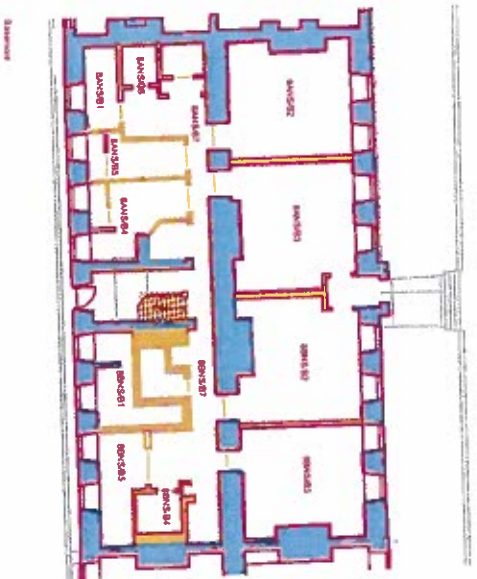
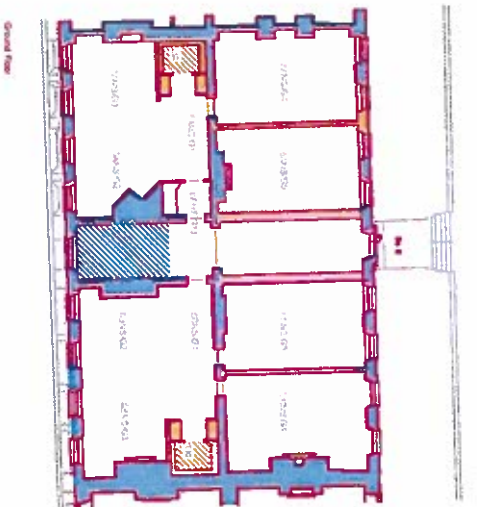
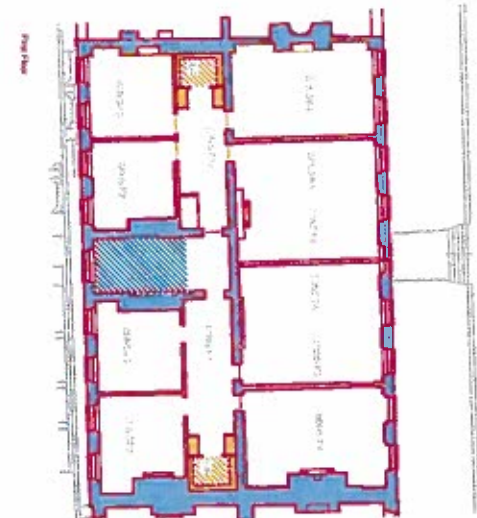
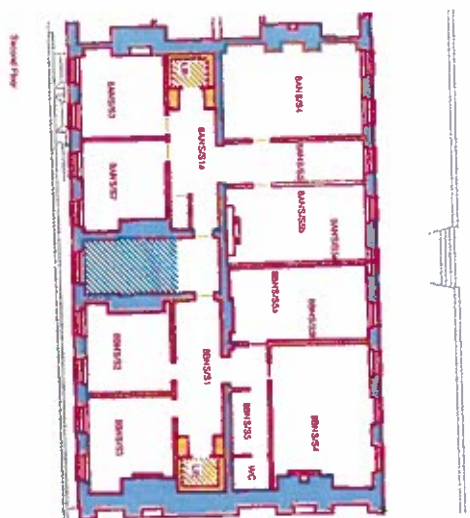
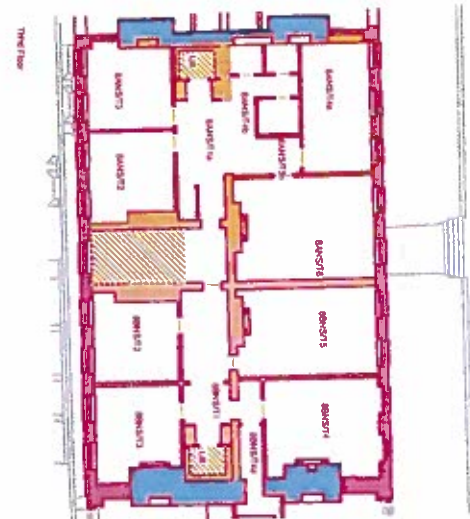
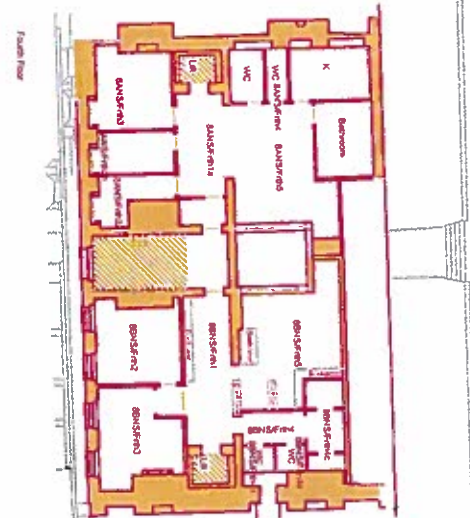
1. Basement as existing.
2. Ground floor as existing.
3. First floor as existing.
4. Second floor as existing.
5. Third floor as existing.
6. Fourth floor as existing.
