6214-FS26-P08

26 FREDERICK STREET, LONDON WC1X 0ND

PROPOSED RESTORED FRONT ELEVATION

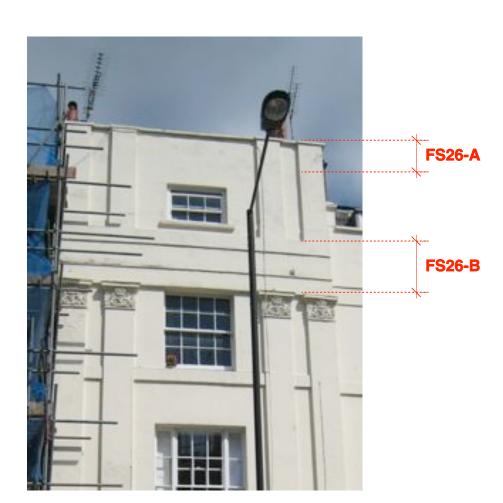
26 FREDERICK STREET FRONT ELEVATION

26 FREDERICK STREET - with incomplete entablature and missing cornice

No.26 3rd floor with paired pilaster strips rising to the top of the parapet and flanking a C20 window. (Nos 12 & 18 3rd floors with paired pilasters flanking recessed sashes and carrying cornice and blocking course).

Paired pilasters with enriched capitals rise through 1st and 2nd floors to support a simplified entablature at 3rd floor level (no cornice).

1st floor window with cast-iron balcony and tripartite sash.

2nd floor, recessed sash with sill band.

Rusticated stucco ground floor and plain stucco 1st floor sill bands. Square-headed doorway with panelled jamb, cornice-head, fanlight and panelled door.

FS26-A: MISSING CORNICE & BLOCKING COURSE - TO BE RESTORED IN GLASS REINFORCED CONCRETE (PROFILE TO MATCH FS18-A)

MATCH FS18-A)
FS26-B: INCOMPLETE ENTABLATURE - TO
BE RESTORED IN GLASS REINFORCED
CONCRETE (PROFILE TO MATCH FS18-B)

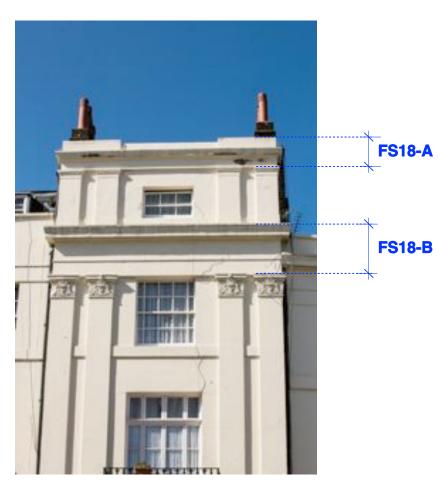
18 FREDERICK STREET

FS18-A: ORIGINAL CORNICE & BLOCKING COURSE

FS18-B: ORIGINAL ENTABLATURE
