SITE INVESTIGATION & BASEMENT IMPACT ASSESSMENT REPORT

4 Wedderburn Road London NW3

Client:	Amanda Shorthouse
Engineer:	Heyne Tillett Steel
J14267	
November 20	14

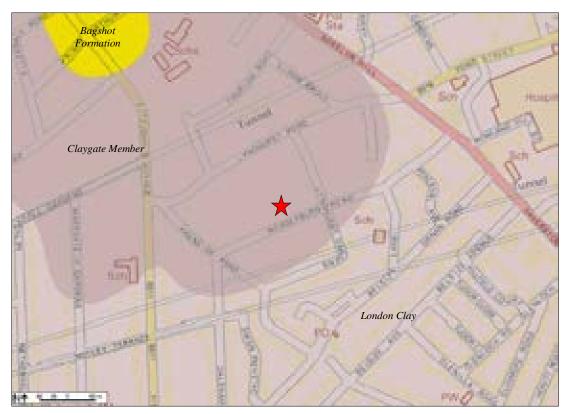
The British Geological Survey (BGS) map of the area (Sheet 256) indicates that the site is underlain by the Claygate Member, overlying the London Clay. According to the geology map, the boundary between the Claygate Member and London Clay is located approximately 60 m to the southeast of the site. An extract from Findmaps is included below, indicating the location of the site with respect to the geological boundaries.

The geology in this area is generally approximately horizontally bedded, such that the boundary between the geological formations roughly follows the ground surface contours lines.

The boundary between the Claygate Member and London Clay can however be very difficult to determine as it is a gradational contact with close similarities in composition and geotechnical properties between the Claygate Member and underlying Unit D of the London Clay.
