Expansion of Kingsgate Primary School and Redevelopment of Liddell Road

Geotechnical Study

GROUND INVESTIGATION REPORT

Proposed Kingsgate School
Liddell Road
London
NW6 2EW

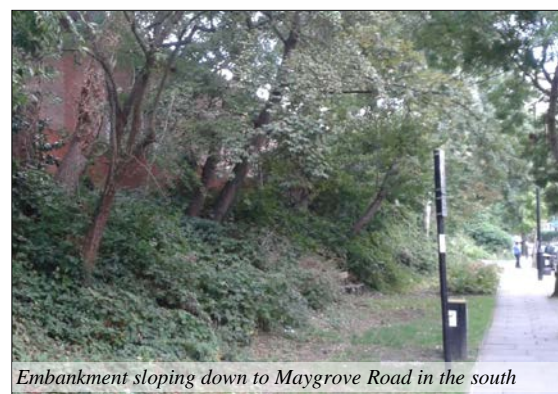
Embankment sloping down to Maygrove Road in the south

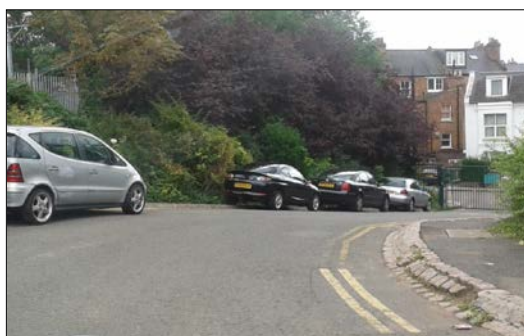
Access to Liddell Road sloping down to Maygrove Road in the southeast

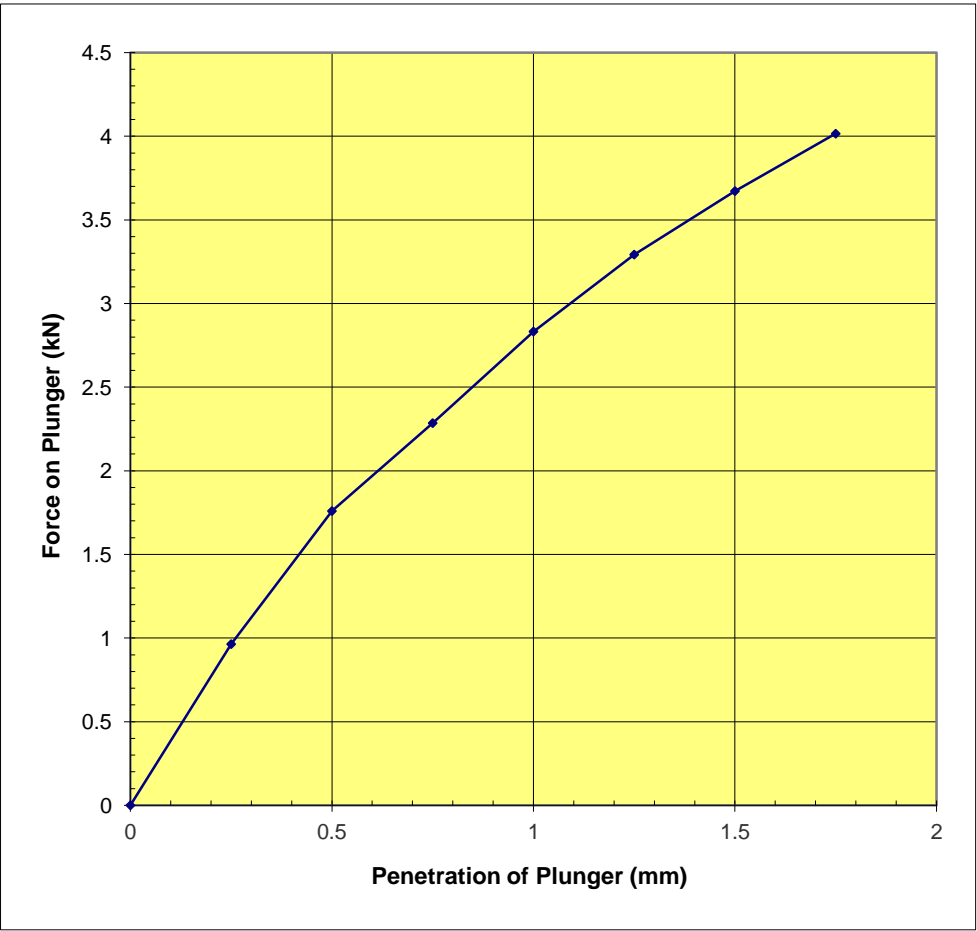
Penetration of Plunger mm	Force on Plunger	
	Dial Reading	Load kN
0	0	0
0.25	132	0.96
0.50	241	1.76
0.75	313	2.28
1.00	388	2.83
1.25	451	3.29
1.50	503	3.67
1.75	550	4.02

RESULTS:

Moisture content (%)	11	Penetration mm	Force kN	Standard Force kN	CBR %
		2.5	-	13.2	-
In-situ CBR value %	>30	5	-	20	-

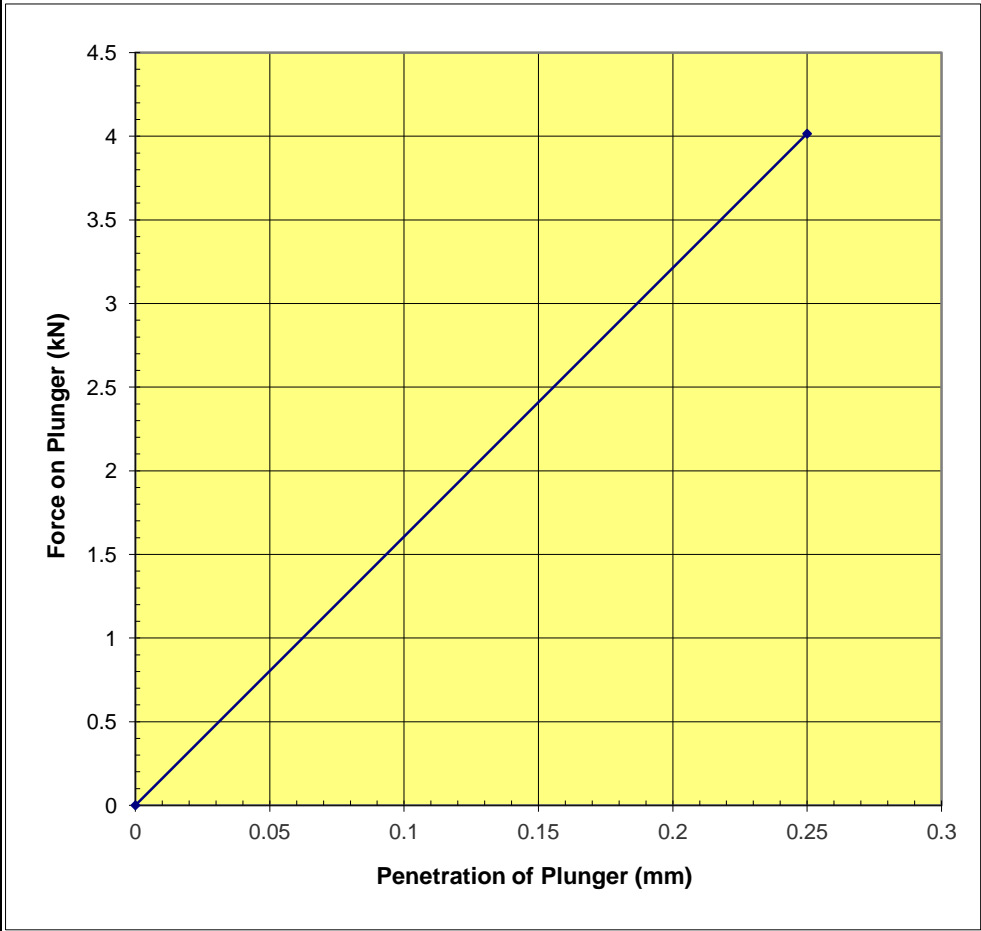
Penetration of Plunger mm	Force on Plunger	
	Dial Reading	Load kN
0	0	0
0.25	550	4.02

RESULTS:

Moisture content (%) 12		Penetration mm	Force kN	Standard Force kN	CBR %
		2.5	-	13.2	-
In-situ CBR value % >30		5	-	20	-
