**Camden Stable Market
Provender Stores**

Drawing Title
**PROVENDER STORES
UNAUTHORISED REMEDIAL WORKS
-Proposed Ground floor single door**

December 2014 Drawing No
B-WP-01

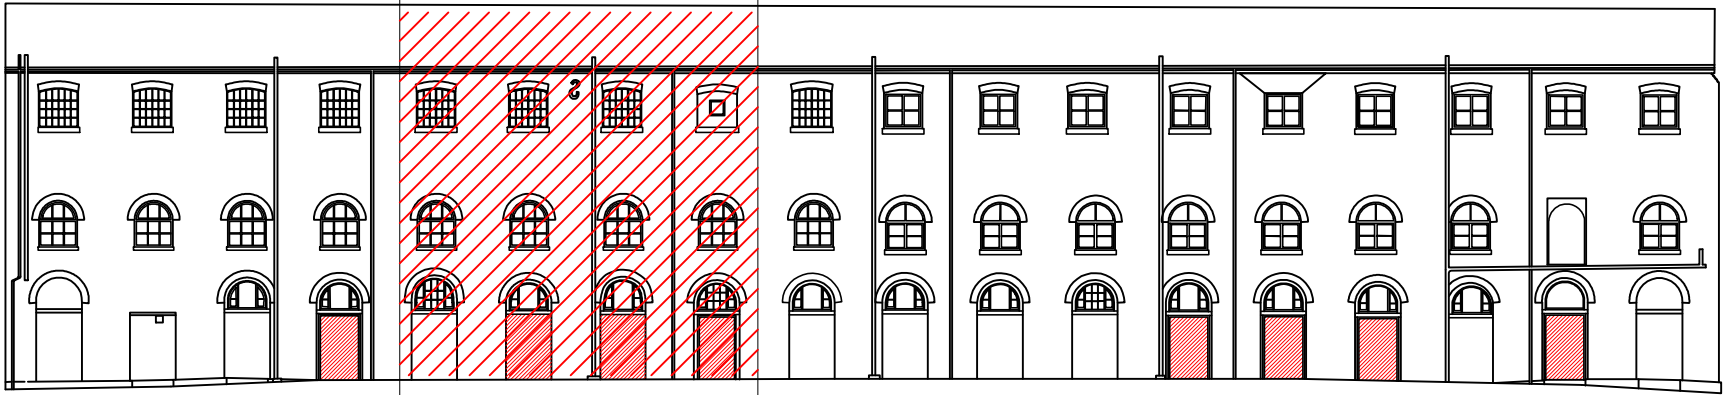
SOUTH ELEVATION
Windows of this type highlighted in red are proposed to be altered as part of this application. Those not hatched are to be refurbished. The hatched area is that part of the building affected by fire damage.

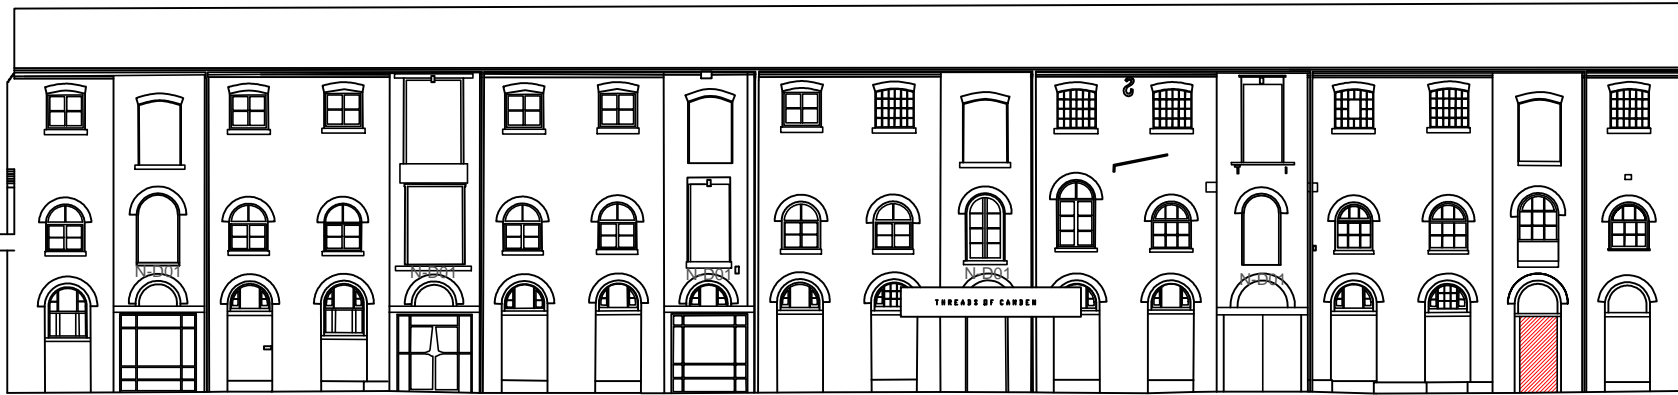
NORTH ELEVATION
Windows of this type highlighted in red are proposed to be altered as part of this application. Those not hatched are to be refurbished.

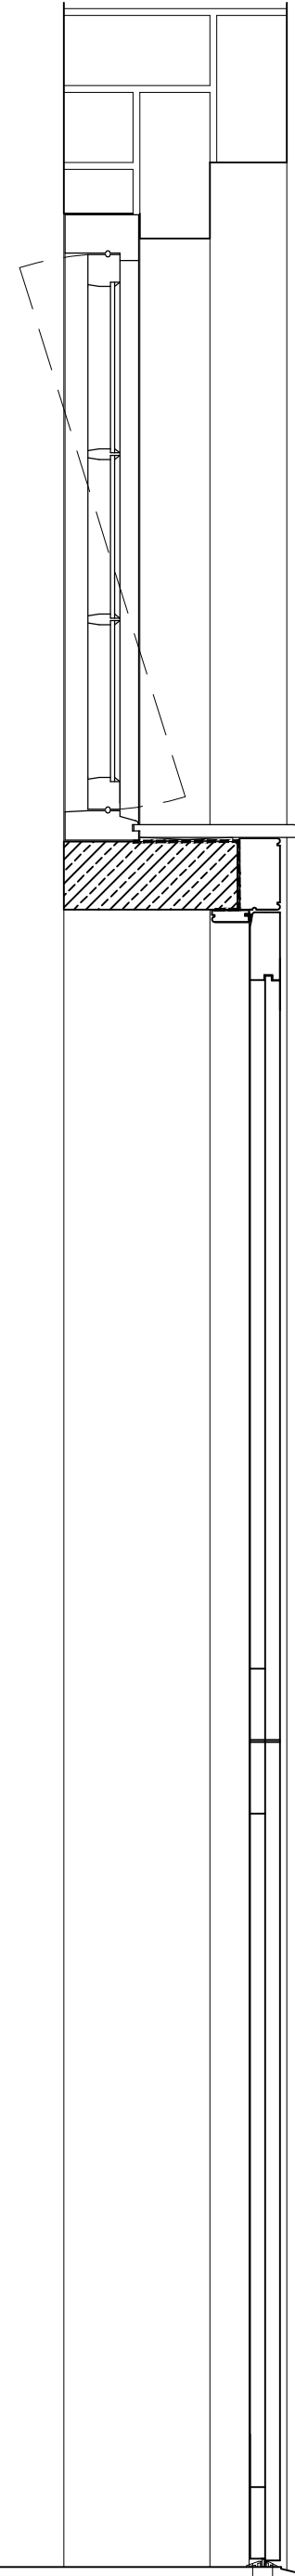
Section

**Proposed Ground floor single door -
Scale 1:10**

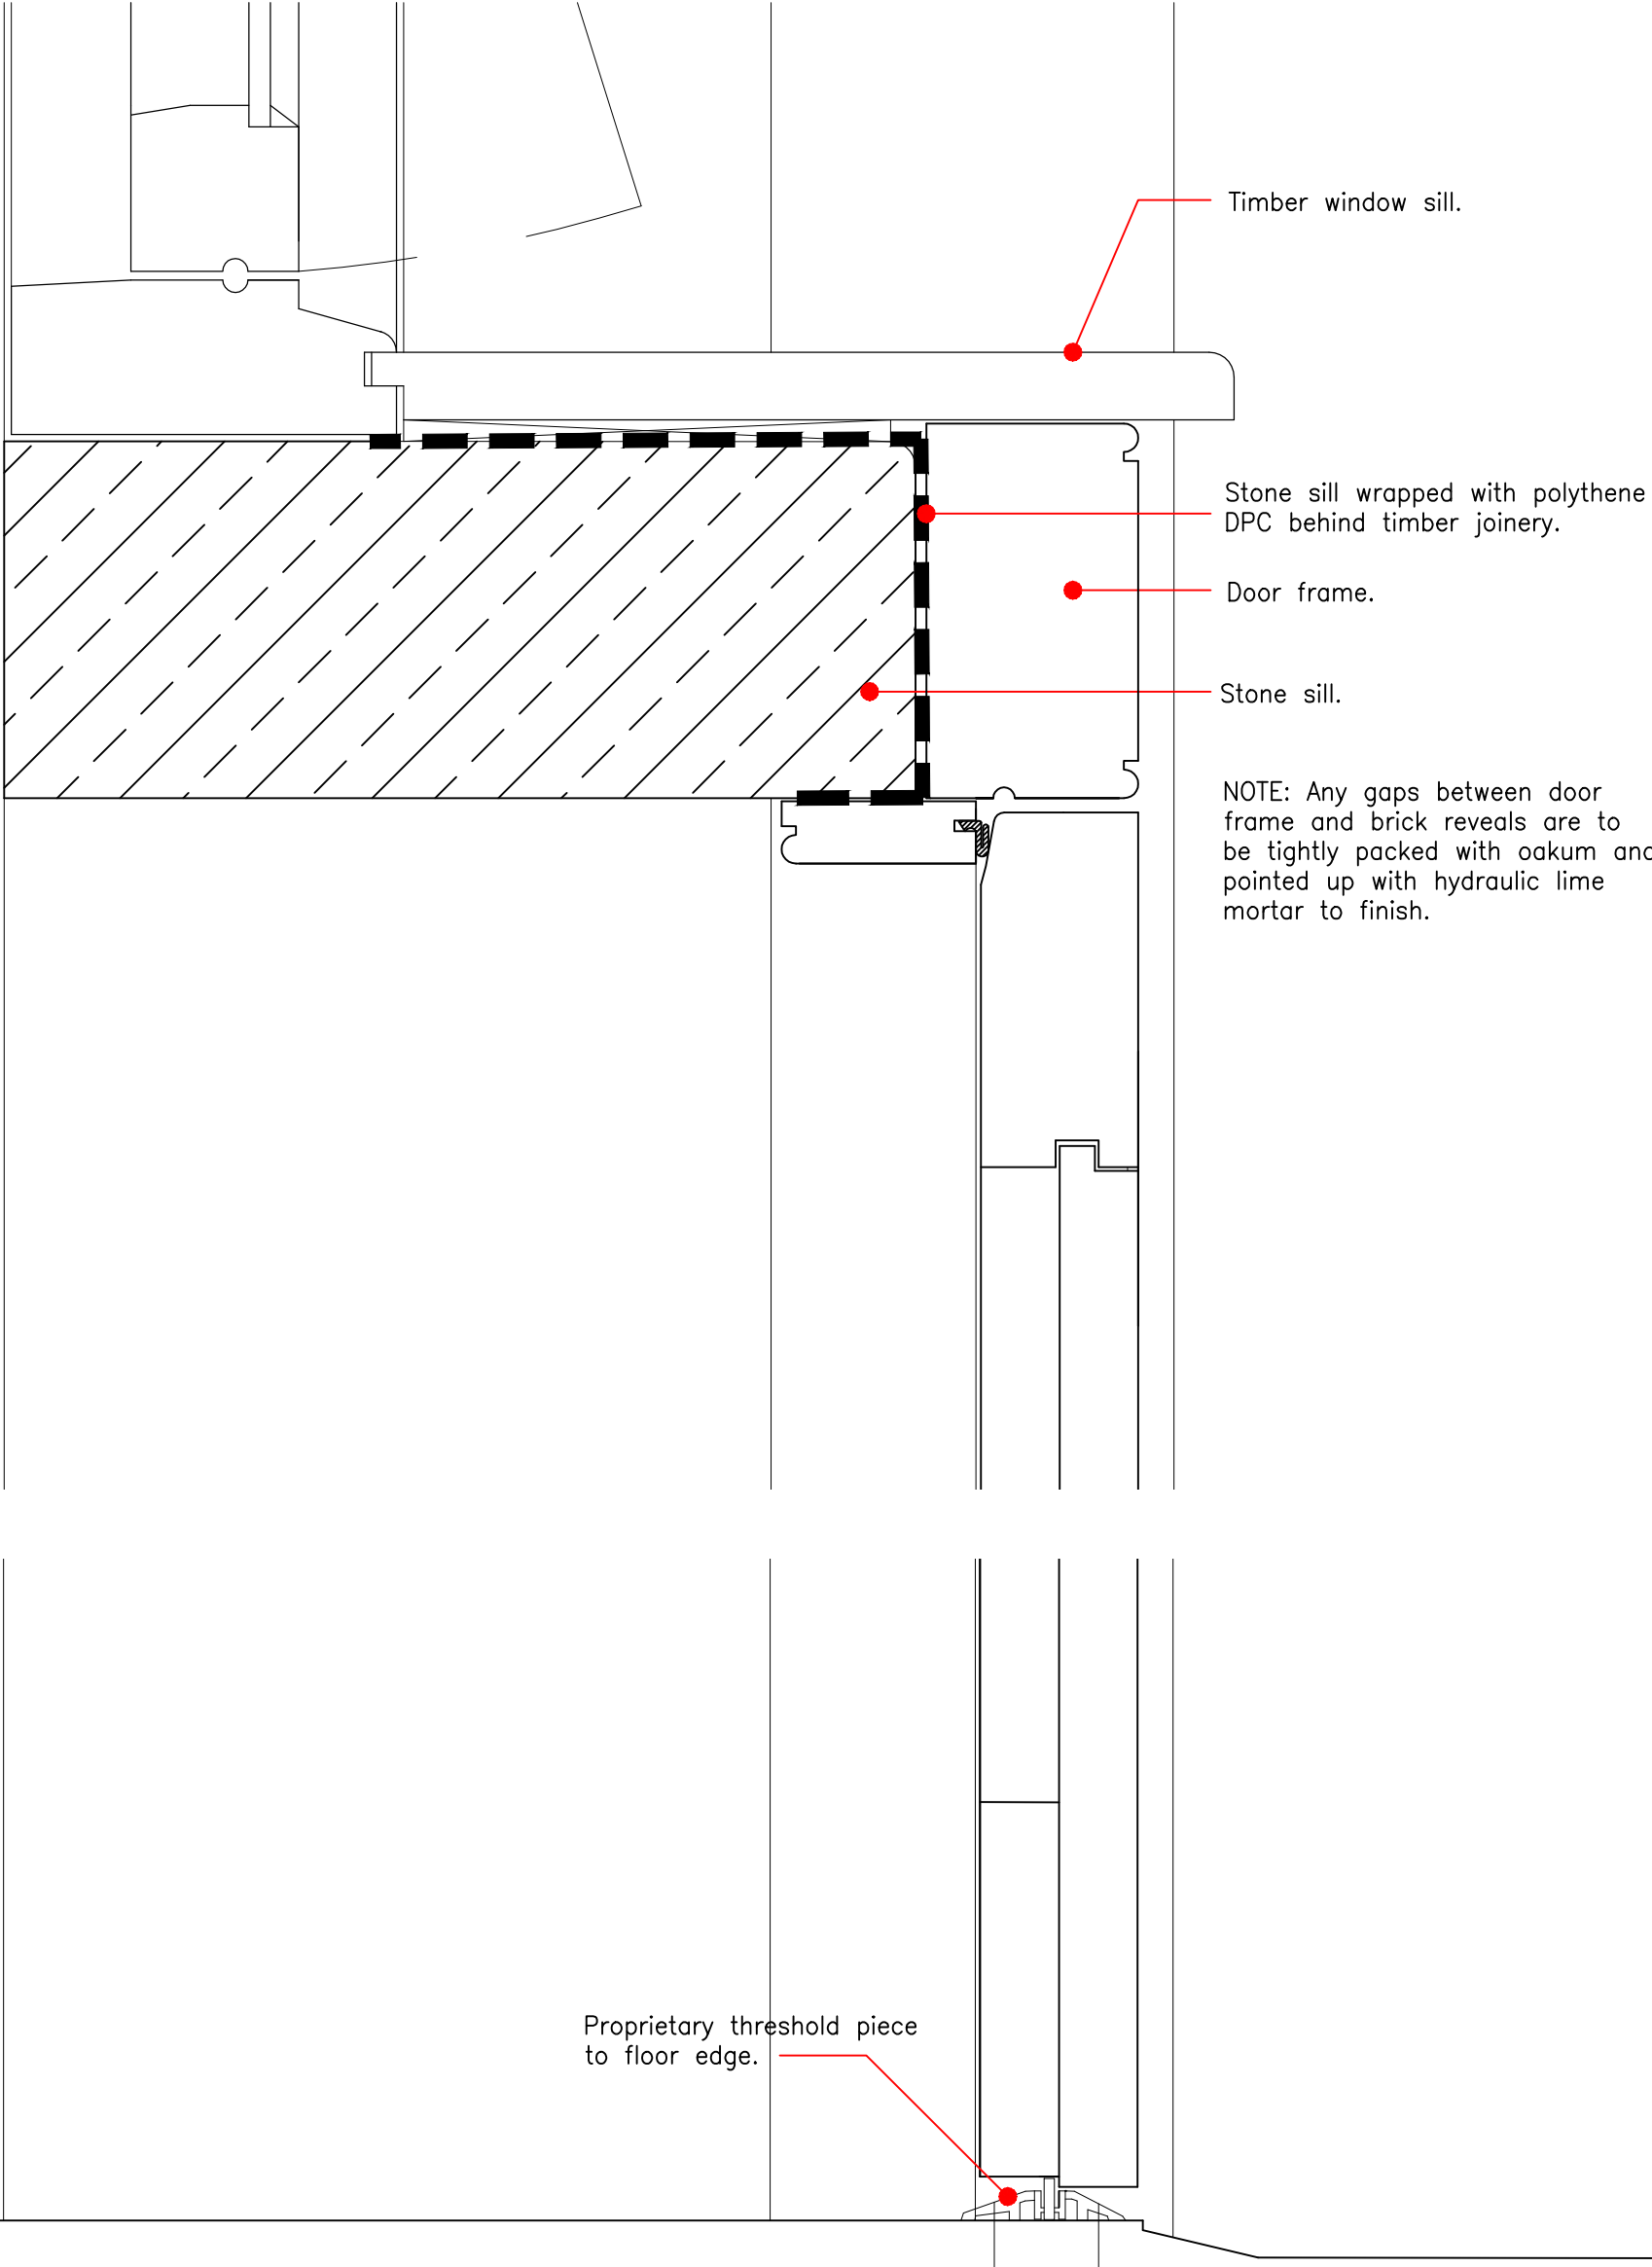
Note:
Window profiles are to match existing and to be agreed by design team prior to any manufacture following stripping of existing windows.

Note: All structural opening sizes to be checked and confirmed prior to any manufacture.
