# Basement Impact Assessment: 26 Lower Merton Rise

**(Surface Water and  
Groundwater)**

**Report reference:** 62274R1, January 2015

**Confidential**  
**Prepared by**  
**ESI Ltd**

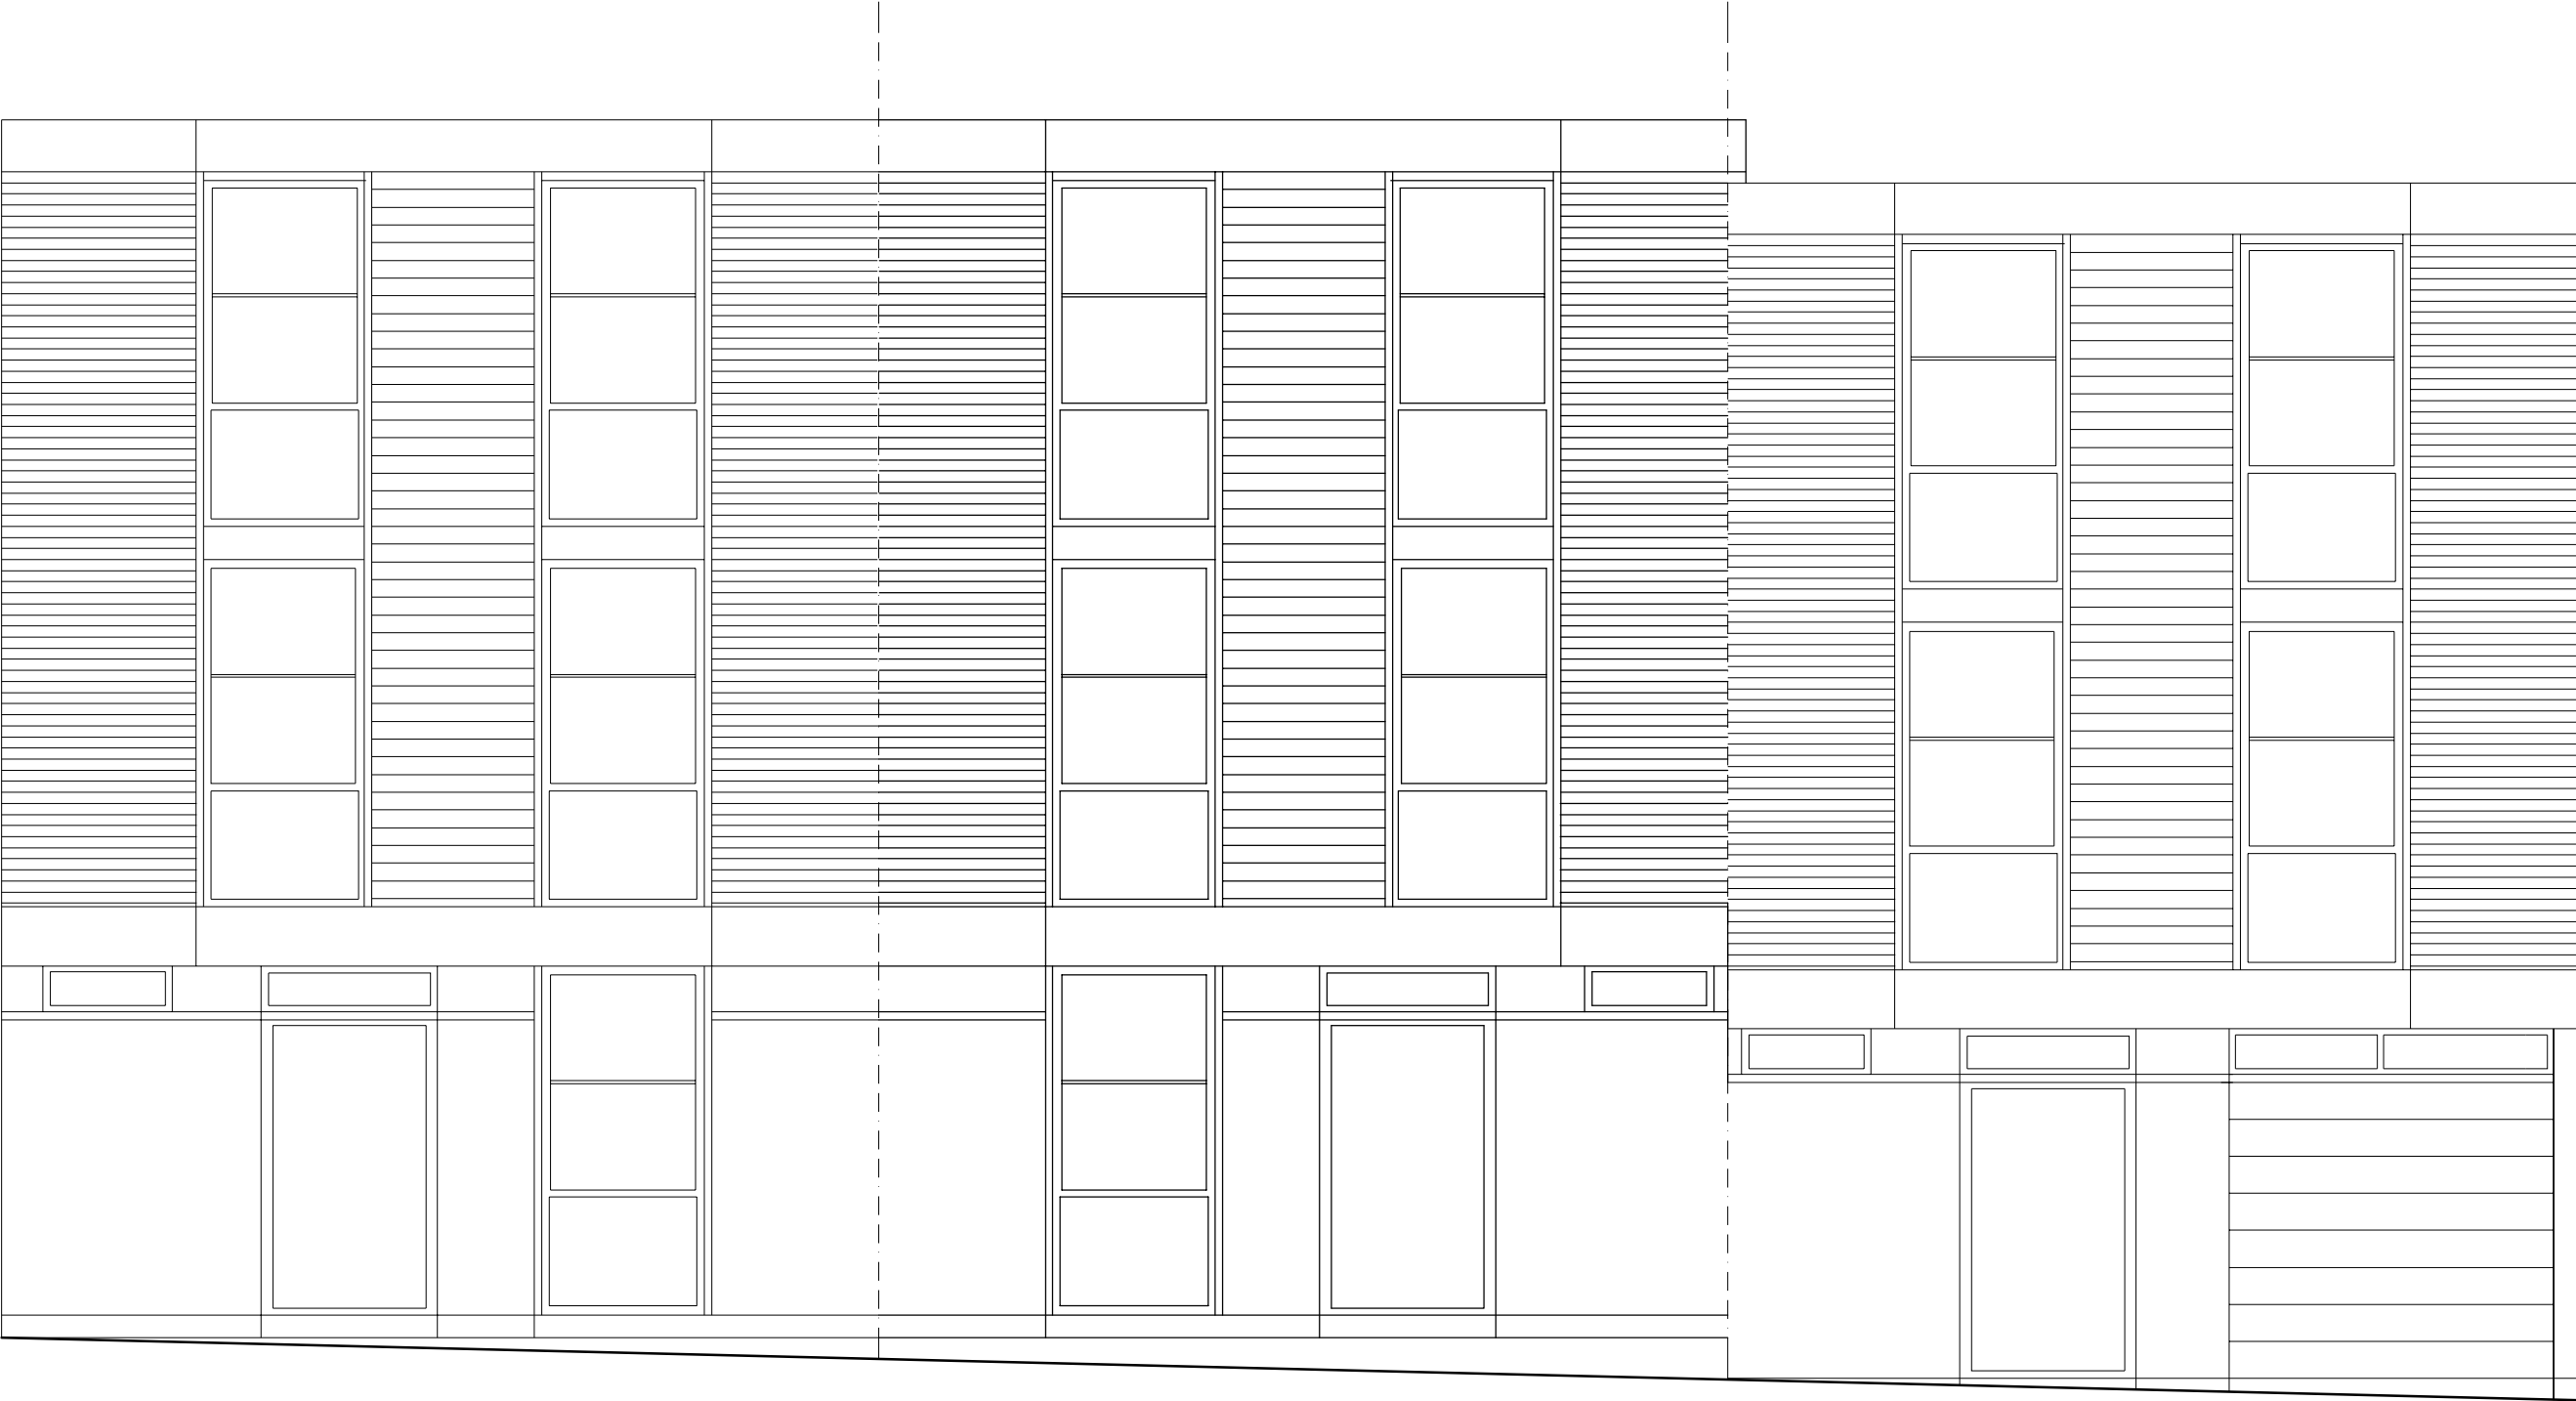
NEW WINDOW AT  
GROUND LEVEL

DO NOT SCALE FROM THIS DRAWING THIS DRAWING IS COPYRIGHT	REVISIONS:	PROJECT: 26 LOWER MERTON RISE LONDON NW3 3SP	Scale: 1:50 @ A3	Date: 14.10.13	KASIA WHITFIELD <i>Design Consultant</i>  Tel: 020 75869624 Mob: 07985 035333 email: KasiaWhitfield@gmail.com
		DRAWING TITLE: FRONT ELEVATION as Proposed	Dwg No: LMR26/2-PP1	Rev:

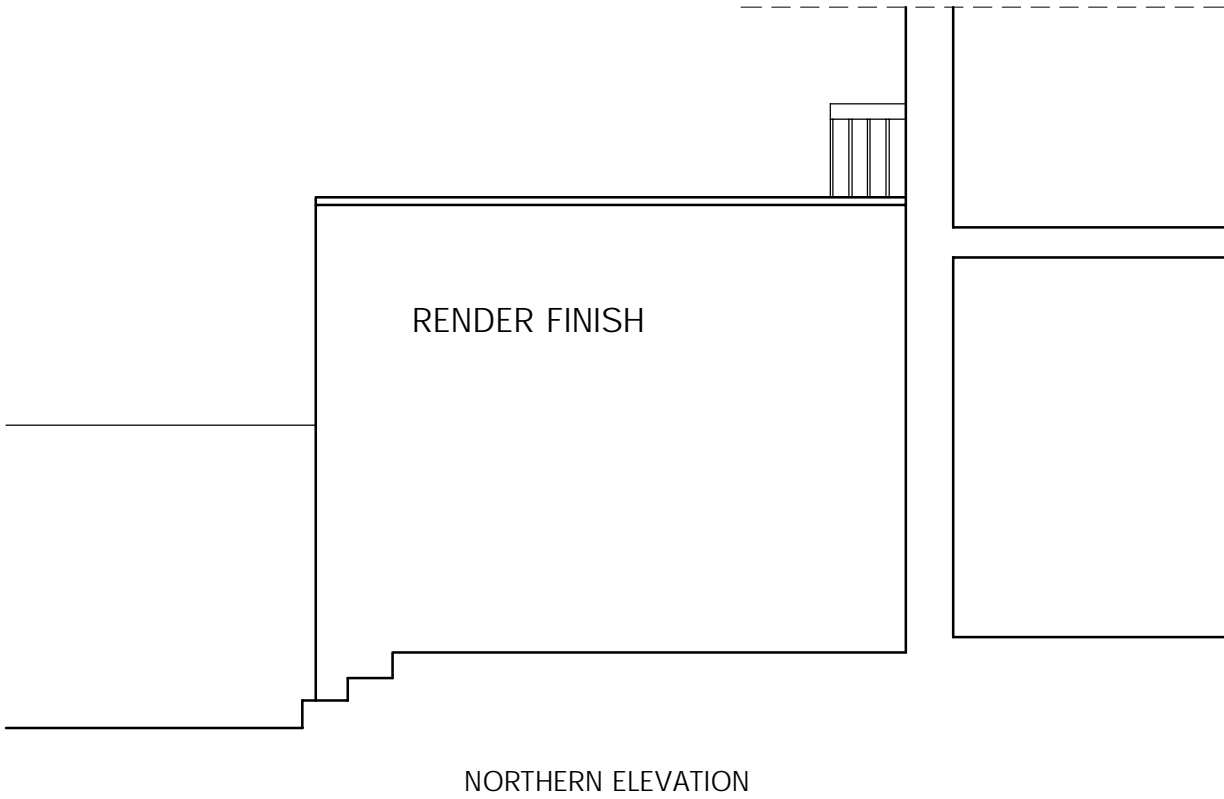
DO NOT SCALE FROM THIS DRAWING THIS DRAWING IS COPYRIGHT	REVISIONS:	PROJECT: 26 LOWER MERTON RISE LONDON NW3 3SP	Scale: 1:50 @ A3 1:100 @ A3	Date: 14.10.13	KASIA WHITFIELD <i>Design Consultant</i> Tel: 020 75869624 Mob: 07985 035333 email: KasiaWhitfield@gmail.com
		DRAWING TITLE: SIDE ELEVATIONS, ROOF PLAN as Proposed	Dwg No: LMR26/2-PP5	Rev:	
NOTES:

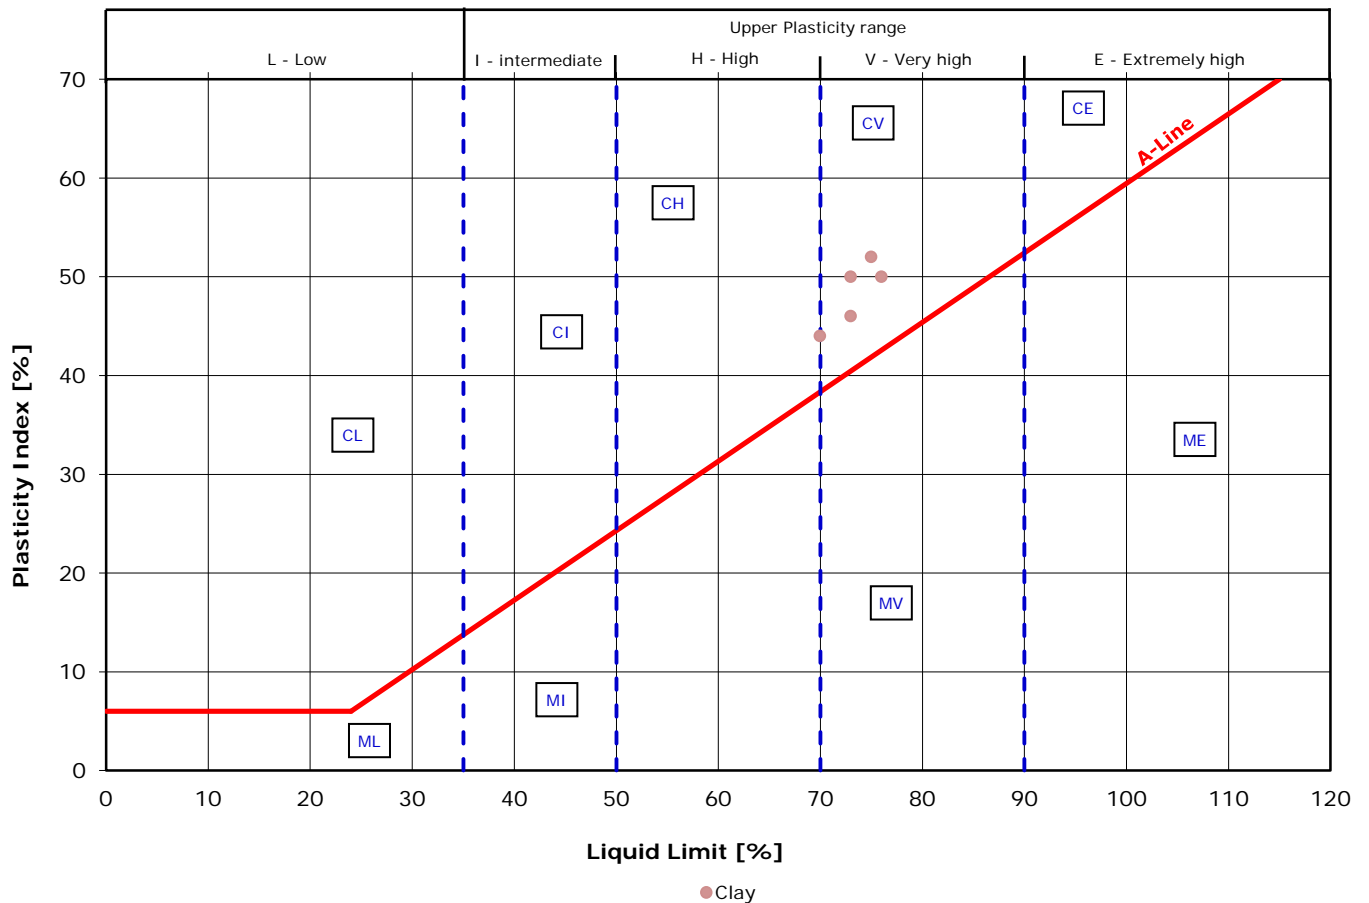
## Plasticity Chart

M - SILT [plots below the A-Line]  
C - CLAY [plots above the A-Line]

Classification in accordance with BS5930:1999+A2:2010 "Code of practice for site investigations"

Live rootlets were evident to depths of 2.10m in WS1 and 2.30m in WS2. Laboratory index testing has indicated the London Clay to be of a high to very high plasticity and **High** volume change potential [with reference to NHBC Chapter 4.2 'Building near trees']. Our laboratory index testing did not indicate any significant desiccation within the samples tested as the moisture contents were generally higher than the corresponding plastic limits.

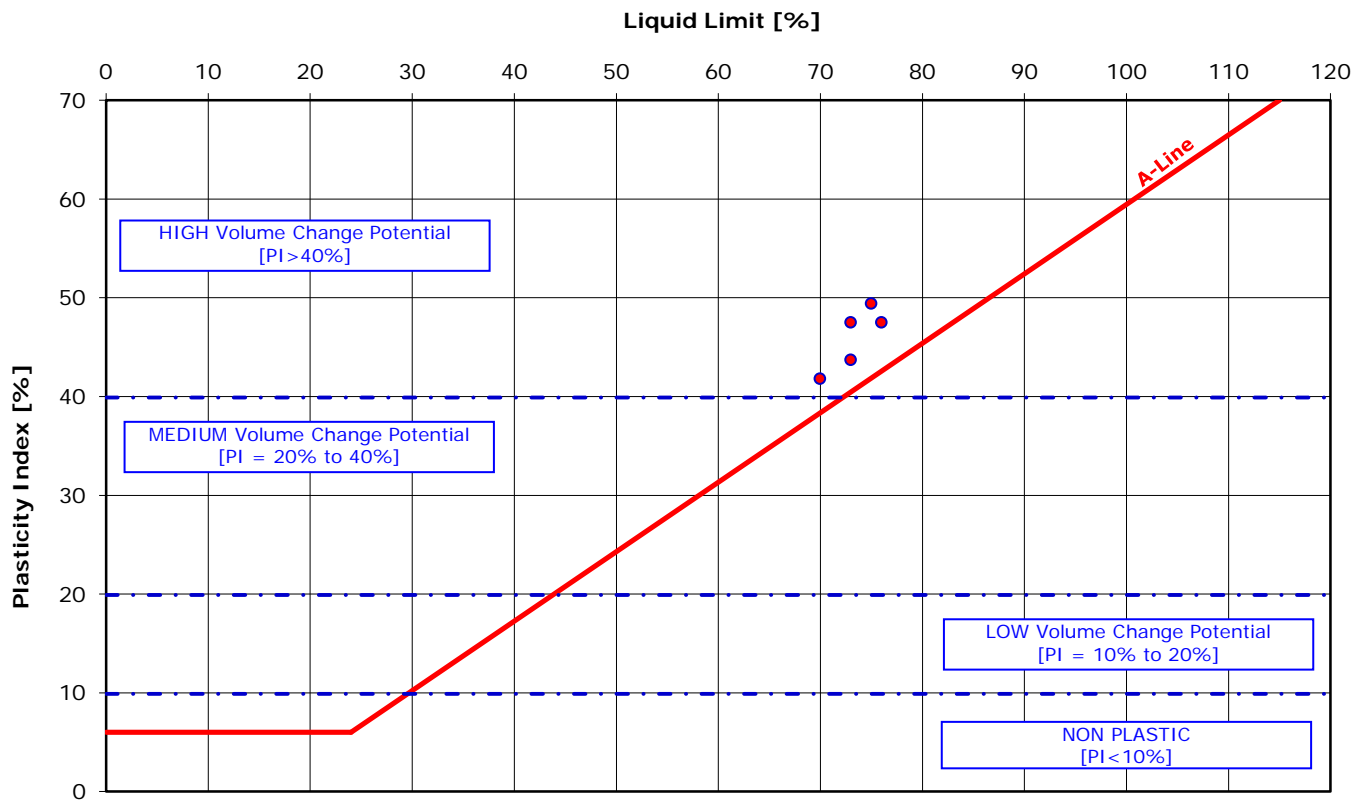
## Plasticity Chart

Modified Plasticity Index,  $I'_p$ :

$$I'_p = \frac{I_p \times (\% \text{ passing } 425\text{mm})}{100\%}$$

Classification in accordance with NHBC Standards, Part 4 'Foundations', Chapter 4.2 'Building near trees'
