ORIGINATOR davidmillerarchitects WWW.DAVID-MILLER.CO.UK	DRAWING TITLE BLOCK B - GREEN WALL DETAIL - LOCATION OF BIRD/BAT BOXES	JOB NO 335	STATUS FOR INFORMATION
JOB TITLE 159-161 IVERSON ROAD, WEST HAMPSTEAD, LONDON, NW6 2RB	SCALE As indicated @A1	DATE 09/29/14	CHECKED KM
PROJECT	ORIGIN	ZONE	LEVEL
IVR	DMA	ALL	ALL
TYPE	ROLE	SEQ NO	REV
DET	A3	22000	B

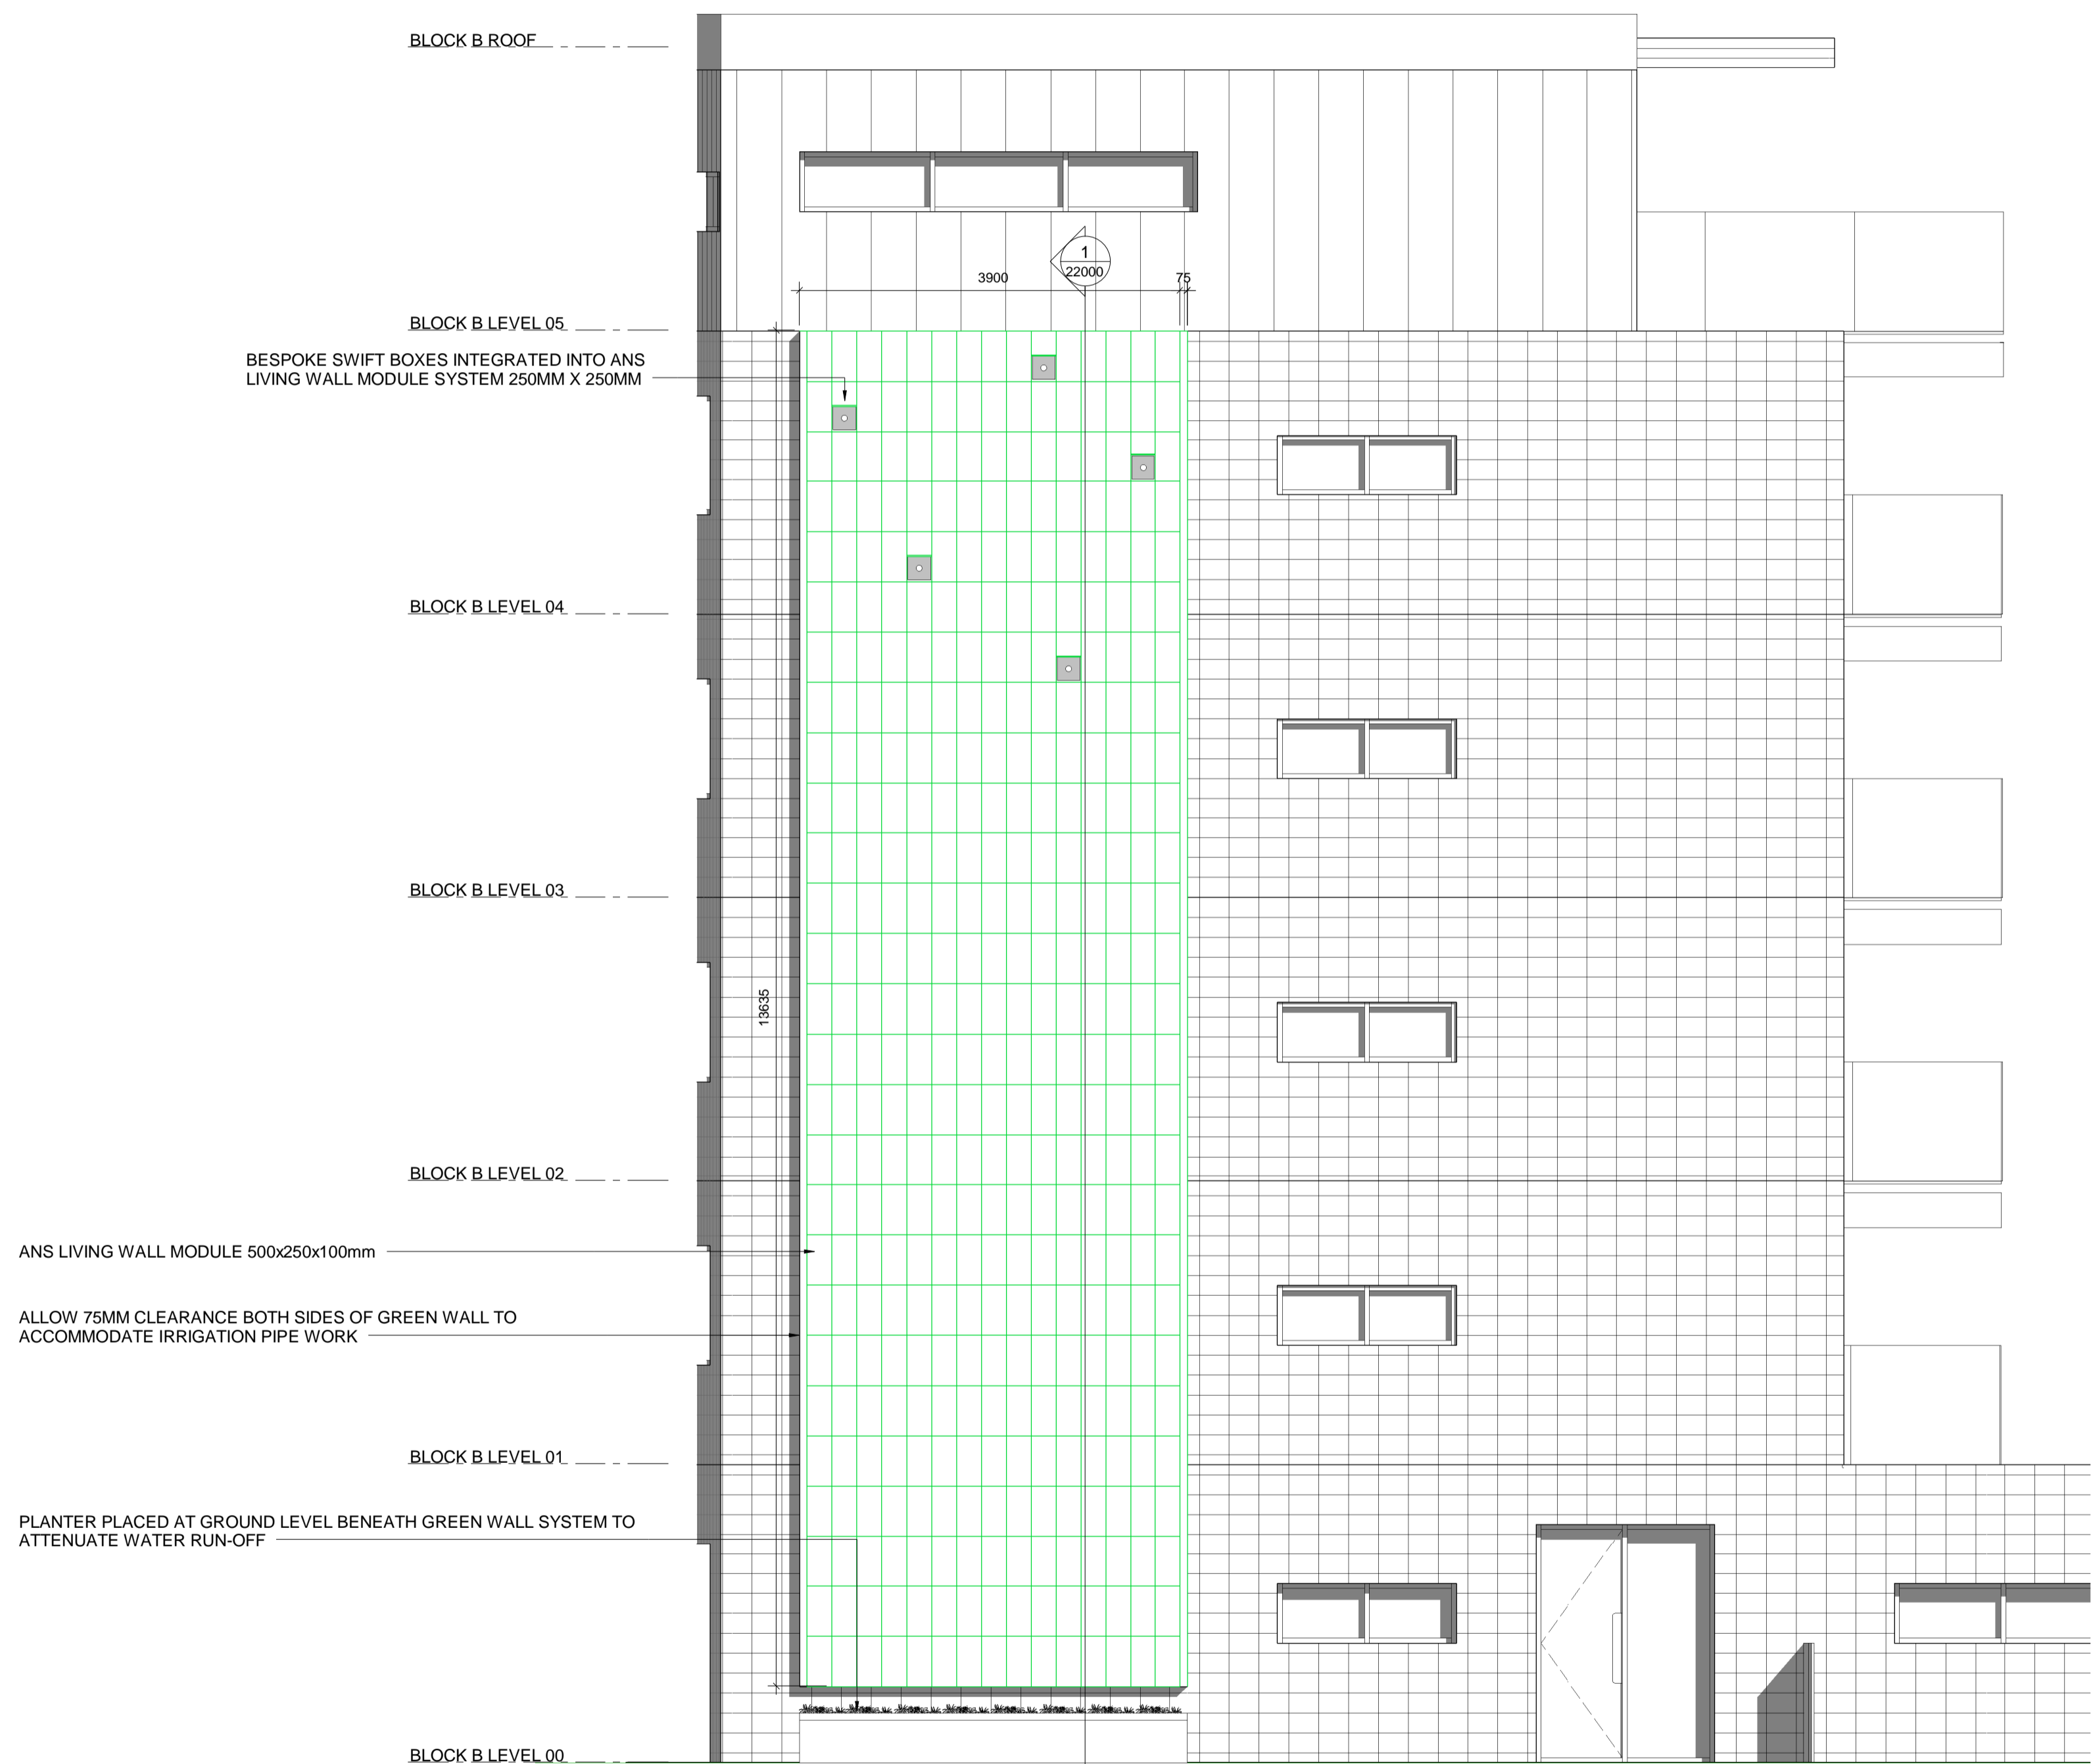
2 Block B Green Wall Setting Out 1:50

THE BIRD BOXES HAVE BEEN PLACED 2-4 METERS UP THE LIVING WALLS AVOIDING STRONG SUNLIGHT AND THE WETTEST WINDS. THIS WE HAVE LOCATED ALL BIRD BOXES ON THE EASTERN LIVING WALL LOCATED ON BLOCK A

BIRD BOXES PLACED HIGH ON THE LIVING WALL CAN BE READILY USED BY HOUSE SPARROWS AND STARLINGS. AS THE BIRDS NEST IN LOOSE COLONIES, TWO OR THREE BIRD BOXES CAN BE SITED SPACED OUT ON THE SAME SIDE OF THE BUILDING.

BAT BOXES
UNDER THE ADVICE OF AN ECOLOGIST 3 BAT BOXES HAVE BEEN PLACED ON EACH LIVING WALL ELEVATION AT LEAST 4-5 M ABOVE GROUND LEVEL.

THEY ARE LOCATED IN AREAS SHELTERED FROM WINDS AND EXPOSED TO THE SUN FOR PART OF THE DAY

BAT BOXES HAVE BEEN REMOVED FROM THE WEST ELEVATION GREEN WALL UNDER THE ADVICE OF CAMDEN COUNCIL SUSTAINABILITY OFFICER - AMY FARTHING

SWIFT BOXES HAVE BEEN INTEGRATED INTO THE GREEN WALL SPECIFICALLY LOCATED AT THE TOP OF THE GREEN WALL ON THE WEST ELEVATION UNDER THE ADVICE OF CAMDEN COUNCIL SUSTAINABILITY OFFICER - AMY FARTHING

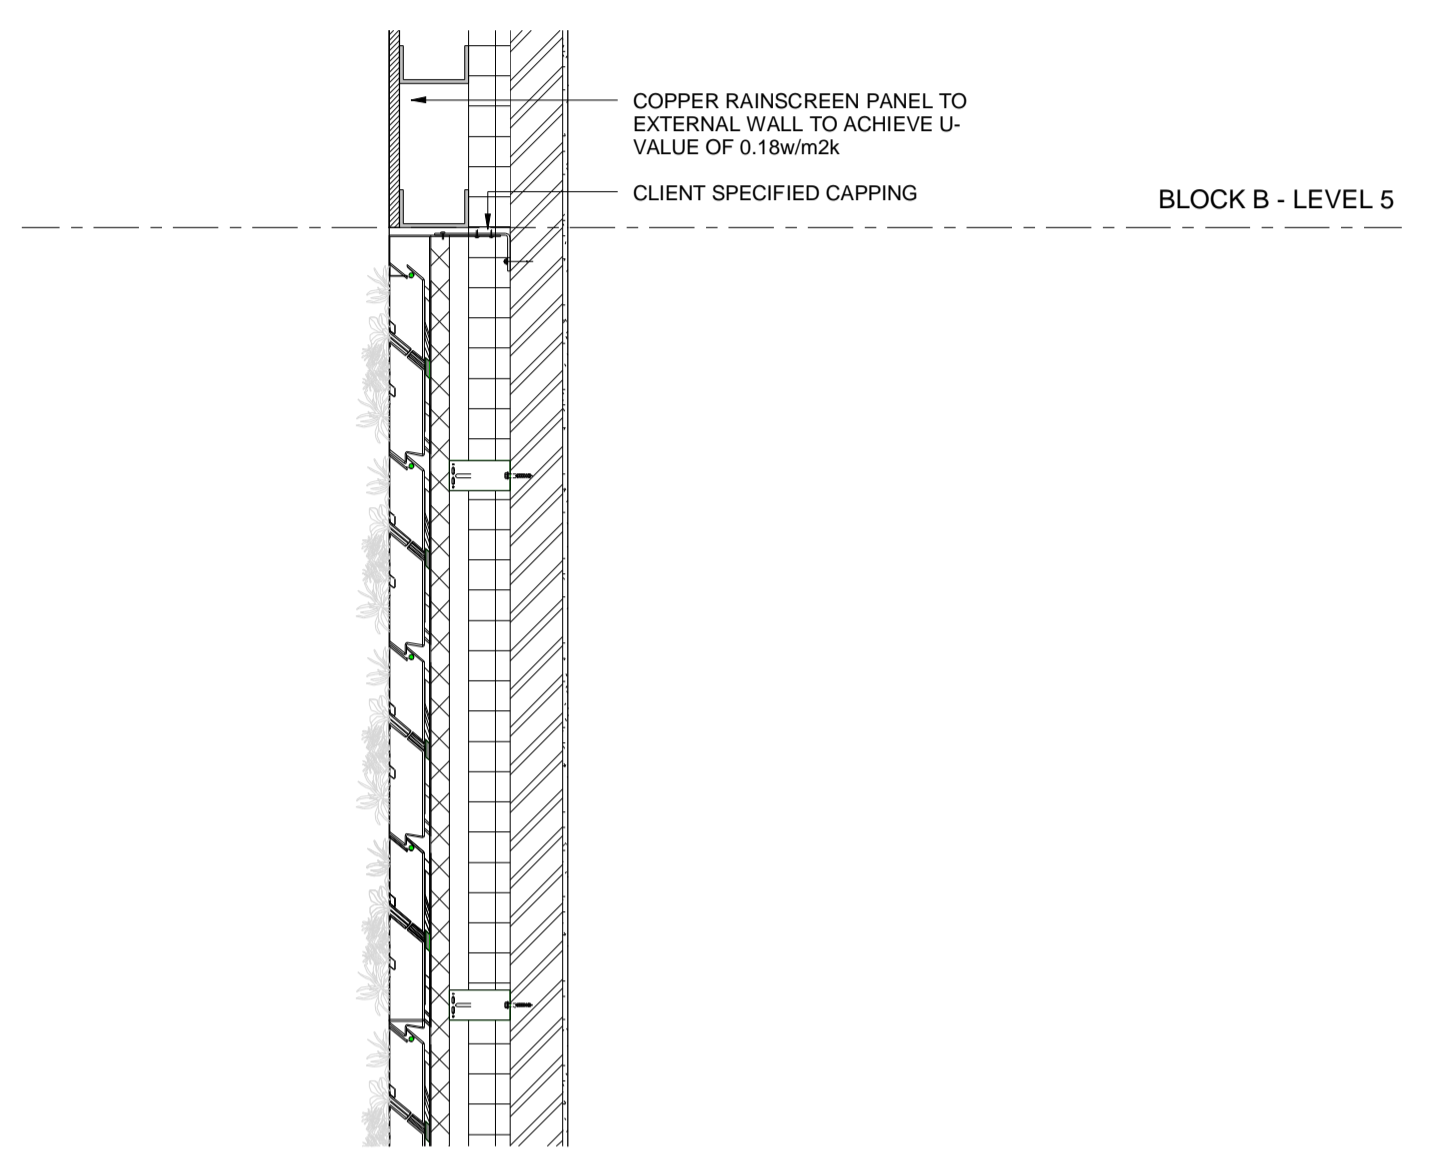
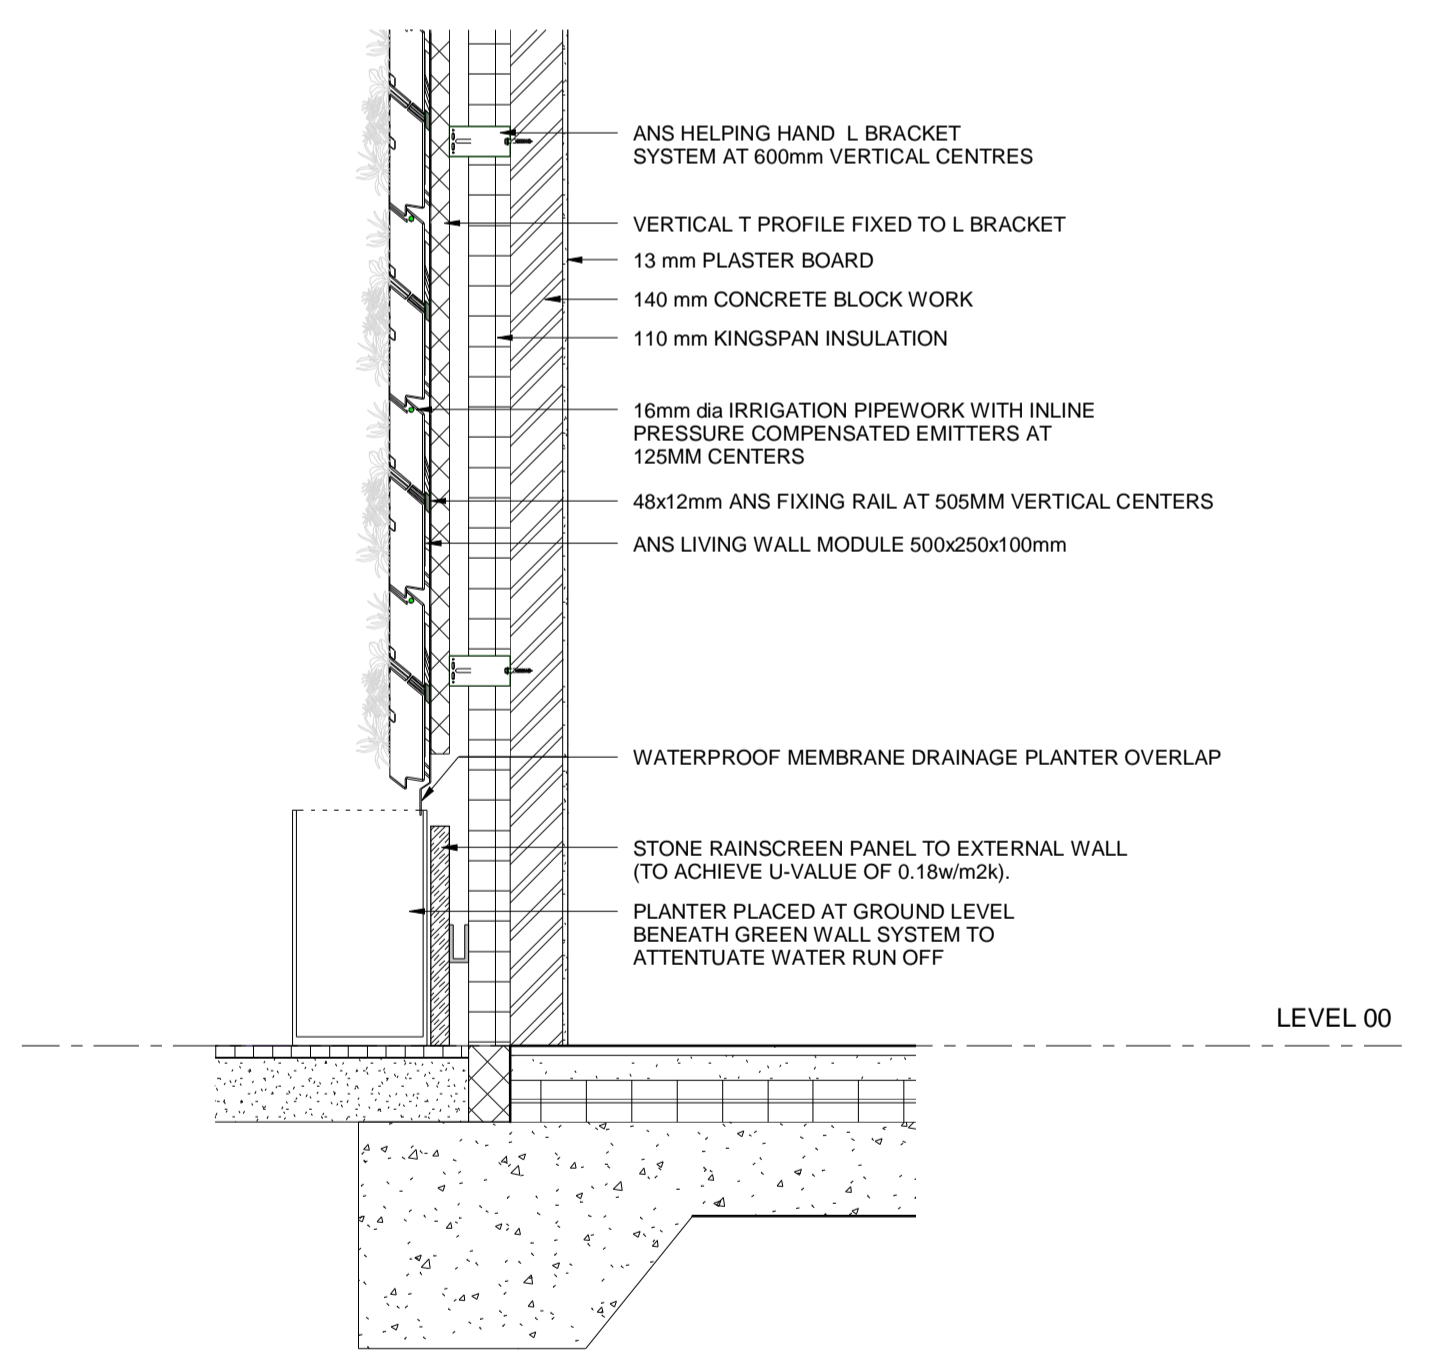
1 BLOCK B GREEN WALL SECTION 1:20

BIRD BOXES
SITING BIRD BOXES INTEGRATED INTO GREEN WALL MODULES WILL BE USED WITH A VIEW TO ATTRACTING TITS, SPARROWS OR STARLINGS, ROBINS AND WRENS.
